Santos, Rodrigo B; Dourado, Francisco; Schumm, Leonard  
Hazard Mapping in Urban Environmental Protected Areas: Tijuca National Park  
urbe. Revista Brasileira de Gestão Urbana, vol. 15, e2020210, 2023  
Pontifícia Universidade Católica do Paraná

# Hazard Mapping in Urban Environmental Protected Areas: Tijuca National Park

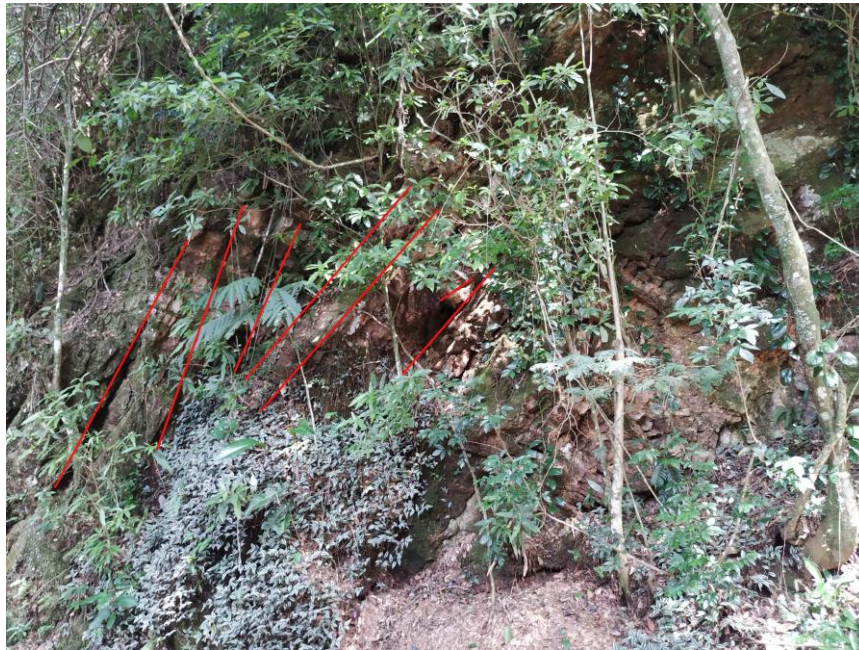
There are two types of road cuts: rock and soil. In most cases, the rock cuts have a high density of fracture families, which favors the fall of blocks (Figure 4).

**Figure 4** – Biotite-Gnaiss outcrop in an advanced stage of weathering with its high angle bedding leaning towards the road. Source: Authors (2022).

This fracturing pattern, which reflects the regional geology, can also be seen in the banding of the biotite-gnaiss, presenting a sagging to the road. The landslides might happen because of consolidated material characterized by a high degree of fracturing and friability. Ideally, the cuts in banded rocks should always be done perpendicularly, thus avoiding cutting the layers, resulting in a lower probability of debonding. If this is not possible, as was the case at some points on Redentor Road, the correct thing to do is to apply some kind of containment structure, avoiding greater damage. In addition, these exposed rocks are highly susceptible to weathering (Toledo, 2014). This, added to the ease of weathering, increases the hazard in the area. According to Highland & Bobrowsky (2008), oriented structural discontinuity is one of the triggering mechanisms of landslides.

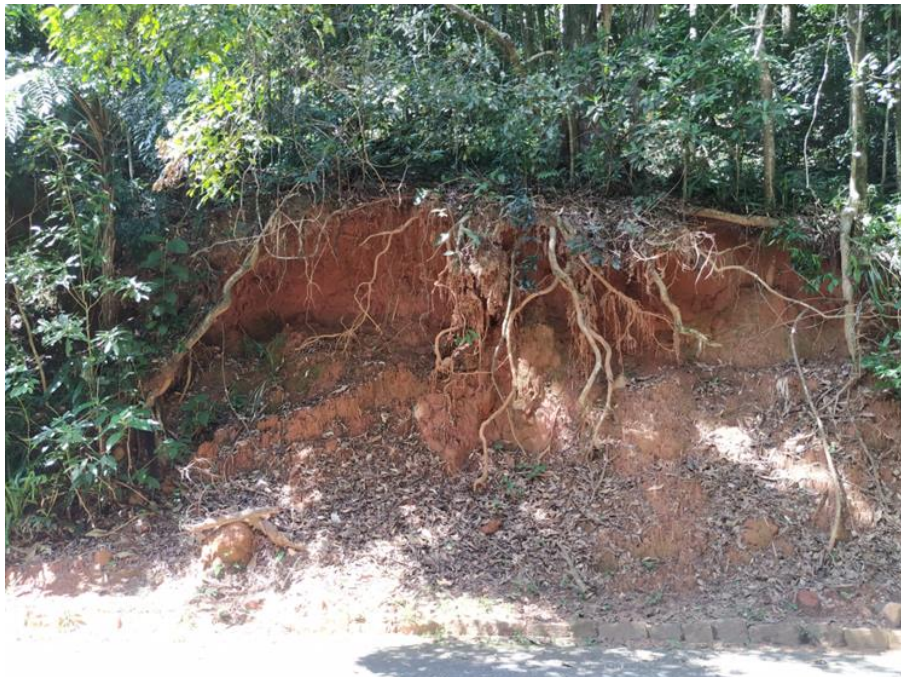
On the other hand, soil cuts often present a high erodibility rate, and record small mass movements, resulting in destabilization of the cut, exposure of roots (Figure 5). All these consequences result in increasing even more the erodibility rate, especially in periods of high rainfall, since the rain has the ability of causing erosion due its kinetic energy of the raindrops summed to the area slope and soil characteristics (Roose,1978).

**Figure 5** – Road cut in soil with a small mass movement and roots exposure, culminating in the increase of erodibility rate and hazard level. Source: Authors (2022).

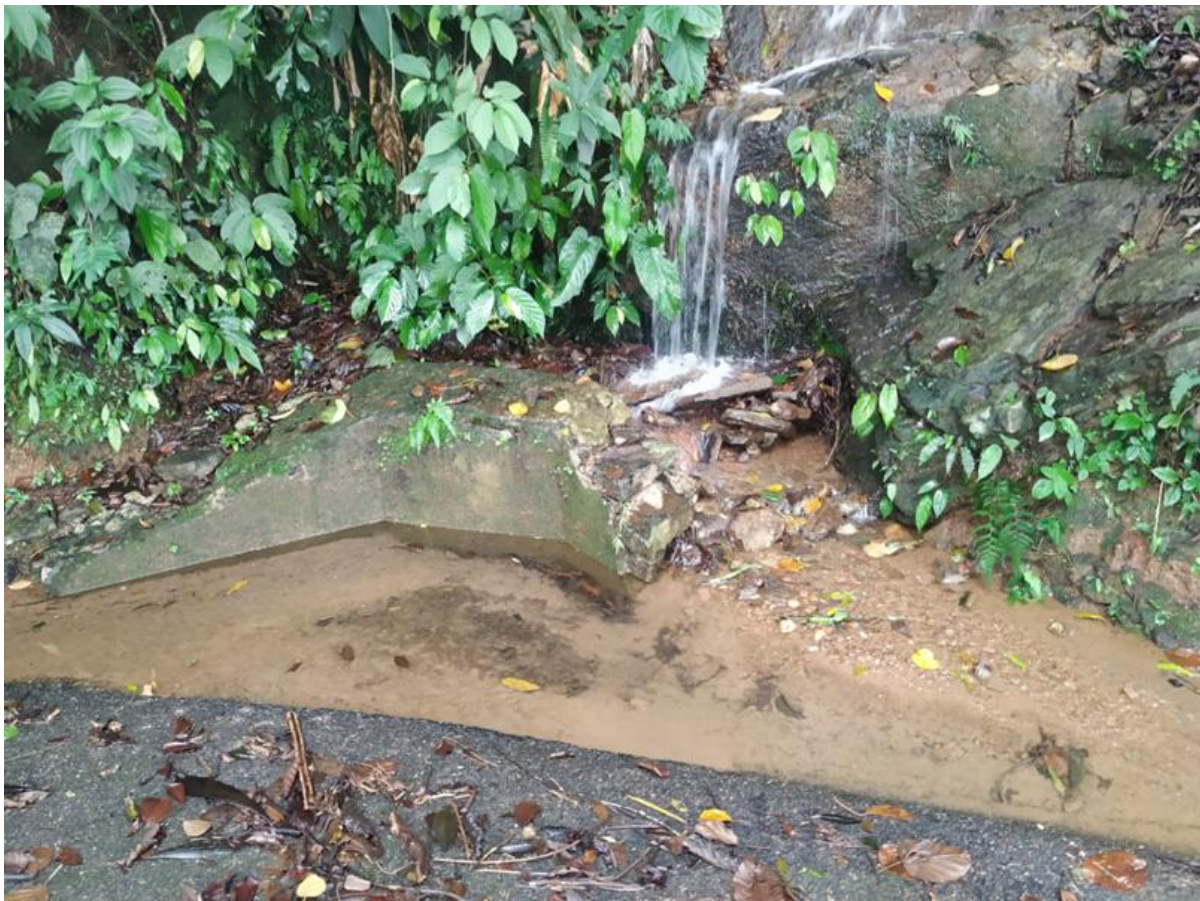
**Figure 6** – Manhole completely clogged by sediments coming from a drainage in Central sector. Source: Authors (2022).

Most clogged manholes are in sectors with higher water presence. The reason for clogging is the presence of several drainage channels, which may be intermittent or not, and end up carrying many sediments of the most varied types, from silty fraction to rolled blocks. Therefore, the water is not properly drained by the drainage system, thus flowing through the road and its cracks. These cracks, as shown in Figure 6, sometimes present long extensions, reaching up to 30m in length.

- (a) Periodic surveys along the Road to evaluate the conditions.
- b) Development of a study and application of this methodology on Sumaré Road.
- c) Evaluation of the danger in the highlighted areas and start mitigation plans.
- d) Cleaning of the manholes during rainy periods.
- e) Maintenance of the existing containment structures.

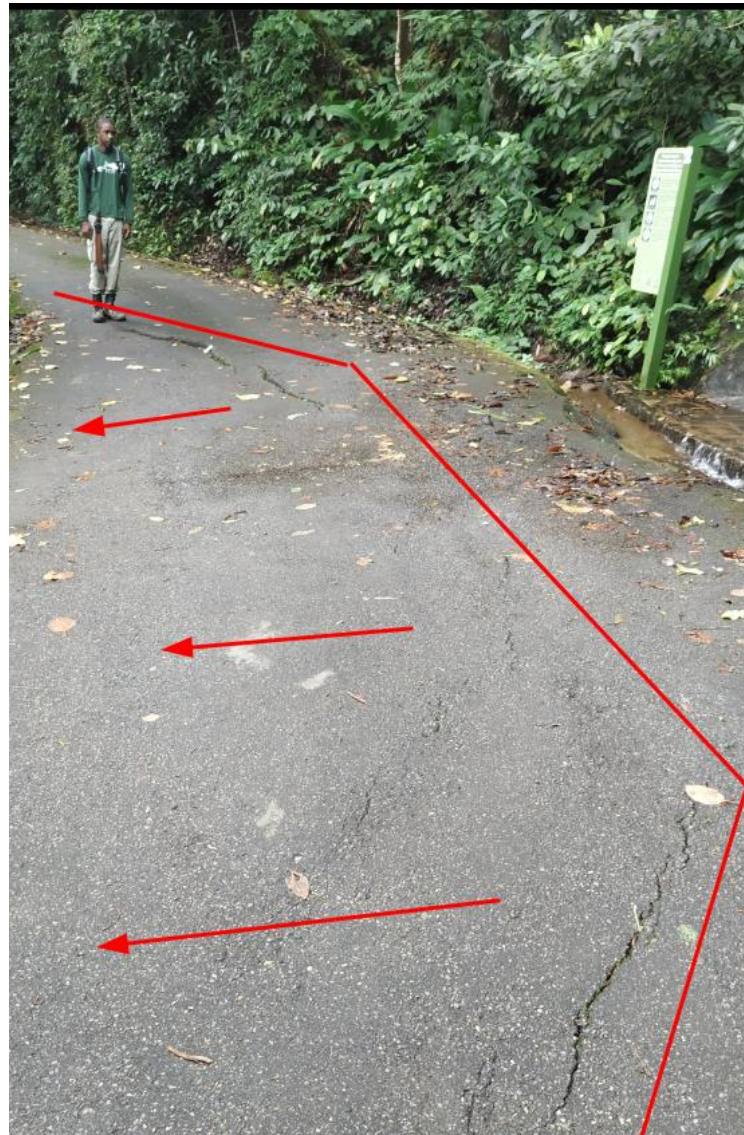
**Figure 7** – Road cracks with significant displacement nearby a clogged manhole, indicating subsidence towards downstream. Source: Authors (2022).

These asphalt displacements, in most cases, had a vertical variation of up to 5 cm, which indicates a creep, and eventually may culminate in a landslide. Most likely, the relationship between these two features, clogged manholes and cracks in the asphalt, are because water infiltrates into the soil layer below the asphalt, and also because of the intense flow. These two processes cause the carrying of these supporting sediments, thus causing the asphalt layer to settle.

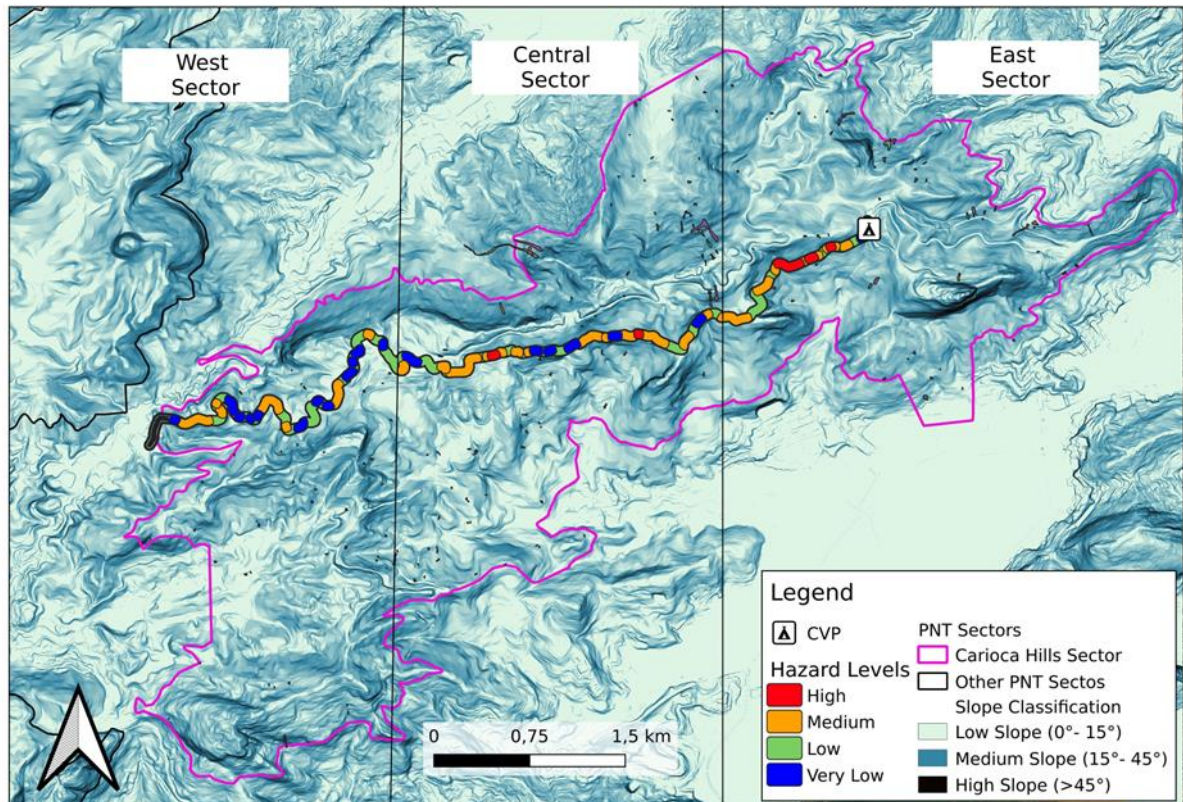
All data analyzed resulted in the Hazard Map for the Redentor Road, with locations where there is danger, divided into three sectors (West, Middle and East), in order to facilitate data interpretation. The East and Middle sectors have longer zoned in which the danger level is medium or high, in relation to the West sector (Figure 8).

**Figure 8** – Slope and Hazard Maps around Redentor Road. The slope classified as low is represented by a light blue color; medium slope is in blue and high slope in black. The classification for slopes is presented in Table 2. The colors and hazard classifications are described in Table 2. The road was segmented in three sectors in order to facilitate the interpretation. Source: Authors (2022).

In Redentor Road, there are 3784.3m of low hazard zones (47.46%), it is the longest length classification. Then, the second longest is the medium hazard zone, with 2743.7 meters (34.42%). The least common hazard classes in length are very low with 1091m (13.66%) and high with 353.2 meters (4.46%).
