# Exploring the Lighthouse of *El Morro* in San Felipe: Professional Practice and Academic Collaboration for the Conservation of Immovable Cultural Heritage in Old San Juan, Puerto Rico

**ABSTRACT**

This work describes the conservation practice carried out in the Lighthouse in the *El Morro* Castle in San Felipe, Old San Juan, Puerto Rico; located in a 16<sup>th</sup> century fortification that went through two phases of construction, whose different materials now present deterioration specific to coastal environments: humidity, salinity, and wind erosion. As a building listed in the World Heritage Sites (WHS, UNESCO), coordination between local authorities and the US National Park Service (NPS) is crucial for the conservation and management of the Lighthouse in the *El Morro* Castle in San Felipe. Moreover, professional practices between academic institutions in Latin America and the Caribbean in the field of conservation and restoration of immovable cultural property are essential to deepen the knowledge and skills of professionals; however, improvements in the availability of resources and time are necessary to maximize their effectiveness.

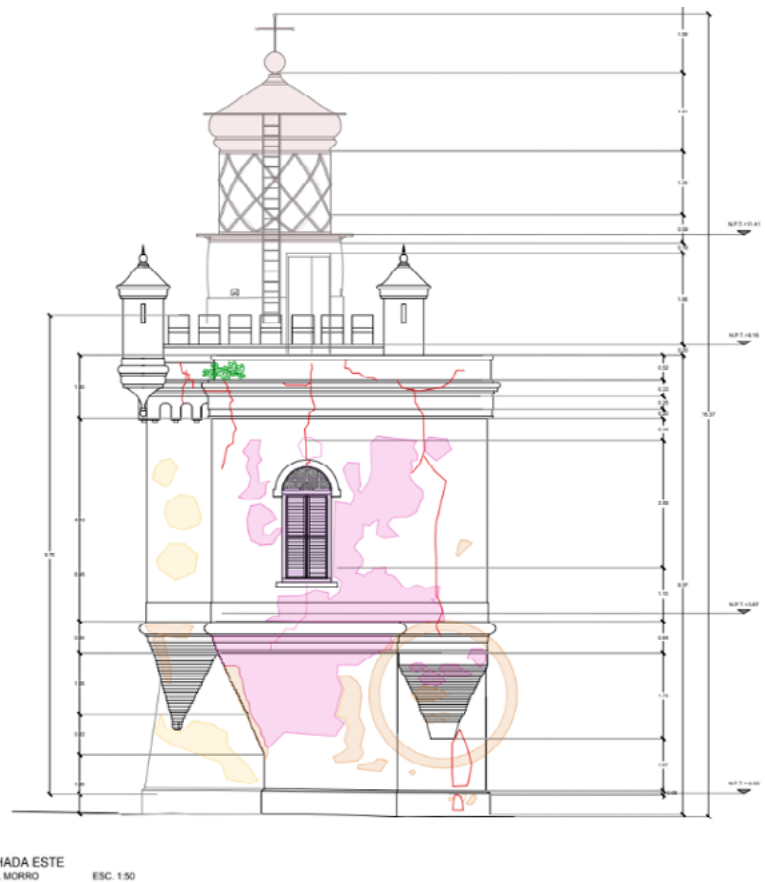
Damage to the Lighthouse is predominantly related to lack of maintenance, visible in the building's finishes, both interior and exterior. These have been caused by water infiltrations in the cover and structural problems resulting from the geometry of the building, which has led to cracks and fissures of cantilever elements. Furthermore, factors of the coastal environment, which promote corrosion of metal objects, the emergence of efflorescence on walls and weathering of masonry elements. Additionally, through *in situ* observation we identified that the materials used during the different periods did not react to the environment in the same way, determining that (Figures 6 and 7):

FIGURE 6.  
Schematic of the  
damage survey of *El  
Morro* Lighthouse  
in San Felipe (East  
elevation) (Drawing:  
Sarahí Soriano  
and Rodrigo Sáinz,  
2019).
