## Application of GUT Matrix in the assessment of pathological manifestations in heritage constructions

Revista de la Asociación Latinoamericana de Control de Calidad, Patología y Recuperación de la Construcción,  
vol. 9, no. 3, 2019

The present paper presents the application of GUT (Gravity, Urgency, Tendency) Matrix methodology as a tool in the assessment of pathological manifestations in buildings. Three heritage constructions of the historic center of Sobral, Ceará, Brazil were studied through in situ inspections, photographic records and elaboration of the damage map. The GUT Matrix was used as a tool to rank, in each building, priority levels for each damage in order to define their order of treatment. Thus, it was possible to conclude that the applied method can be used as a useful tool to manage the maintenance of buildings through prioritization of the most significant problems and, to contribute directly to the preservation and safety of the built historical heritage.

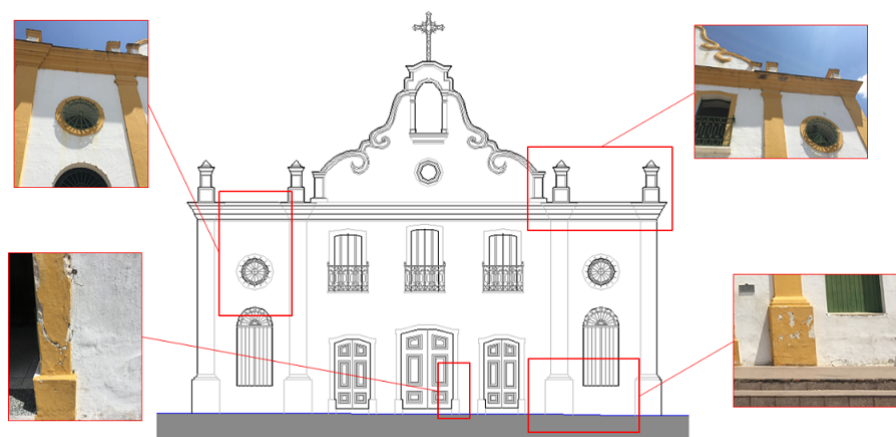
in this work through the GUT Matrix, enriches the results and contributes to their reliability. The inspection of this first church was carried out from the outside to the inside, where firstly the four facades and later the interior were inspected. During inspection the following pathological manifestations were identified: fissures and cracks, disintegration of lining elements, detachment of coating, humidity stains, atmospheric stains, mold/mildew. The main facade presented the biggest number of damages and it is represented by the damage map shown in Figure 4, where detachments are observed in the lower parts of the structure, in the openings and in the central door column some cracks are also visualized, and atmospheric stains can be seen on the top of the church.

The main reason for cracking may be associated with the vibrations existing in the place, because it is located in a central region of the Sobral city and there is a large flow of people and vehicles nearby, that can induce vibrations causing changes in the structure dynamic behavior, which often lead to fissures.

FIGURE 4  
Damage map of the main facade of Nossa Senhora do Rosário Church.

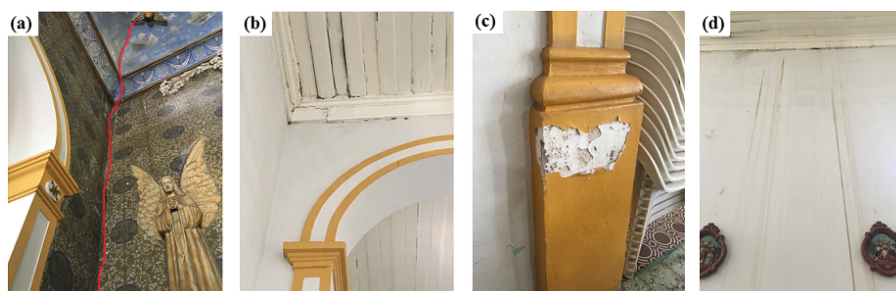
FIGURE 5  
Internal pathological manifestations of the Nossa Senhora do Rosário Church: (a) crack, (b) disintegration of lining elements, (c) detachment and (d) humidity stains.

In the internal part of the church the main, the following pathological manifestations were observed: crack, disintegration of lining elements, detachments and humidity stains, as illustrated by the Figure 5. The most serious situation was the crack located near the altar (Figure 5 (a)), because its presence may be associated with the movements adjacent to the building and new constructions in the vicinity of the sanctuary. These movements occasionally cause sinking of the soil and cracks and fissures in some parts of the church.

For the Gravity in the application of the GUT methodology a score 8 was attributed to the crack located near the altar due its large opening. For the Urgency, a score 8 was also inserted due large area of commitment of this damage that requires urgent intervention. Regarding Tendency, a score 6 is attributed knowing that the problem is in a situation of average progression.

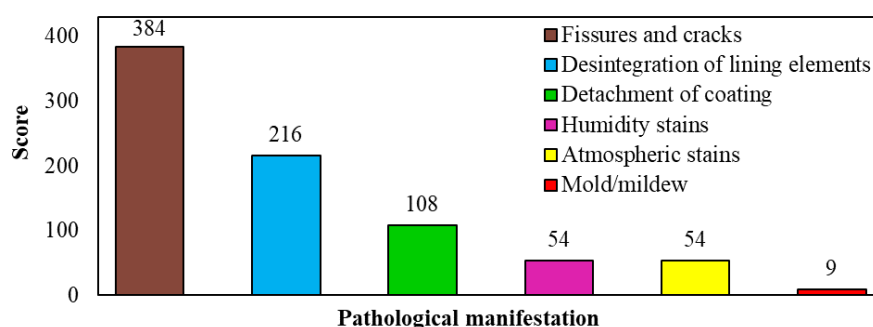
From the application of the checklist of the GUT Matrix in this building it was possible to elaborate the graph of priorities, which is represented by Figure 6, where it is possible to verify that priority pathological manifestations, that must be treated first, are fissures and cracks, in this case, in the main altar of the church, because it presents the highest scores, 384 scores, and represents a high priority damage, according to the descriptions in Tables 1, 2 and 3 of Section 2.

Second, in the order of priorities, it is the disintegration of lining elements with a total of 216 scores, being framed as an average damage. In the third position are the detachments of coating with 108 scores, being also framed in the degree of average damage. Humidity stains and atmospheric stains, both with 54 scores, are also identified as average damage. The damage with lowest severity, which is in the last position of the order of priorities, is mold /mildew, with 9 scores and low damage.

FIGURE 6

Priority graphic of the Nossa Senhora do Rosário Church.

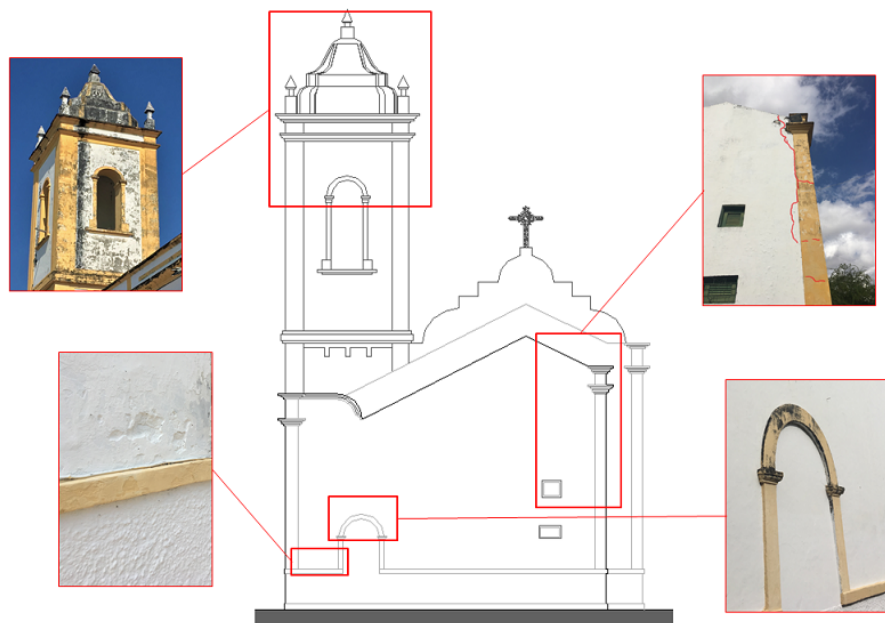
The pathological manifestations identified in the Nossa Senhora das Dores Church were the most numerous among the three churches analyzed. In many parts of the structure, several types of damages were found such as fissures, detachments and humidity stains and atmospheric stains. The damages observed were fissures and cracks, infiltrations, disintegration of lining elements, electrical system failures, mold/mildew, atmospheric stains, humidity stains, detachment of coating, disaggregation of roof elements, grouting inefficiency, frame failure, efflorescence and oxidation of metallic elements. The damage map of this building is presented through its facade with more incidence of pathological manifestations, the back facade, as illustrated by Figure 7.

FIGURE 7  
Damage map of the Nossa Senhora das Dores Church.

Figure 7 shows the incidence of a large amount of atmospheric stains in the lateral tower and also in the upper parts of the church. This type of damage was also evident in all other facades. A large crack in the right part of this figure, that starts from the mid height of the wall to the top, was observed. This anomaly is closely linked to a possible sinking of the soil, considering that the structure is located near of the Acaraú River and that over time was impacted by numerous new constructions in the vicinity. Besides this region, in the circular openings of the other facades, this type of damage is also evidenced. There are also detachments of coating in the lower part of this facade, which are also found in the other facades.

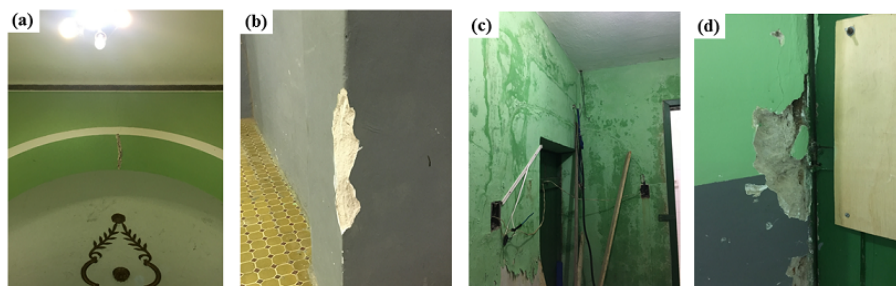
The main pathological manifestations observed in the internal part of the structure were: fissures and cracks, detachment of coating, humidity stains and detachment of coating with exposure of parts of the frame, which are illustrated in Figure 8. In Figure 8 (a), there is the most severe pathological manifestation for this building: a crack located in the central arch of the main nave. This anomaly is in a very aggravated situation, being its occurrence related to the incidence of soil movement of the foundation and to a possible overload in the arch, since many interventions with an increase of load were executed over time, as for example, the exchange of a lining that was previously made of PVC by a slab of reinforced concrete. Thus, to Gravity, a score 10 was attributed, that is, the maximum score of the method here used, which causes a high impairment of the performance of the building. Regarding Urgency, a score 10 was also inserted, due to the large area of commitment of this manifestation, requiring urgent intervention. And for Tendency it was also chosen a score 10, corresponding to the large possibility of evolution of the situation.

FIGURE 8

Internal pathological manifestations of the Nossa Senhora das Dores Church: (a) crack in the central arch, (b) detachment of coating, (c) humidity stains and (d) detachment of coating with exposure of the frame parts.

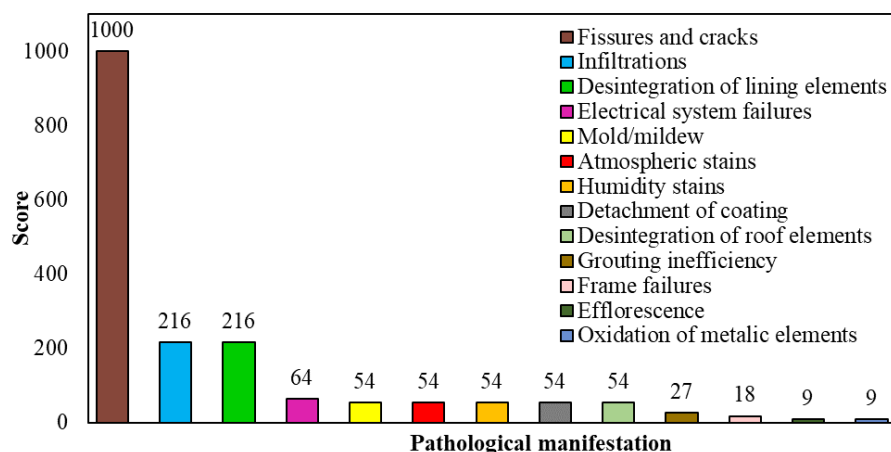
The data obtained from the application of the GUT Matrix in this building were organized in the priority graph shown in Figure 9, where it is verified that the pathological manifestation of highest priority is the crack in the central arch of the main nave, with a total of 1000 scores, which classifies it as a total damage, that is, of extreme gravity, urgency of solution and fast tendency of evolution. In addition, the difference between this damage and the two other (infiltration and disintegration of lining elements, both with 216 scores each) is very high, that corresponds to 784 scores, which show the severity of this crack.

FIGURE 9

Priority graphic of the Nossa Senhora das Dores Church.

Four pathological manifestations presented the same scores (54 scores): mold/ mildew, atmospheric stains, humidity stains, detachment of coating, which evidences pathological manifestations of average damage. The damages: grouting inefficiency (27 scores), frame failure (18 scores), efflorescence (9 scores) and oxidation of metallic elements (9 scores) correspond to category of low potential damages, the latter two occupying the final position of the order of prioritization.

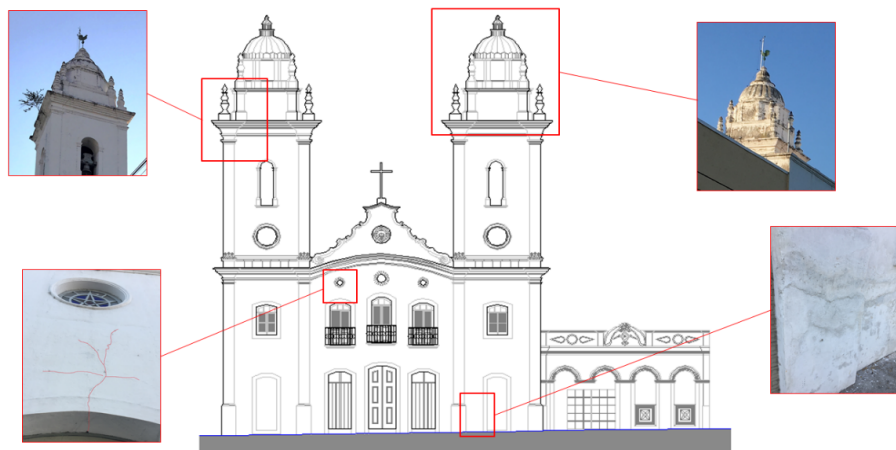
The right lateral facade (connected to the lateral courtyard) and the back facade of the Menino Deus Church were not analyzed because these two facades are linked to the adjacent buildings. However, the other facades as well the internal area were thoroughly inspected, and the main facade presented the most severe damages, which can be observed in Figure 10, where the most evident were: atmospheric stains, located in many regions of the structure mainly on top of the two towers; fissures in the vicinity of circular openings of all doors and windows and in the lower part the columns of a tower, which is accompanied by detachment of coating; and rooting of shrubs, located at the top of the left lateral tower.

FIGURE 10  
Pathological manifestations of the Menino Deus Church.

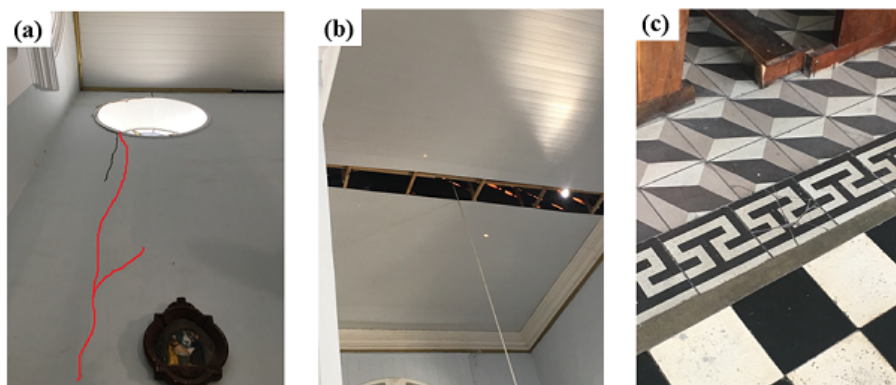
In the internal part of the church the main damages observed were fissures and cracks, disintegration of lining elements and disintegration of floor elements, as shown in Figure 11. Disintegration of lining elements was observed in many parts of the roof, as well as fissures.

FIGURE 11  
Pathological manifestations in the internal part of the Menino Deus Church: (a) Fissures, (b) disintegration of lining elements and (c) disaggregation of floor elements.

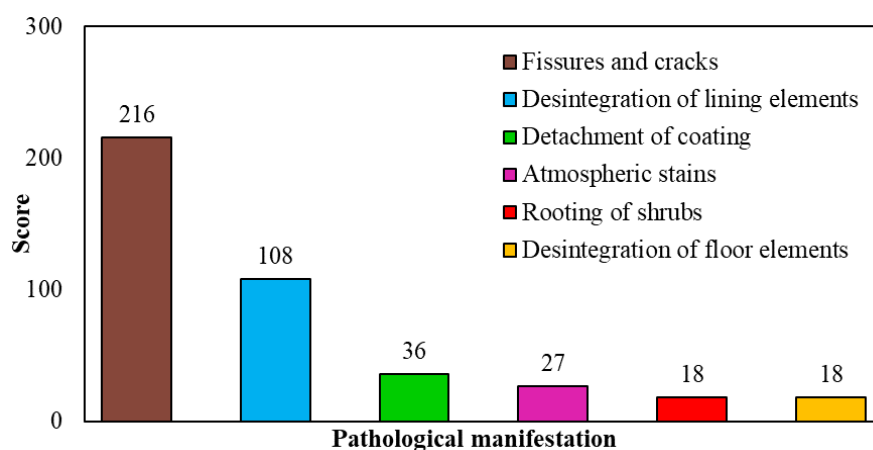
With the results of the checklist of GUT Matrix applied in this building, the graph of priorities was constructed and it is illustrated in Figure 12, where it is verified that the most prioritized pathological manifestation are the fissures, which can be observed in the upper opening of the front facade door (Figure 10) and also in an internal wall of the left lateral facade (Figure 11 (a)). The scores of this anomaly corresponds to 216 and are obtained by applying to the Severity, Urgency and Tendency 6 scores per each one, being

therefore an average priority damage. In second position is the detachment of coating that presents a total of 108 scores, being also an average damage. In third and fourth positions are the disaggregation of lining elements and atmospheric stains, with 36 and 27 scores each one, being classified as average and low damage, respectively. In the final positions in the order of priorities, are the rooting of shrubs and the disintegration of floor elements, with 18 scores each, classified as low damage.

FIGURE 12  
Priority graphic of the Menino Deus Church.

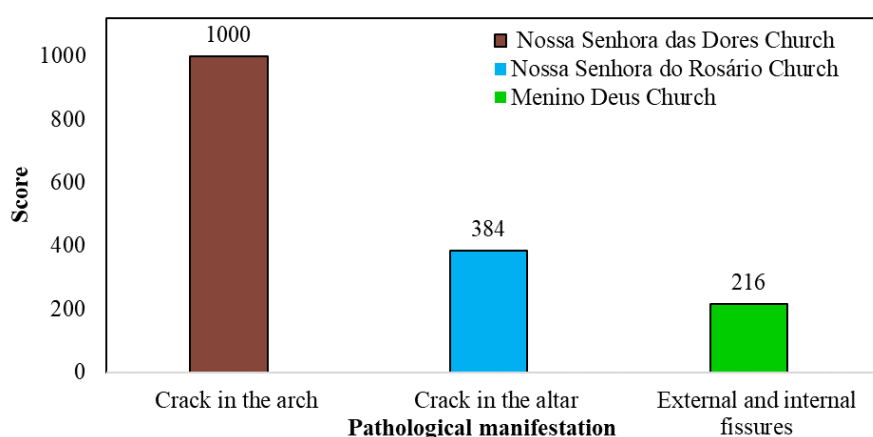
By the comparative analysis of the pathological manifestations listed in first position for each church and having as parameter its total score, among the three buildings studied, the Nossa Senhora das Dores Church presented the most severe damage with a total of 1000 scores for the crack in the central arch of the main nave. The second most severe was the Nossa Senhora do Rosário Church with a total of 384 scores also for a crack in the main altar. And finally, the third most severe damages were the fissures present in the main facade near the opening of the upper window, in the lower part of one of the columns of a tower and in walls of the internal part of the Menino Deus Church with a total of 216 scores. Figure 13 shows the comparison between the most severe damages of these churches.

FIGURE 13

Comparative graphic between the most severe pathological manifestations for each church.
