Practical use of the safety factor in the column repair strategy of a concrete building with historical value

Briceño-Mena, J. A.; Castro-Borges, P.

Revista de la Asociación Latinoamericana de Control de Calidad, Patología y Recuperación de la Construcción,
vol. 12, núm. 1, 98-109, 2022

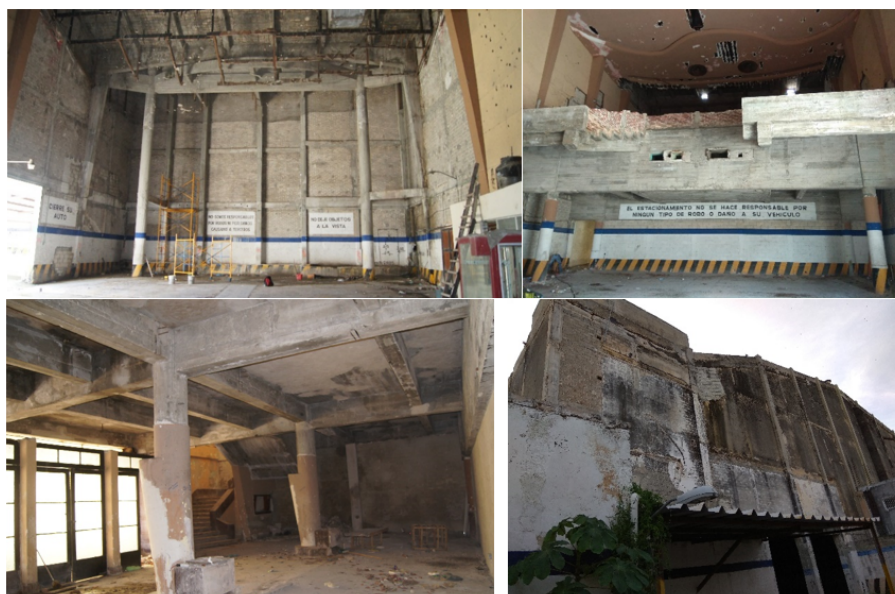
FIGURE 2

The structure had as its primary function that of being a cinema, later it functioned as a parking lot and was finally abandoned. These changes in use and abandonment were factors that potentiated the damage, as partially observed in the photos of Figure 2.

State of the structure before being repaired. To develop an optimal repair, a structural analysis should be considered where the construction processes to be carried out during said intervention are considered since, during this process, loads can be added or removed due to the demolition of elements, vibrations, changes in the same properties of the repair materials, changes in resistance, shoring, among others (Ministerio de Vivienda y Urbanismo – Minvu, 2018; Allen, 1991). Therefore, it is important to establish the values with which it will work, such as the old and new resistance of the elements, safety factors, to name a few. In the present work it is illustrated, for the case of the columns, how the safety factor (SF) was used for the repair of the former Selem cinema.

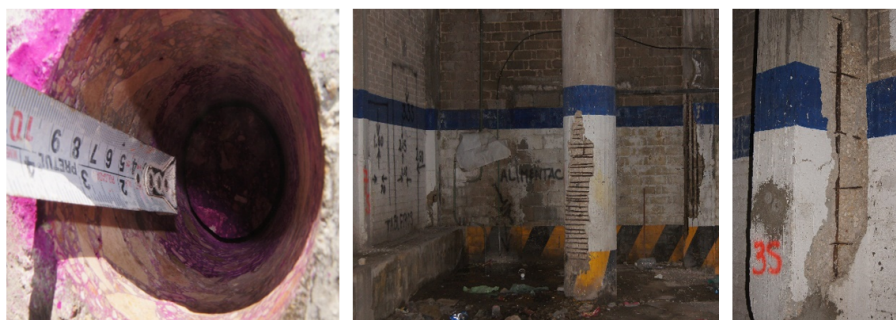
FIGURE 3
Carbonation and detachment of concrete.

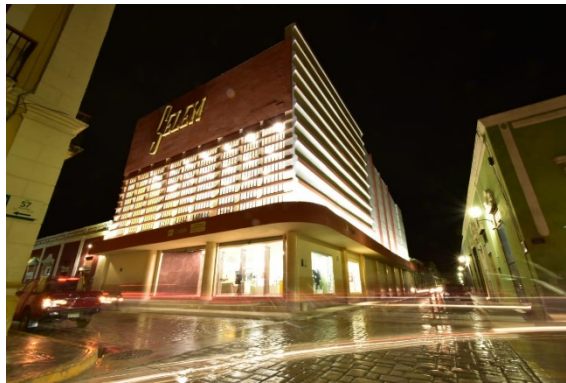
FIGURE 7
View of the intervention building
