Gallardo-Saavedra, Sara; Hernández-Callejo, Luis; Duque-Pérez, Óscar
Analysis and characterization of PV module defects by thermographic inspection

Revista Facultad de Ingeniería Universidad de
Antioquia, no. 93, 2019, October-December, pp. 92-104
Facultad de Ingeniería, Universidad de Antioquia

Analysis and characterization of PV module defects by thermographic inspection

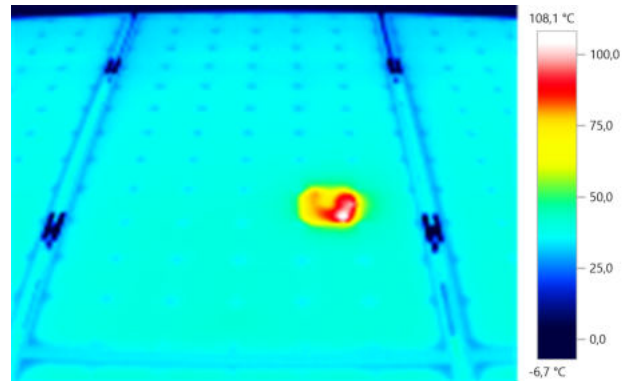
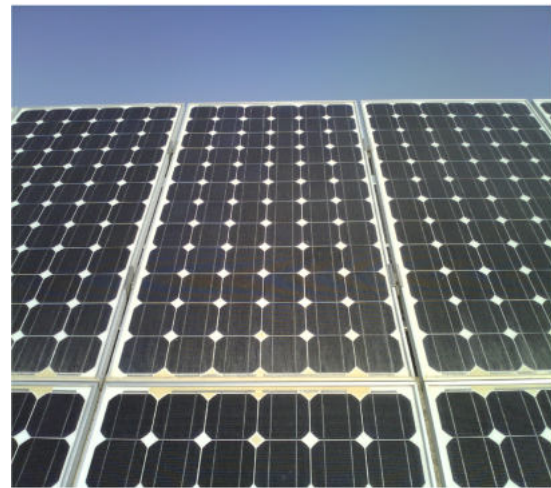
Reviewing all cells hotspot defects, it has been concluded that the pattern of this fault is an overheated cell, of approximate $15 \times 15 \text{ cm}^2$ depending on the module manufacturer, located in any cell along the module. The analysis performed does not reveal any preference of appearance of the overheated cell in any of the three strings circuits. The following figure, Figure 7, presents the ΔT of each of the 859 cell hotspots detected in the inspection in descending ΔT order, obtaining an average temperature of 12.4°C with a standard deviation on 12.8°C . Other relevant statistical values are the median, 7.4°C , and the first and third quartile, 3.8°C and 17.8°C , respectively. As it can be seen in Figure 7, the highest ΔT detected in the tests is 77.4°C , which supposes a cell hotspot

Figure 4 Hotspot located in the third string of a module, with a ΔT of 71°C

temperature of over 130°C . Reaching high temperatures can generate a fire hazard. Authors in [38] determined that the maximum hot-spot temperature on rear surface of PV module reached to 347°C with bypass diode not turned ON condition.

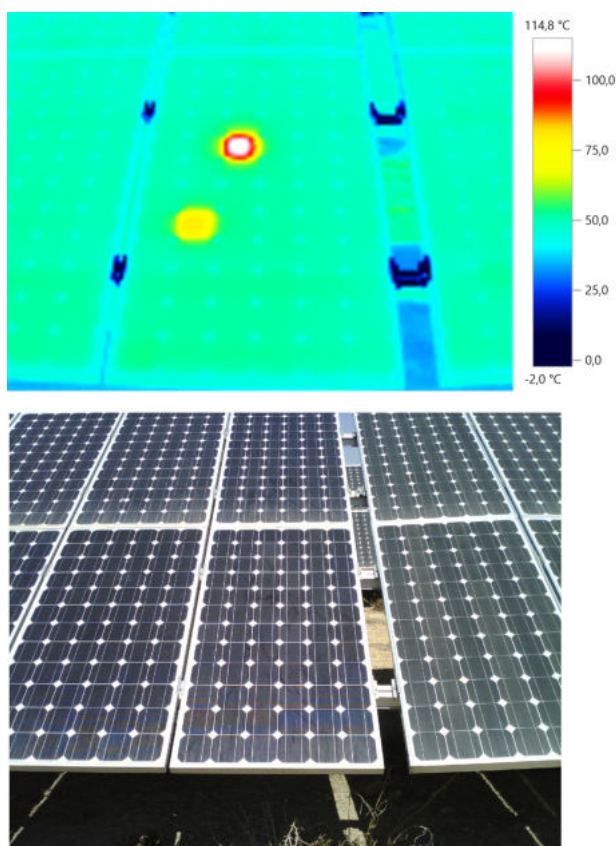
Figure 5 Two overheated cells within a module, one in the first bypass circuit and the most overheated in the second circuit, with a ΔT of 63.5°C

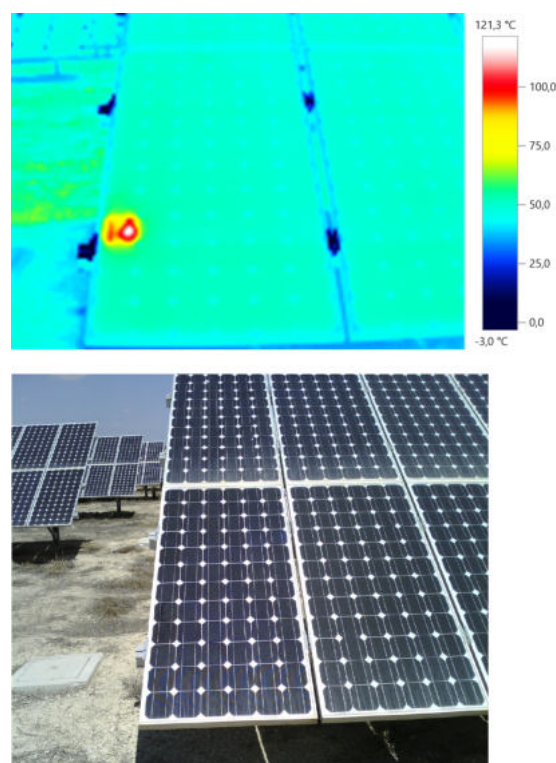
Figure 6 Overheated cell in the first bypass circuit next to the module frame, with a ΔT of 71.2°C

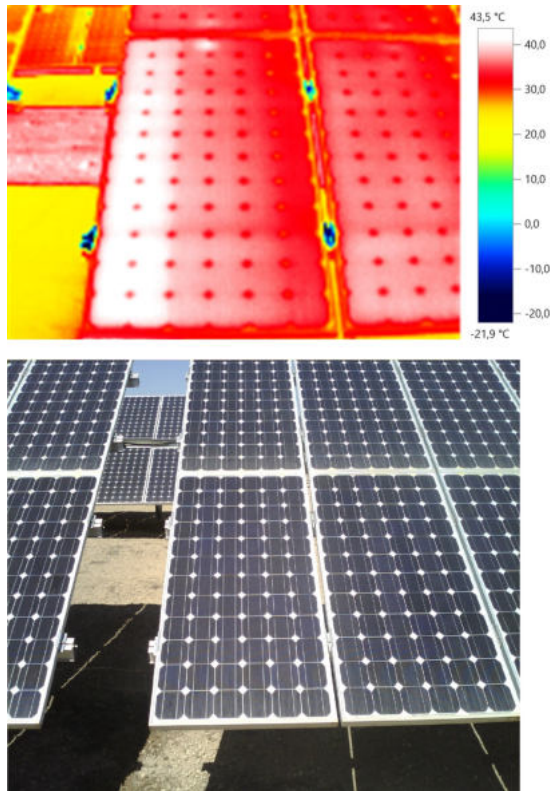
The thermographic and visual image of one bypass circuit overheated with a temperature difference of 5.7°C between the healthy area and the overheated bypass is presented in Figure 8.

Figure 8 Bypass circuit overheated with a ΔT of 5.7°C

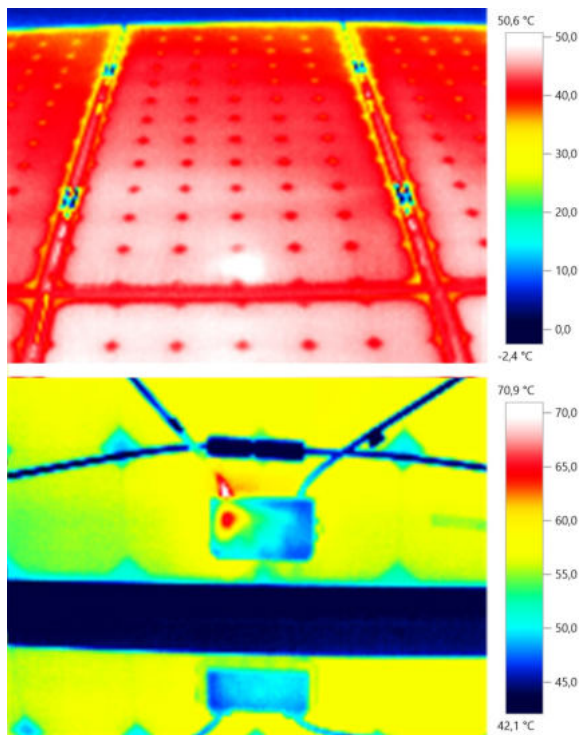
In relation with the pattern this kind of defects present, it has been shown that they are revealed as an overheated point in the middle part of the shorter side in which the box is located. This overheated point habitually appears in the middle of two different cells. In the PV plant in which the research has been performed, the modules of the upper row have the junction box underneath while the modules of the second row have the box in the upper part, as it can be seen in Figure 11 and Figure 12. The location of junction boxes along rows must be considered if a software must classify automatically the defects. The following figure, Figure 13, presents the ΔT of each of the 79 overheated junction boxes detected in the inspection in descencing ΔT order, obtaining an average temperature of 5.3°C with a standard deviation on 2.8°C. The maximum ΔT detected has been 15.6°C. Other relevant statistical values are the median, 5.6°C, and the first and third quartile, 3.3°C and

Figure 11 Front site of a module with a bypass diode overheated and of the junction box at the back of the module. ΔT is 6.7°C and 22.6°C respectively

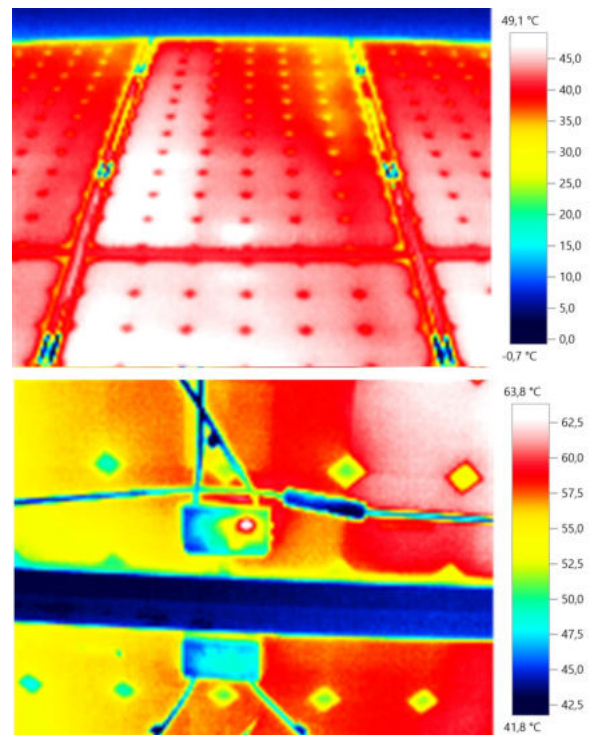
Figure 12 Front site of a module with a bypass diode overheated and of the junction box at the back of the module. ΔT is 9.3°C and 17.2°C respectively

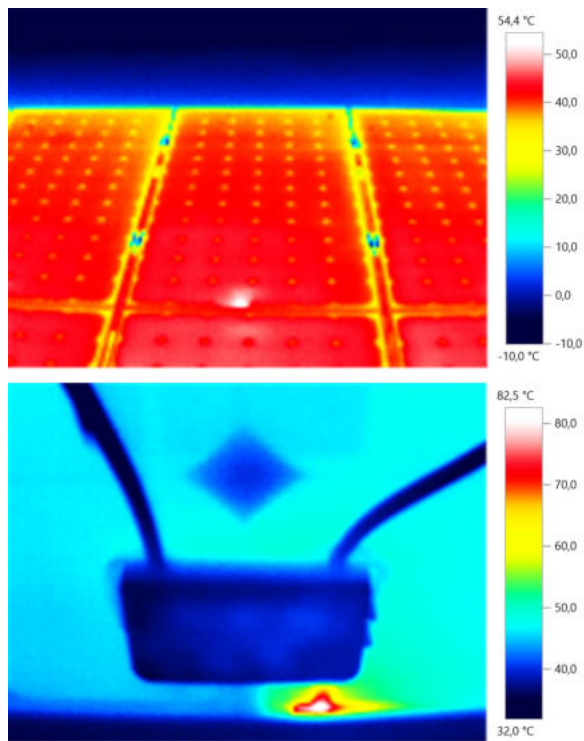
An example of an overheated connection found during the analysis is introduced in Figure 14. As it can be seen, the overheated area is not in the junction box, but in the connection between bus ribbon or bus wires and the box.

Reviewing all connection defects, it has been concluded that the pattern of this fault is an overheated point, generally smaller than a cell, located next to the frame in the same side in which the junction box is placed. The following figure, Figure 15, presents the ΔT of each of the 78 overheated connections detected in the inspection in descending ΔT order, obtaining an average temperature of 10.9°C with a standard deviation on 8.1°C. The maximum ΔT detected in this case has been 45.1°C. Other relevant statistical values are the median, 9.0°C, and the first and third quartile, 5.2°C and 13.8°C, respectively.

Figure 14 Overheated connection between the bus ribbon or bus wires and the junction box with a ΔT of 11.7°C and 35.8°C, at the front and back side respectively

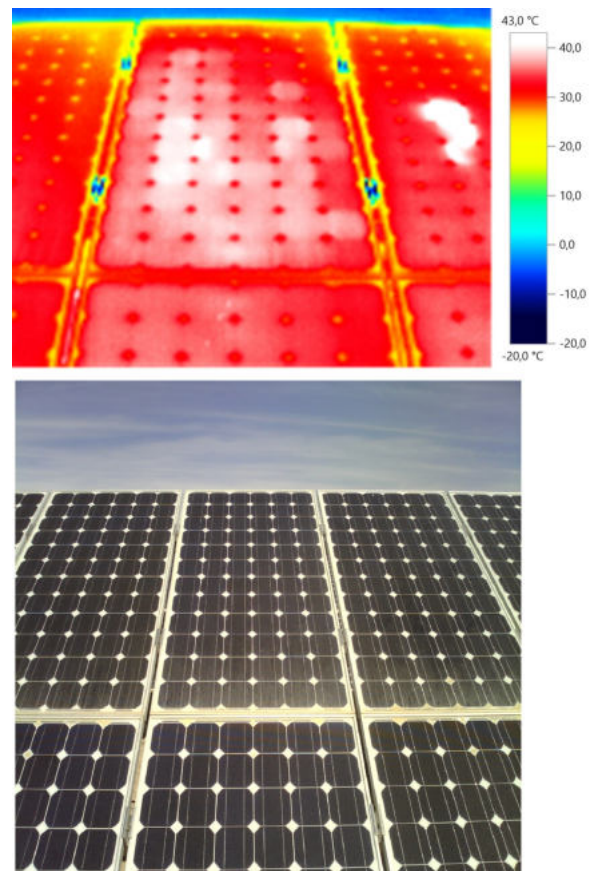
If one module or several modules connected in series have a higher temperature than the rest, the modules may not be connected to the system and the wiring should be checked. Figure 16 shows the only defect in the whole

module detected during the site inspection.

It has been noticed that differences in temperature between a module and the rest of modules of the same row or string could be due to an erroneous connection between them, mismatching or to internal defects of the module affecting all the bypass circuits. This kind of defect can be automatically detected as a difference of the mean temperature of one module with respect to the rest of the modules of the same PV structure.

Figure 16 Overheated module with a ΔT of 10.5°C between the mean temperature of the adjacent modules and the mean temperature of the overheated module surrounded in the figure
