Bermúdez-Castañeda, Angela; Esguerra Arce, Johanna; Esguerra-Arce, Adriana; Vargas-Pabón, Sofia Valentina; Ortiz-Martínez, Juan Guillermo; Blanco-Estupiñán, David Leonardo; Castaño, Juan Guillermo; Mischler, Stefano  
A comparative surface analysis of explanted hip joint prostheses made of different biomedical alloys

Revista Facultad de Ingeniería Universidad de Antioquia, no. 100, 2021, July-September, pp. 35-47  
Facultad de Ingeniería, Universidad de Antioquia

# A comparative surface analysis of explanted hip joint prostheses made of different biomedical alloys

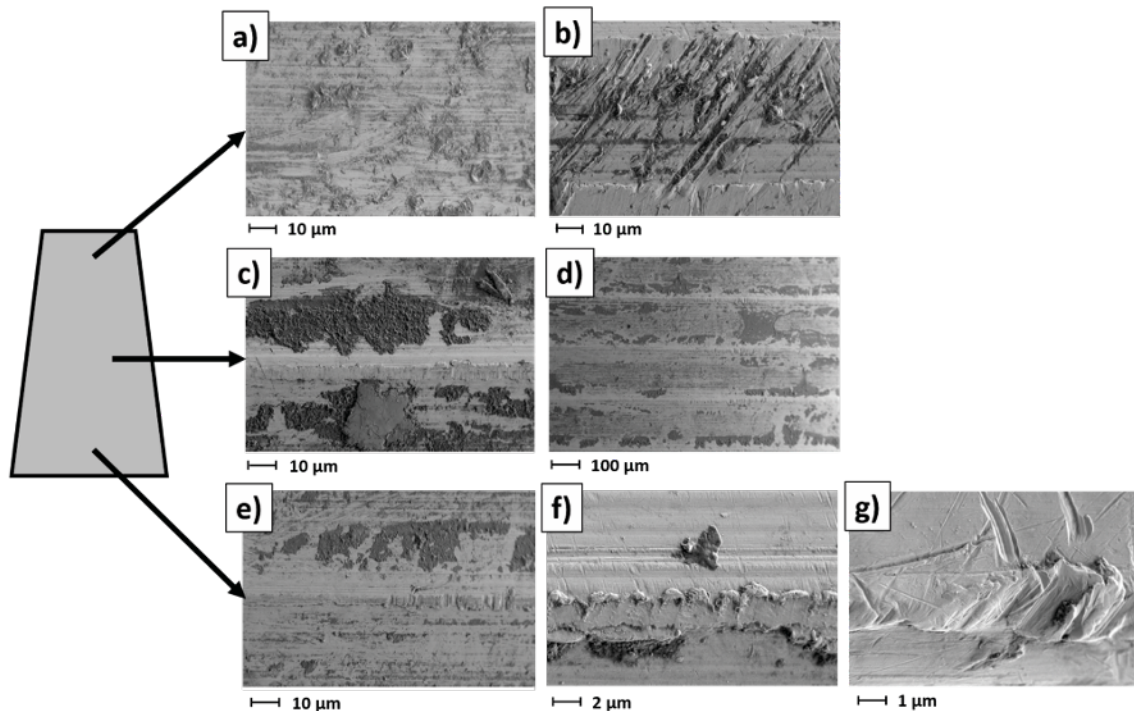
Some debris particles were observed around the deformed material Figure 3 **a)** - **b)**. Small movements could cause some particles to be trapped in the deformed area. As long as the ploughing generates surface stacking between modular parts, there is less movement, and the ejection of metallic or oxidized worn particles is less likely.

A detailed surface examination shows, deformation marks in the extraction and insertion direction were observed, as shown in Figure 3 **c)** - **d)**. In this respect, the distal area was the most affected in the areas shown in these images. Furthermore, ploughing on the fillets from the thread was observed Figure 3 **e)** - **g)**. In arthroplasty procedures, implant parts are assembled by hammering, in order to ensure a tougher fixation between the femoral head and the trunnion. This action produced ploughing in the fillets of the trunnion thread pattern, which suggests an effective stuck phenomenon in the distal area.

Images from the middle part of the trunnion show ploughing, although to a less severe degree than in the distal area. Moreover, some particles of organic material (biofilms), which composition is shown in Table 3 and Figure 4, can be found at this distance, as shown in Figure 3 **d)**. The entry of this material shows that even if the obstruction is produced at the entrance, material and particles can pass through the length of the trunnion.

**Figure 3** SEM images of a Ti6Al4V trunnion from hip explant. Proximal part a) 500x, b) 1000x; medium part c) 500 x, d) 100x; distal part e) 500x, f) 3000x, g) 5000x

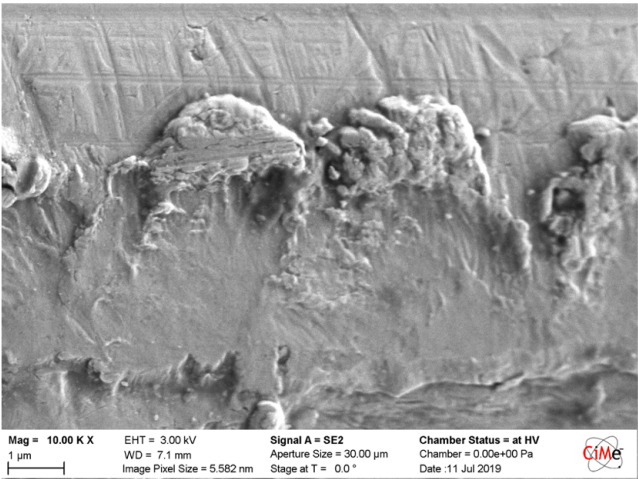
Furthermore, a closer observation of the smeared areas in Figure 5 shows no cracks or their propagation in distal zones.

Figure 5 Ploughing found in fillets on the thread patterns in Ti6Al4V trunnion in the distal area. Image amplification 10000x

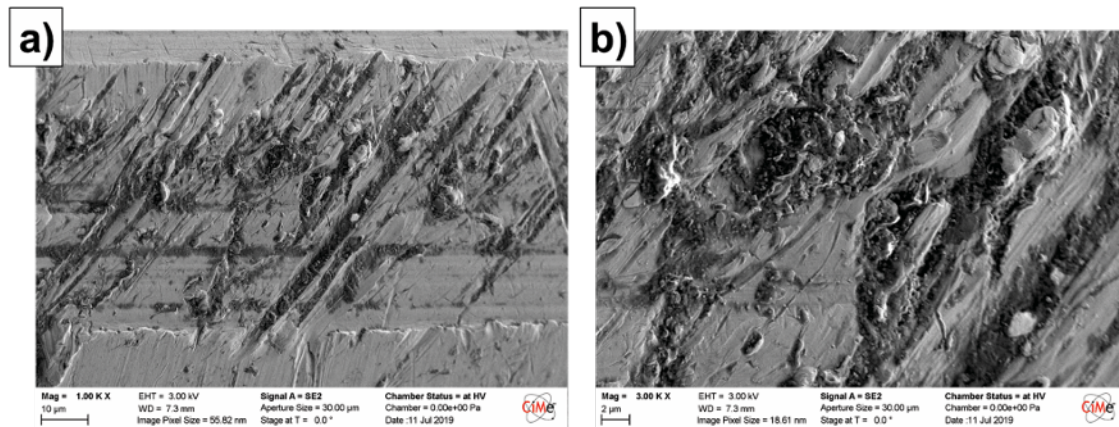
Some differences in material wear were found in the proximal part with respect to the rest of the implant. Nonetheless, ploughing is observed in the thread. Tracks, abrasion lines, and debris particles were also found in the thinner part of the cone, as observed in Figure 6 **a)** - **b)**. Those findings suggest that more micro-movements were generated in this area, due to the higher wear produced by the fretting mechanism.

**Figure 6** Wear and debris particles found on Ti6Al4V trunnion surface in the proximal zone. Image amplification a) 1000x and b) 3000x

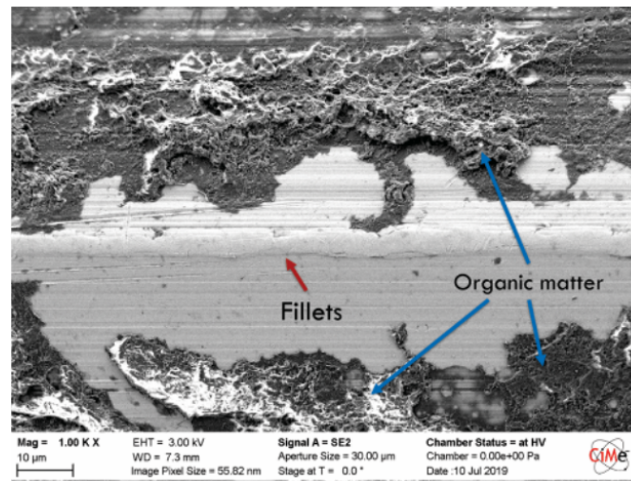
made in the revision procedure. Furthermore, higher hardness, according to Table 1, can explain the lower plastic deformation found [fillet in Figure 8]. Moreover, the

high dislocation density (produced during fillet machining) could explain the brittle failures observed.

**Figure 8** Biofilm and fillets identified in the proximal part of the trunnion

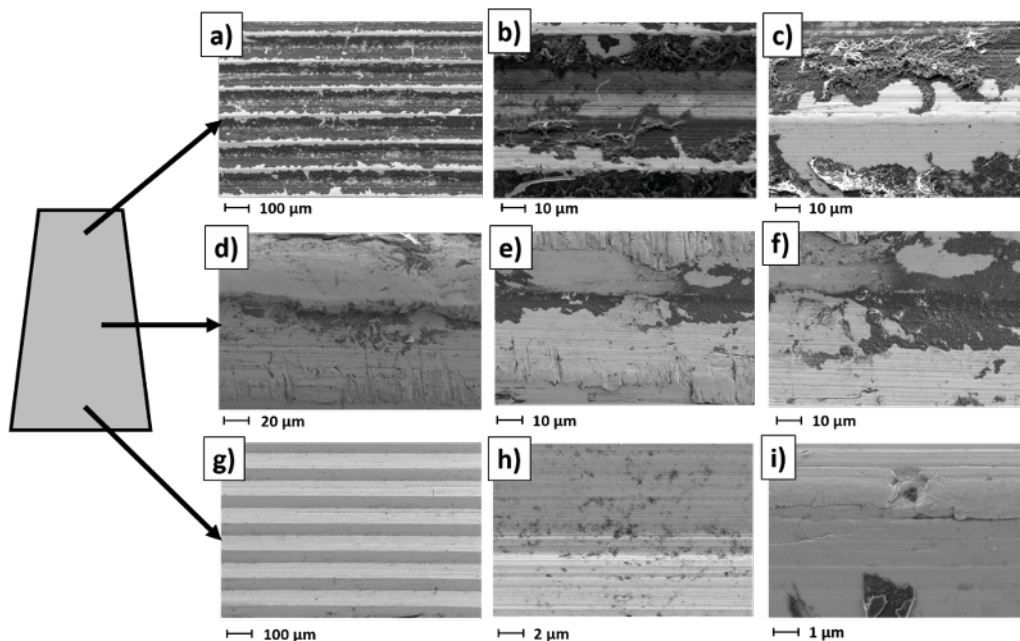
Although the femoral head has a thread pattern to enhance fixation, no significant deformations were observed in the CoCr trunnion as it was observed for titanium alloy explant. This explanted prosthesis shows a large amount of biofilms deposits on the thread pattern fillets in the proximal part (as corroborated by EDX in Table 4). That suggests a free entry of organic matter and its easy deposition in the proximal zone (Figure 8 **a)**, **b)**, and **c)**, suggesting a poor stuck between the trunnion and the femoral head with a mismatch angle as A. Ashkanfar *et al.* [23] found. Although previous studies (Su *et al.* [24]) indicate that those deposits are mainly corrosion products, the EDX spectra of the CoCr trunnion analyzed in this study do not show oxygen content. In contrast, carbon content was observed, which suggests that they may correspond to biofilms (Table 4) where the amount of metallic material is more significant. In addition to those layers, deformation lines, such as scratches, as well as detached material in the direction of the insertion and extraction processes (Figure 9 **d)**, **e)** and **i)** were found in the distal part, and especially in the middle part.

Compared to the titanium alloys prostheses, the deformation level of the thread patterns is lower, and some brittle failures were identified (Figure 9 - 5kX). The latter probably formed during the remotion of the head

**Figure 9** SEM images of a CoCr trunnion from hip explant. Proximal part a) 100x, b) 500x, c) 1000x; medium part d) 500 x, e) 500x, f) 1000x; distal part g) 100x, h) 3000x, i) 5000x

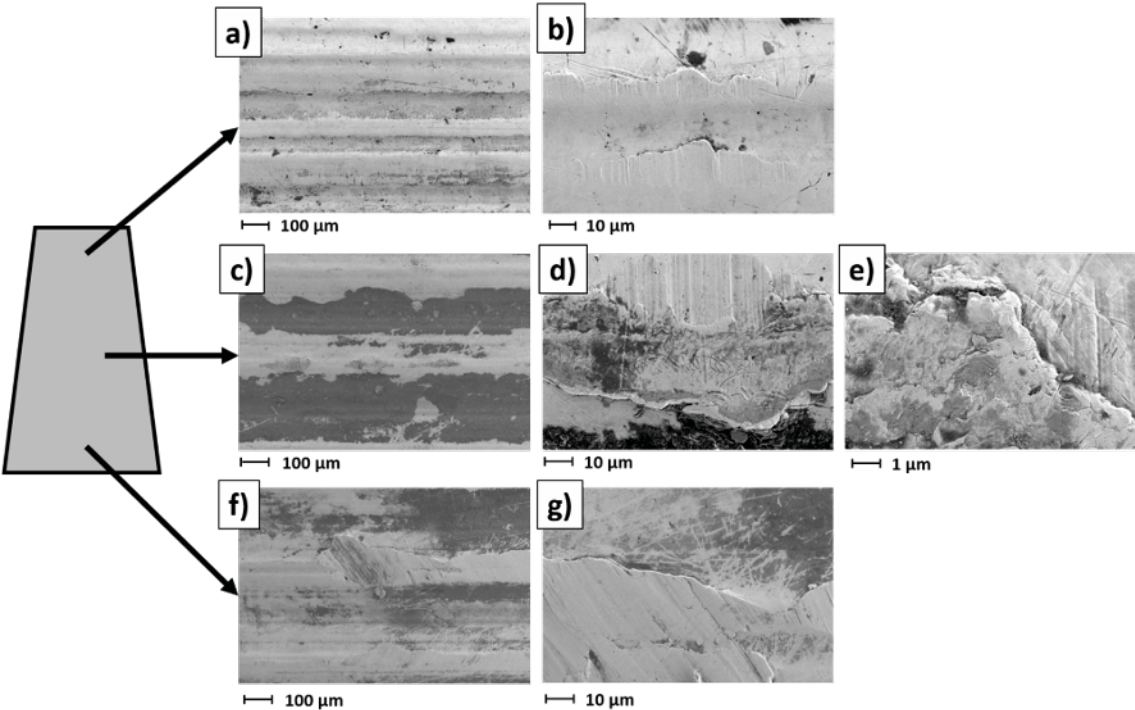
The explanted stainless-steel trunnion, as well as the Ti-6Al-4V and CoCr prostheses, are subjected to surface texturization to promote adhesion, as can be seen in Figure 10 **a)** and **c)**. The chemical composition by EDX is shown in Table 5, the spectrum shown in Figure 11. SEM images of each part of the trunnion are shown in Figure 10. The distal part exhibits a higher intensity of damage than the proximal part. Tribocorrosion phenomena are evident in the SEM analysis. Abrasion lines are observed along the length

**Figure 10** SEM images of a stainless-steel trunnion from hip explant. Proximal part a) 100x, b) 500x; medium part c)100 x, d) 1000x, e) 5000x; distal part f) 100x, g) 500x

abrasive performance was observed on the part of the stainless-steel particles rolling in the contact, as shown in Figure 10, which can be explained by the hardness of the material. Once the particle is detached, reincorporating it into the material in the contact can be more difficult compared to what was observed for titanium particles.

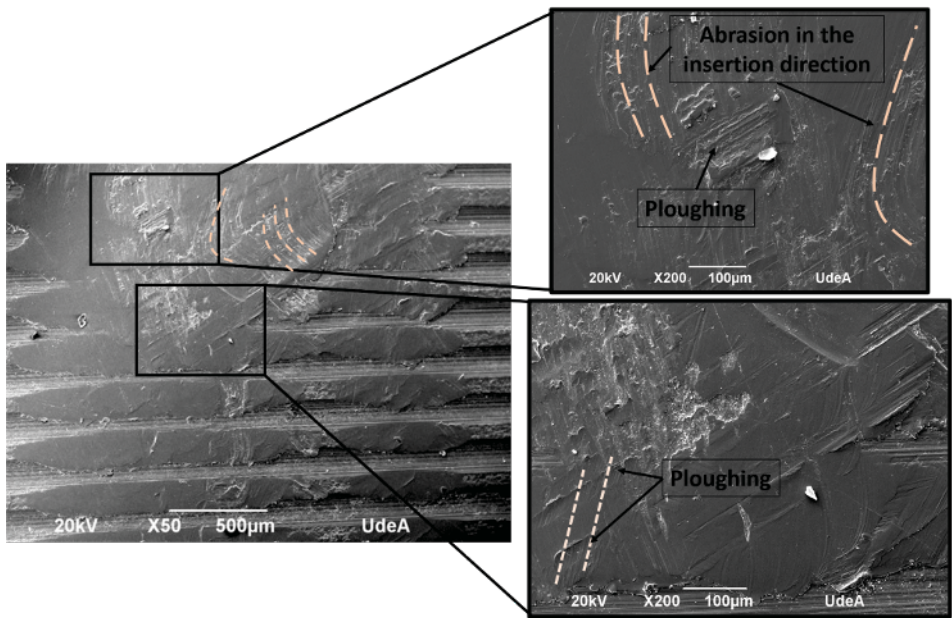
of the trunnion and along the direction of insertion and extraction, as well as ploughing in the perpendicular direction of insertion. This is observed in Figure 12. As mentioned, this wear was much lower compared to examined prostheses made of CoCr and Ti6Al4V, which could possibly be explained by the stainless-steel hardness (Table 1). However, there is a significant difference in the damage caused with respect to the Ti-6Al-4V prosthesis as, rather than deformed particles; detached particles are observed that are smeared inside the contact and rolled on the surface, creating an abrasive phenomenon, as shown in Figure 13.

Figure 12 Wear mechanisms found in 316L SS trunnion surface

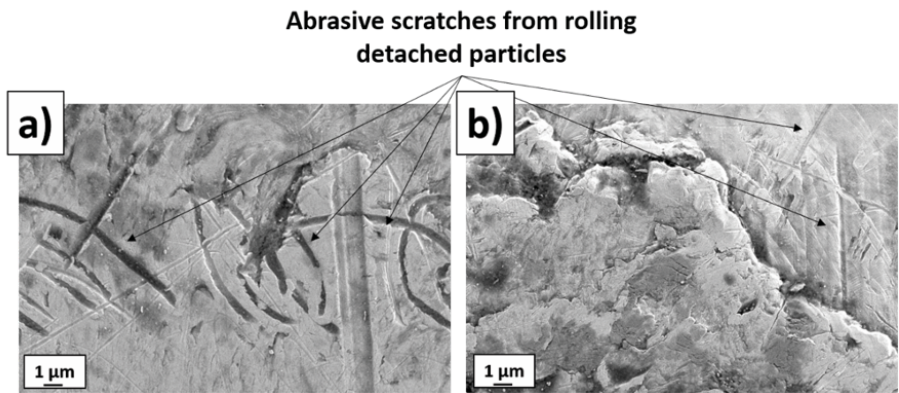
Figure 13 Stainless-steel hip explant degradation, a) 500X and b) 5000X

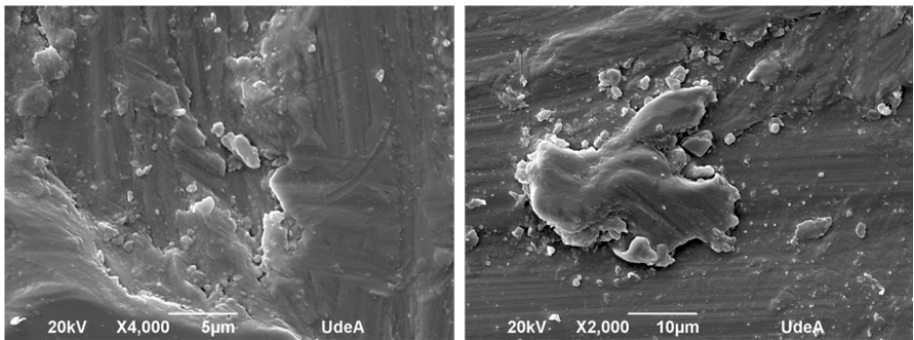
Detached particles can be observed in Figure 14. These particles have the same chemical composition as the SS prosthesis. Moreover, no oxygen is observed, which indicates the presence of metallic material. In addition, EDX analysis in Figure 15 shows a material layer formed on the material surface similar to those reported in previous studies [16, 25], [26]. These films, known as a tribofilm, are formed by the oxidized and metallic material worn from both interfaces in contact. The layer was found on the explanted trunnion of 316L stainless steel, which was paired against a Co-Cr alloy head. The alloy contains an average of 18.55% of Cr, according to EDX (see Table 5 and Figure 11). However, the chemical analysis of the surface

Figure 14 Detached particles and their chemical composition in SS trunnion surface

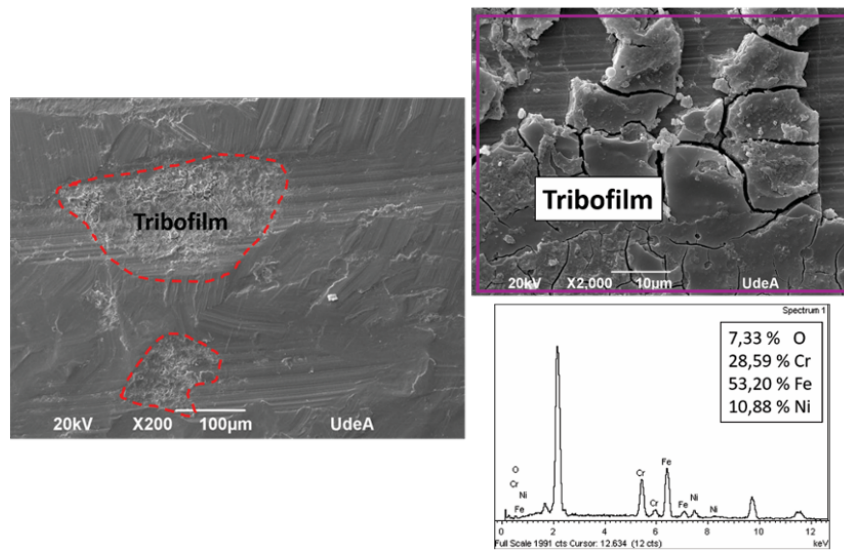
covered by organic material exhibits higher contents of Cr, of 28.51 %, as well as oxygen contents of 7.33 % (Figure 15). This chromium excess and oxygen could indicate fretting corrosion in this system, with material transfer from the Co-Cr alloy to the SS trunnion.

**Figure 15** Detail of the tribofilm material found in the surface of the SS trunnion

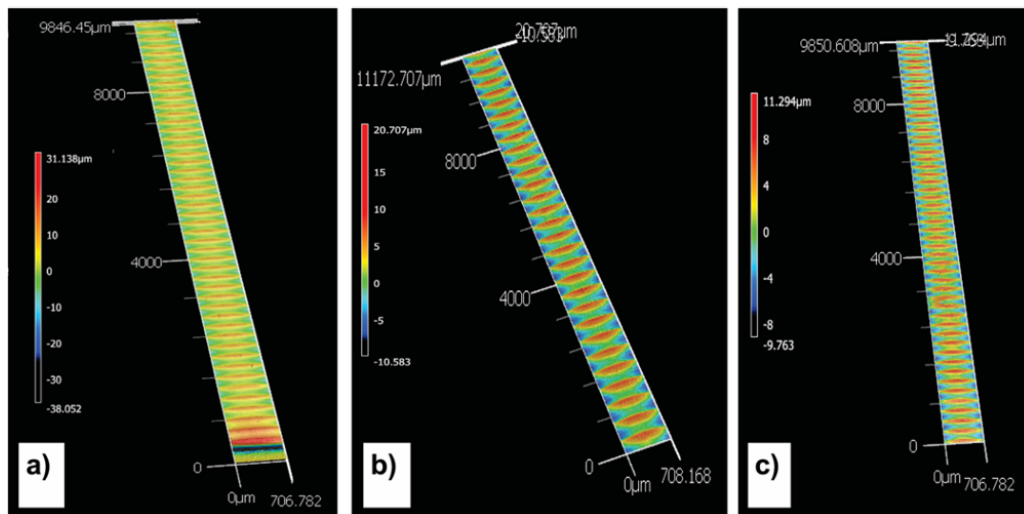
the trunnion length are taken by the confocal and laser microscope and are assembled in order to examine the trunnion extension. The most deformed areas are colored in red. As observed, bigger red zones were localized in the distal than in the middle and proximal region.

Consistent with previous observations in titanium alloy trunnions, the 3D map shows a more extended degradation area in the distal part compared to the proximal part (Figure 16 **a**)). For the stainless-steel

trunnion, although a difference along the trunnion is observed between proximal and distal zones, it is not as pronounced as in the case of the titanium alloys, as shown in Figure 16 **c)**. Finally, the 3D map taken of the CoCr trunnion shows no significant difference between the distal and the proximal part, as was found in the examination done by SEM.

**Figure 16** Optic profilometry of the explanted a) Ti6Al4V, b) CoCr, and c) SS trunnion surface
