# EVALUATION OF PERFORMANCE AND EARLY DEGRADATION OF A 180.8 KWP ROOFTOP ON A GRID-CONNECTED PHOTOVOLTAIC SYSTEM IN A COLOMBIAN TROPICAL REGION ENVIRONMENT

This study presents the results of the performance and early degradation assessment of a 180.8 kWp rooftop on a grid-connected photovoltaic system, installed in Barranquilla, city located in northern Colombia, during its first year of operation. Two methods were used to assess the performance and early degradation: i) Estimation of solar conversion efficiency, and ii) visual inspection. The first method includes a cross analysis between climatic conditions, irradiance levels and the generated energy downstream inverters. To calculate the plane irradiance, a correction factor is proposed, using the global irradiance. In addition to a cost analysis aimed at identifying how much money the non-generated energy represents. The second method consists of periodical visual inspections of installed modules to observe if there is any of the following degradation modes: Discoloration, delamination, busbar corrosion, cracking of solar cell, glass breakage, anti-reflection coating and solder bond. The results show the solar conversion effic

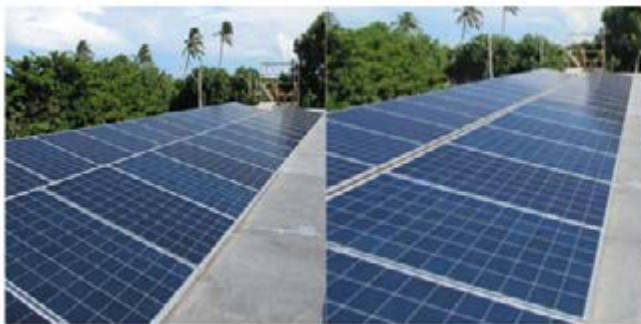
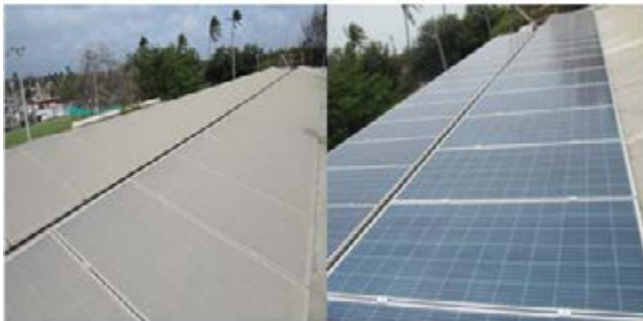
**Figure 2** shows panoramic images of the same row of PV modules in the four inspection periods. Dust concentration is a direct function of dry (December – March) and rainy periods (April to November), an image corresponding to the end of dry periods (march before clean-up) shows high dust concentration. After the cleaning process there is a slight deterioration in the modules' color as compared to the first inspection. According to **Table 1**, the identified failure mode is discoloration.

**Figure 2.** Panoramic images of the same row of PV modules in the four inspection periods: a. October 2018, b. January 2019, c. March 2019 (before clean up), d. March 2019 (after clean up)

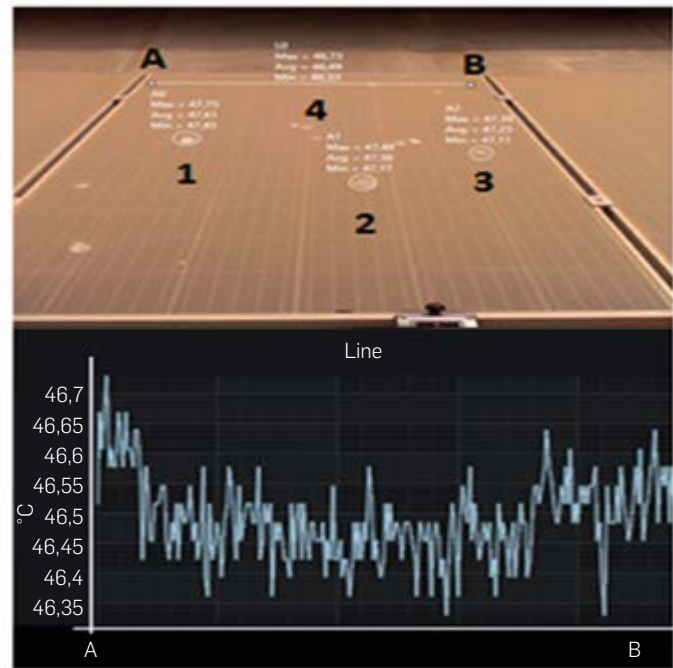
During the third inspection, a high level of dust content and a significant quantity of bird droppings were observed in the modules. A thermal analysis was performed to assess the module temperature performance; this analysis showed that the dust level maintains a homogeneous temperature on the surface, whose maximum value was 46.7 °C and minimum value was 46.35 °C, see **Figure 3**. Apparently, as the level of dirt increases, the modules temperature decreases; this phenomenon could be caused by the change in the amount of energy passing through the dirt layer.

**Figure 3.** Thermal Analysis to assess module temperature performance

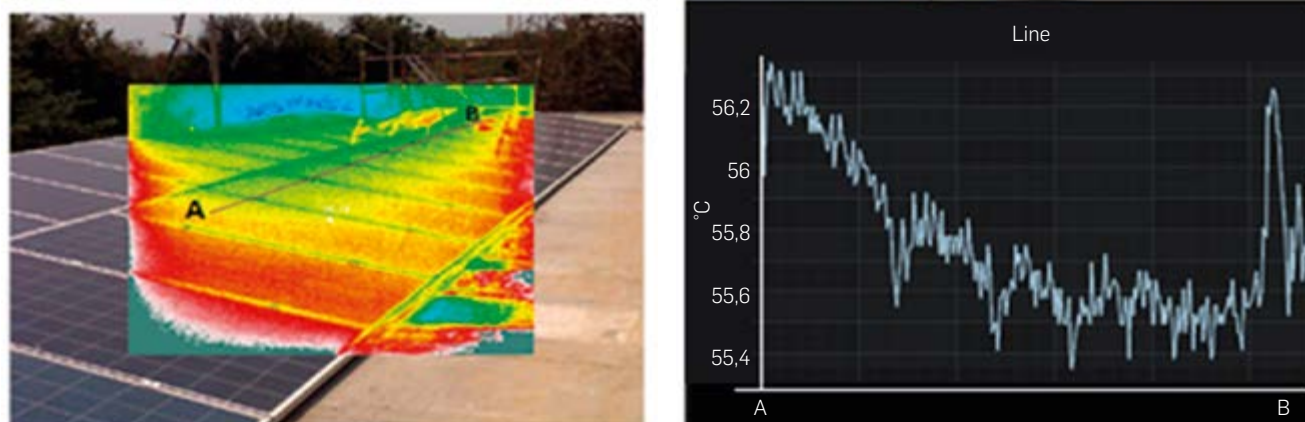
A thermal analysis was carried out after the cleaning process; such analysis showed that the modules temperature in the analyzed row varies by less than 1 °C. It was also noticed that discoloration has not generated changes in module temperature so far, see **Figure 4**.

**Figure 4.** Thermal Analysis after clean up to assess module temperature performance

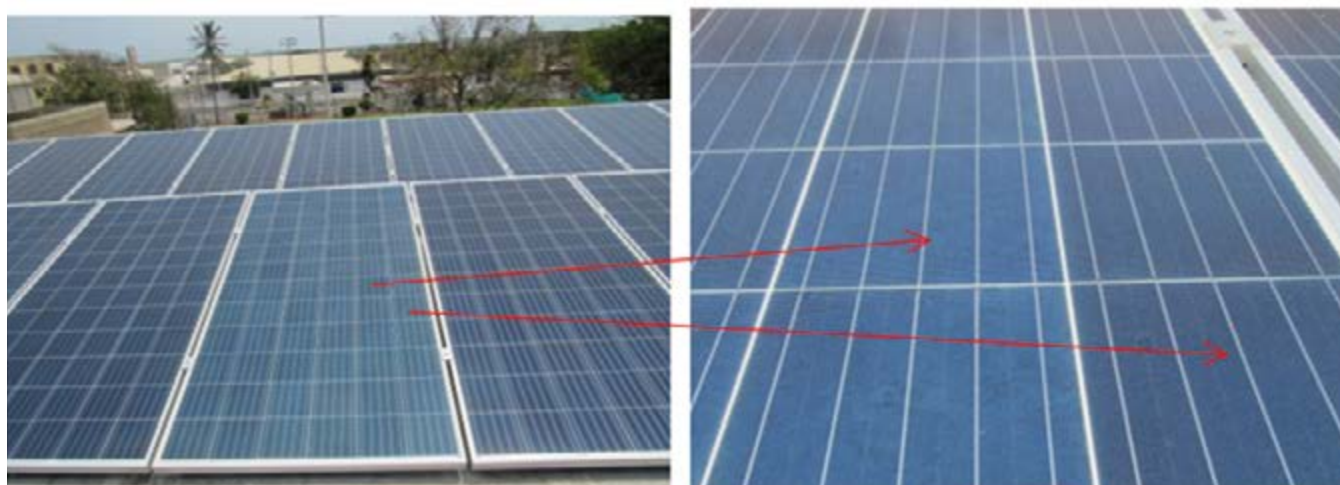
**Figure 5** shows a discoloration between cells in the same PV module. A thermal analysis was carried out to assess the effect on module temperature; however, thermography indicated that the variation between these points did exceed 1 °C, see **Figure 6**.

**Figure 5.** Discoloration between cells in the same PV module

The early degradation analysis suggests discoloration as the most common failure mode. However, according to Figures 5 and 6, at this time, there is not a substantial contribution of this failure mode on module temperature. This phenomenon could cause a problem if there would be a loss of adhesion between the encapsulating polymeric and the cells of the module, causing penetration of water within it. There are no failure modes such as delamination, corrosion

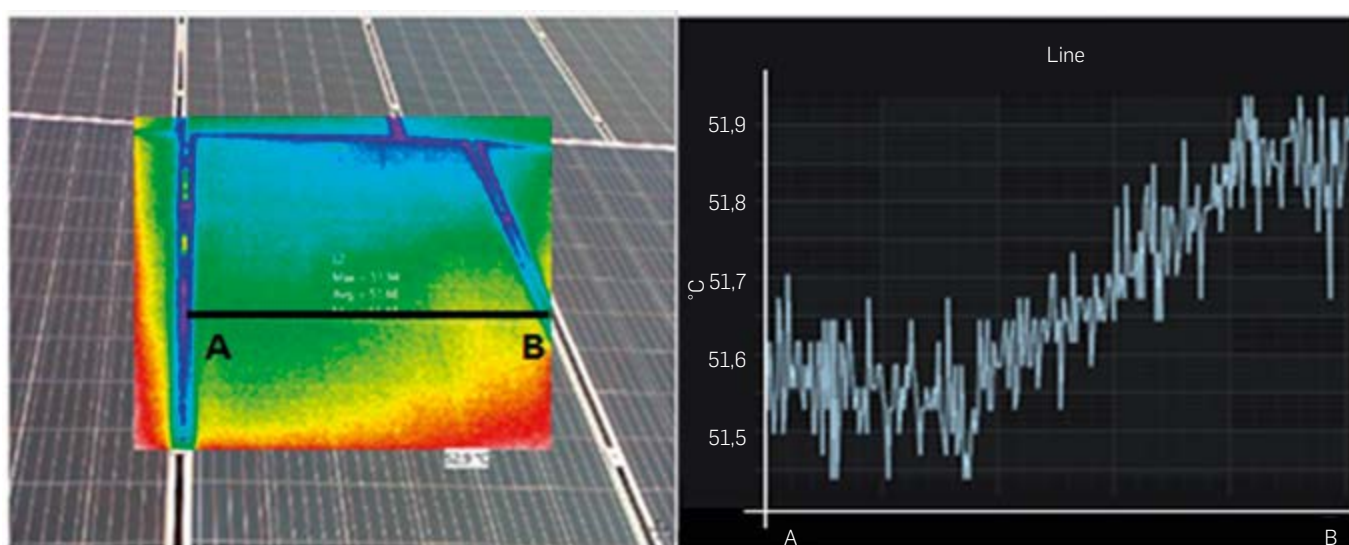
**Figure 6.** Thermographic analysis in cells which present discoloration

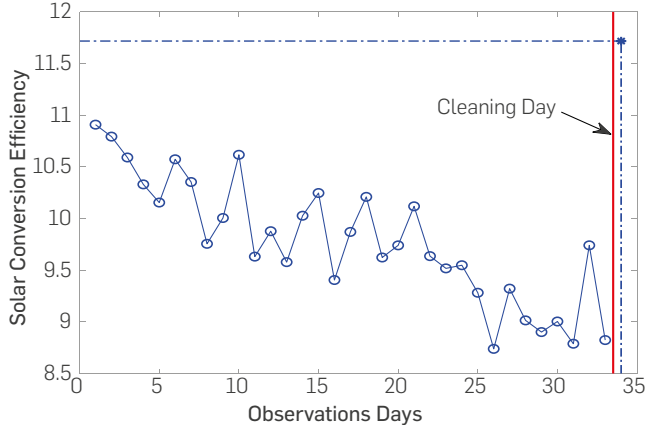
Figure 7 shows the solar conversion efficiency changes after 33 days of dust accumulation on the surface of the photovoltaic modules. Hence, there is a substantial reduction in system efficiency. Although the design efficiency value is 15.32 %, the highest value, measured on the first day of analysis, was 10.91 %, and the lowest value was registered on day 26, as 8.65 %.

**Figure 7.** Solar Conversion Efficiency performance.

On day 34, a cleaning process was performed on the photovoltaics system to analyze efficiency behavior; this value was registered with a superior performance of (11.72 %) and a global irradiance of  $570 \text{ W/m}^2$ , which means an increase of 2.98 %. This value is marked with an asterisk in Figure 7.

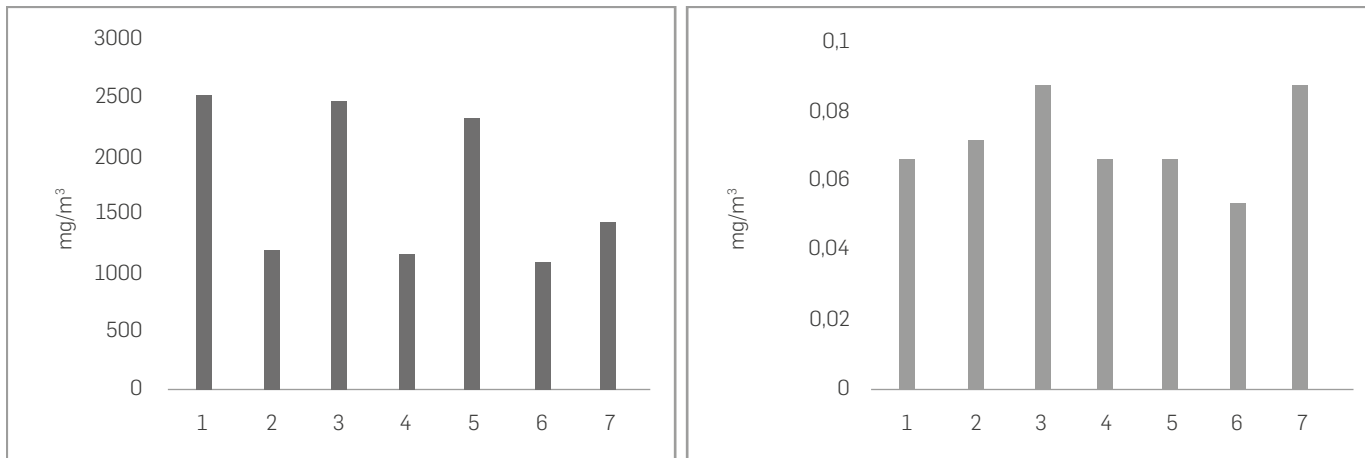
The atmospheric characterization is carried out in the presence of relative humidity greater than 70 %, which facilitates the condensation on metal surfaces, promoting the formation of a wet film that may contain contaminants such as chlorides and sulfides that accelerate the corrosion process [25]. **Figure 11** shows the reports of the concentration of chlorides and sulphides identified

According to ISO 9223 [26], it is possible to categorize outdoor atmospheric corrosivity into 5 levels: very low (C1), low (C2), medium (C3), high (C4) and very high (C5) according to the content of  $\text{SO}_2$  and chloride type contamination [27, 28]. Given the results of the dust samples obtained, the sulfide concentration exceeded  $30 \mu\text{m}^3$  and levels up to  $2500 \text{ mg/m}^3$ , placing it in a high corrosivity category (C4). With this information, it is then estimated that the degradation of the aluminum structures of the photovoltaic panels is generated by the loss of mass between  $2\text{-}5 \text{ mg/m}^2$  year assuming uniform corrosion, which must be frequently evaluated to identify localized corrosion faults.

**Figure 11.** (a) Chlorides concentration ( $\text{mg/m}^3$ ); (b) Sulphides concentration ( $\text{mg/m}^3$ ) material taken from the surface of photovoltaic panels
