Failure analysis of stainless steel lanyard wire rope

Defence Metallurgical Research Laboratory, Kanchanbagh, Hyderabad, 5000258, India

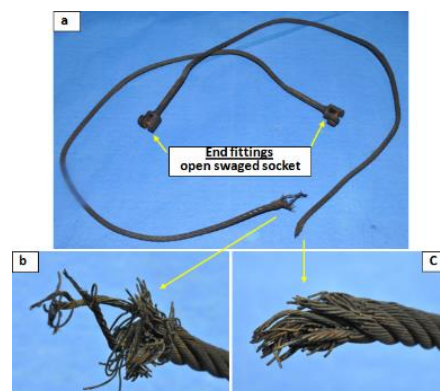
The broken wire rope in as-received condition is shown in Figure 1(a-c). This displays dark brownish colour. The wire rope supplied with two broken ends (Figure 1a). This consists of many small diameter wires wound together into strands and then these strands are knit jointly into a wire rope. The end fittings of the wire rope are fastened with open swaged socket. Broken end region displays several wires unwound and loosen from their strands (Figure 1b and c). Chemical composition of the wire rope indicates that the wires are made using austenitic stainless steel AISI 304 grade (Table 1).

Fig. 1. Photograph of failed wire rope: (a) as-received condition, (b) one end of the broken rope, (c) another end of the broken rope displays several wires unwound from its strands and loosens from their strands.

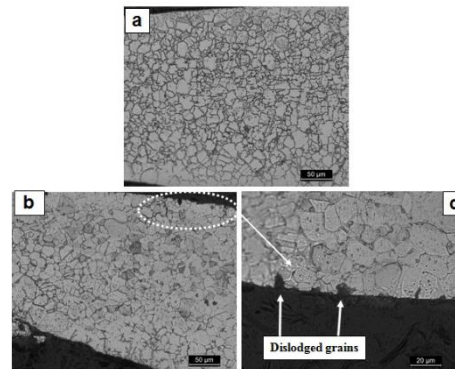
Optical microstructures of failed wire rope are shown in Figure 2. This displays the presence of typical equiaxed austenitic grains along with annealing twins (Figure 2a). The average grain size is ~ 15 μ m (ASTM No. 8.5). The grain size near and away from failed region appears to be same. The optical microstructure of the wire exhibits two

features namely (a) overall grain size is nearly uniform from center to periphery and (b) several cracks along the grain boundaries at the periphery of the wire rope (Figure 2b and c). Presence of annealing twins within the equiaxed austenitic grains indicates that the wire rope is used in annealed condition (Figure 1, 2a). This also suggests that the rope wires are initially prepared by wire drawing and subsequently annealed. In addition, several grains have been dislodged from periphery of the individual broken wire (Figure 2b and c). The dislodged materials have broken and separated from the wire along the grain boundaries. This clearly reveals that the grain boundaries have significantly weakened during service. Very close to the fractured area, the microstructure exhibits extensive material degradation due to grain boundary weakening.

Fig. 2. Optical micrograph of failed wire rope shows (a) austenitic grain structure with annealing twins, (b) few grains are dislodged from the grain boundaries at the surface near fracture and (c) high magnification of dislodged grains.

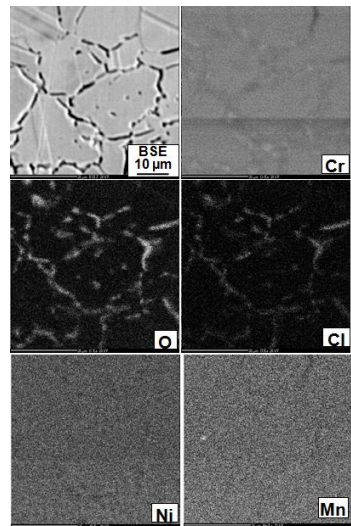
BSE micrograph close to the fracture obtained in un-etched condition exhibits continuous thin film along grain boundaries (Figure 3). This observation is analogue to the optical microstructure (Figure 2). The X-ray elemental mappings of Cr, O, Cl, Ni and Mn elements of failed wire rope in un-etched condition obtained by EPMA are shown in Figure 4. Elemental distribution mapping reveals that the grain boundaries are enriched with Oxygen, Chlorine and Chromium. On the other hand, uniform distributions of Nickel and Manganese are observed in the matrix.

Fig. 4. X-ray elemental distribution mappings of Cr, O, Cl Ni and Mn obtained by EPMA illustrates enrichment of Cr, Cl and O along the grain boundary.

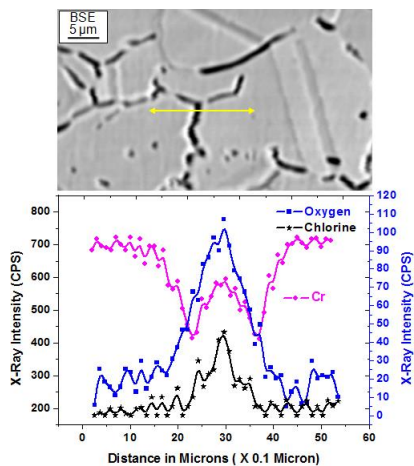
In order to confirm the results of elemental mapping, X-ray line scan technique has been employed for Oxygen Chlorine and Chromium elements and results are shown in Figure 5. This reflects evidently that the line scan profiles have validated the enrichment of Oxygen, and Chlorine at the grain boundary. Line profile has also displayed the chromium enrichment at the grain boundary as well as the depletion at either side of the grain (i.e. vicinity of grain boundary). The weakening of grain boundaries along with dislodged materials from the periphery of the wire therefore indicates that the rope is exposed to corrosive environment during the service. Presence of Cl and O at the grain boundaries in the form of thin film supports the same.

content / vapours from humid atmosphere have initially reacted with chromium oxide passive film formed on the surface of the wire and then diffused within the material along the grain boundaries. The depletion of the Cr in vicinity of the grain boundaries supports the same (Figure 5). This has resulted in the failure of the wire rope in intergranular mode due to substantial weakening of grain boundaries.

Fig. 5. EPMA Line profile of the elements O, Cl and Cr across the grain boundary demonstrates as reflected in the X-ray mappings.

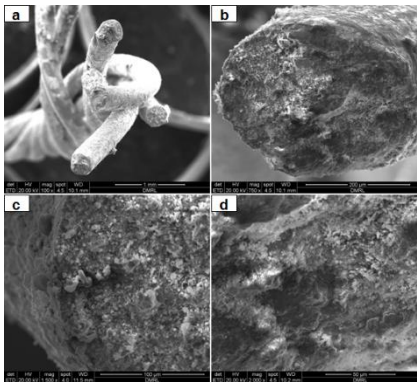
The fracture surfaces of failed wire rope near the actual fractures are shown in Figure 6 (a-d). Thick layer of foreign material deposition is exhibited over the fracture surface of the individual wires and also all around the surface of each wire. In fact fracture surfaces of the failed rope have shown the presence of corrosion debris which has masked the actual fracture (Figure 6). The fracture surfaces of the wire appear to be rough and the individual

wire does not show distinctive mode of fracture features. These are similar to mud cracks with oxide layer (Figure 6b-d). The Energy Dispersive Spectroscopy (EDS) spectrum taken on fracture surface of the failed rope near the actual fractures has revealed the presence of chlorine and oxygen in addition to matrix elements (Figure 7). These results are well agreement with those obtained by EPMA analysis (Figure 4 and 5). All the wires in the failed rope have shown similar behaviour.

Fig. 6. SEM fractographs of individual failed wire obtained at (a) Low magnification and (b-d) high magnification show thick layer deposition of corrosion debris over the fracture surface.

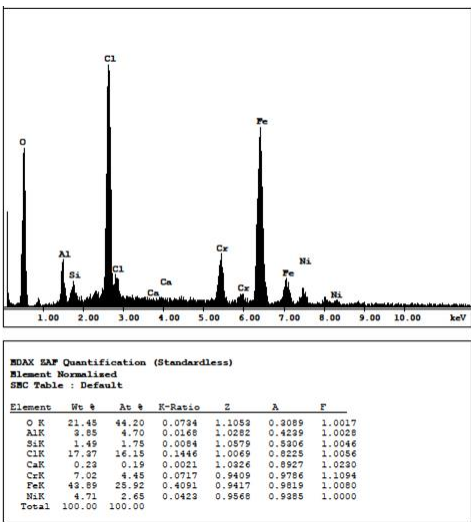
Fig. 7. EDS Spectrum taken from the fracture surface of the failed individual wire exhibits presence of O and Cl in addition to matrix elements.

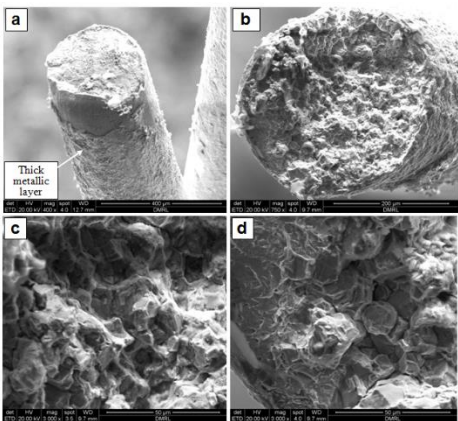
The results of the tensile tests of the failed and unused wires have been utilized to explain the occurrence of typical fracture features of the failed wire rope. The fracture surfaces of tensile tested specimens of the failed and unused wires are shown in Figure 8 and 9. The flat fracture with no reduction in the cross sectional area is seen in the failed individual wire (Figure 8a). The fracture surface of the wire appears to be rough and clearly reveal the presence of intergranular fracture (Figure 8c-d). The failed wire clearly shows typical brittle fracture in spite of the presence of corrosive debris. Fracture surface of tensile tested wire of the failed rope displayed a thick metallic layer covered around the circumference of the failed wire.

However, a part of the thick layer of the individual wire has fallen away from close to tensile fracture during tensile deformation (Figure 8a).

Unused wire rope has undergone significant necking before tensile failure and finally failed in ductile mode. This clearly suggests that the failed wire rope has slowly deteriorated during service and then suddenly failed with intergranular fracture mode. It appears that the crack propagated along the weak grain boundaries and finally failed in brittle mode of fracture (Figure 8).

Fig. 8. SEM fractographs of tensile tested failed wire rope: (a) low magnification and (b-d) High magnification reveals flat fracture with intergranular mode of failure.
