Rocha, Joaquin Humberto Aquino; Ibarra-Villanueva, Rolando
Identification and analysis of pathological defect appearance in
superstructures of reinforced-concrete bridges in Chapare region, Bolivia
DYNA, vol. 88, no. 216, 2021, January-March, pp. 15-21
Universidad Nacional de Colombia

Identification and analysis of pathological defect appearance in superstructures of reinforced-concrete bridges in Chapare region, Bolivia

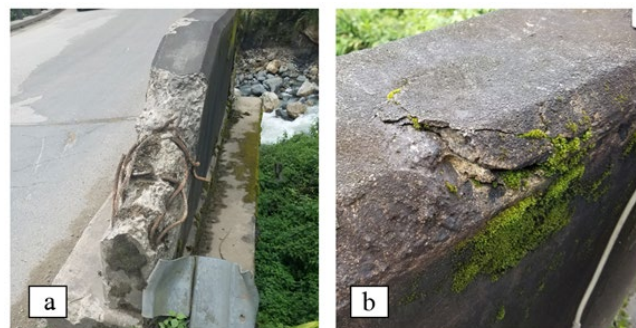
During visual inspection, fissures and concrete disintegration exposing armatures were found in every case. Latter issue is due to steel corrosion process, which gradually evidenced reinforcement exposure with oxidation and loss of cross section (Fig. 4). In addition, it was also evidenced that in some cases it was produced by a motor vehicle accident on the bridge (Fig. 5).

Figure 4. Disaggregation of concrete and armatures exposed: a) San Jacinto and b) Ronco bridges.

Concrete in bridges is acceptable in terms of compression resistance, but corrosive processes that produce disaggregation and armature exposition compromise it. For this issue, different techniques for structural recovery could be implemented, but corrosion process is advanced, and risk of collapse is present. Intervention or structures replacement should be implemented once they serve their useful life [30].

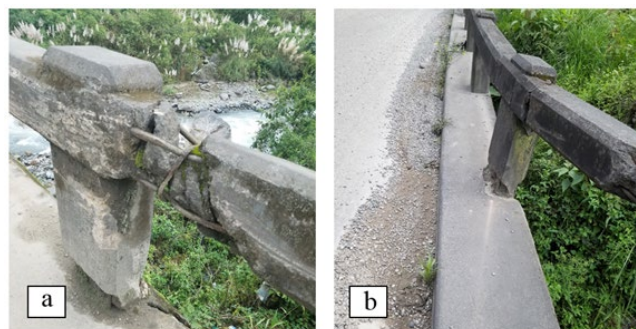
Figure 5. Structures impacted by accidents: a) Roquemayu and b) Ronquito bridges.

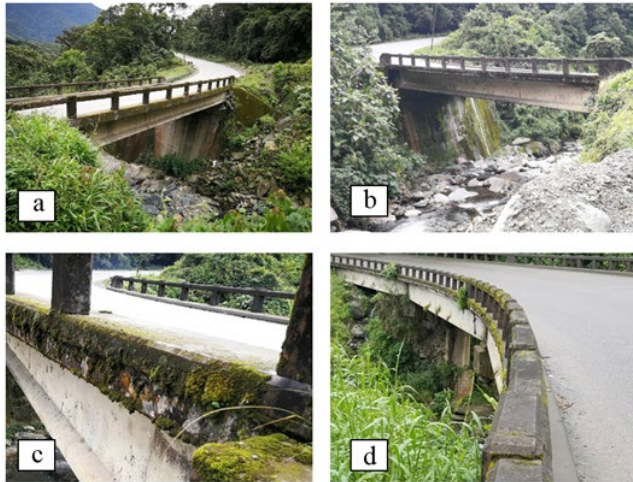
Figure 6. Vegetation, fungus and moss: a) Ronco, b) Ronquito, c) Roquemayu, and d) San Jacinto bridges.
Source: The authors.

Another pathological defect found was excessive vegetation, fungus and moss due to high relative humidity in the air and constant rainfall in the region. These issues are shown in Fig. 6.

It was observed that 100% of the bridges show every issue considered, except for Málaga Bridge, which does not present vegetation (plants) in its superstructure.

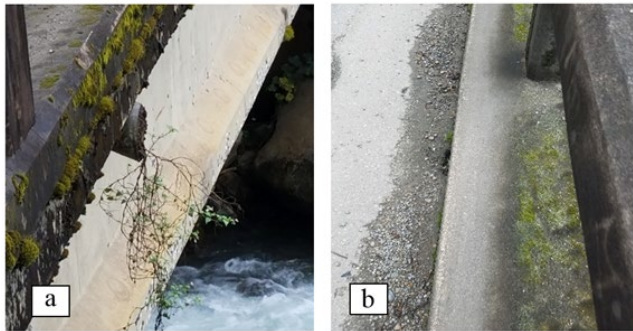
Figure 7. Obstructed drainage: a) Ronquito and b) Ronco bridges.
Source: The authors.

Additionally, during inspection it could be verified that some bridges present their drainage systems obstructed by garbage or vegetation, thus evidencing lack of cleaning service (Fig. 7).

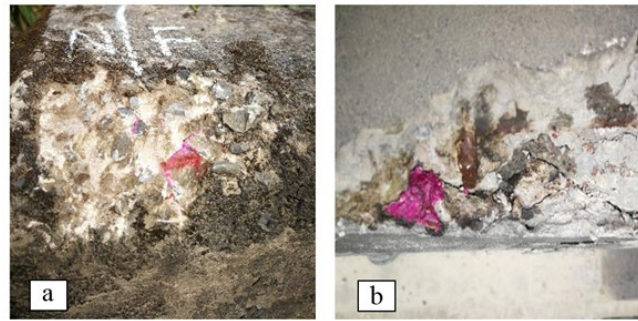
When concrete was broken in some points, iron corrosion was observed. This was verified by carbonation depth testing, since concrete coating showed no coloring compared to concrete found in inner layers (Fig. 8). It is important to mention that every bridge showed advanced carbonation,

Figure 8. Carbonation Depth: a) Roquemayu Bridge and b) Málaga Bridge.
Source: The authors.

which reveals decrease in concrete alkalinity, hydrogen potential (pH) values below eight, which generates iron depassivation [30], that produces corrosion in bars evaluated, although points where carbonation depth was zero, showed corrosion is not present in the whole bridge, but only in some areas.

This corrosion process is due to carbon dioxide (CO₂) present in the environment and high relative humidity in this region, as dry pores show no CO₂ in progress in concrete due to lack of water. Otherwise, whenever the pores are full of water, carbonation process has ideal conditions to progress until reaching the iron [12]. Additionally, temperature is high in the area, which favors progressive corrosion [31].

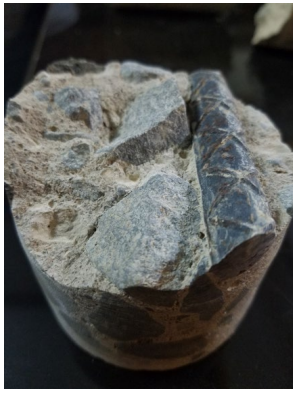
Fig. 10 shows both core extraction and compression testing. In the case of N2-E8 for Roquemayu Bridge, compression test was performed according to C42/C42M-04 recommendations [15]. This core presented iron and oxidation products (Fig. 11).

Figure 11. Roquemayu Bridge core presenting oxidation products.
Source: The authors.
