Martínez-Carvajal, Hernán Eduardo; Aristizábal, Edier; García-Aristizábal, Edwin Fabián A case study on causation of the landslide on 26 October 2016 in the northern Colombian Andes DYNA, vol. 88, no. 216, 2021, January-March, pp. 22-30 Universidad Nacional de Colombia

# A case study on causation of the landslide on 26 October 2016 in the northern Colombian Andes

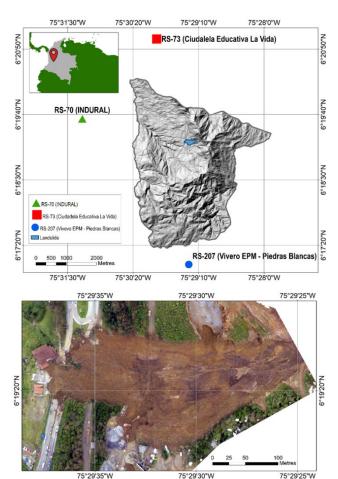
landslide began in the upper part of the slope, between the southern and northern banks of the quarry. Fig. 1 presents the location of the event and a photograph of the magnitude of the movement. The crown of the landslide presented a spoon shape with its middle portion adopting a slightly conical shape and the toe (accumulation area) was clearly wider, suggesting a high degree of water content in the sliding mass. The mass, initially solid, was transformed into a flow that buried the industrial facilities of Las Nieves quarry, both lanes of the Medellín-Bogotá highway, and part of a restaurant located next to the highway.

Figure 1. Location of the landslide in Las Nieves quarry, municipality of Copacabana, Colombia.

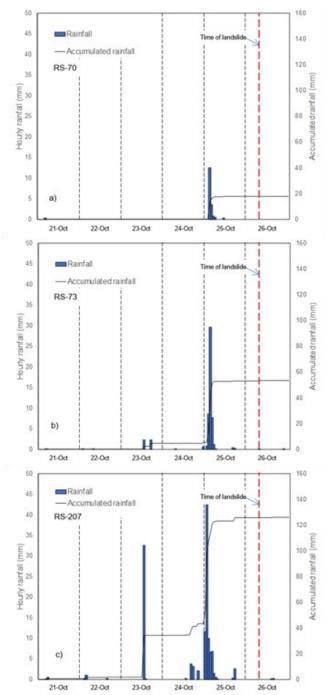
Fig. 4 shows the analysis of hourly rainfall intensity for the selected stations, from 21–26 October 2016. From this figure, it is seen that RS-207 presented a total accumulated rainfall of 125.9 mm for the five days prior to the slide, with a rainfall duration concentrated in the early morning of October 25, one day before the landslide, with a maximum hourly rainfall of 43.3 mm. This condition reflects the reduced presence of rain during the five days prior to the landslide and the dispersed distribution of significant rainfall during the 24 hours prior to the landslide. At RS-70 and RS-73, the total accumulated rainfall was 17.5 and 50.9 mm, respectively, which occurred during the five days prior to the event, with a maximum hourly rainfall of 12.4 and 28.8 mm, respectively. At these stations, the duration of the events was concentrated, as at RS-207, in the early hours of October 25. None of the stations analysed in this study indicated that rainfall occurred at the time of the landslide. This information was corroborated by personal interviews with people that were at the quarry at the time of the slide.

Figure 4. Rain intensity analysis. Hourly rainfall and accumulated rainfall between 22 and 26 October, 2016. a) RS-70 station (Indural), b) RS-73 station (Ciudadela Educativa La Vida), and c) R-S207 station (Vivero EPM - Piedras Blancas).

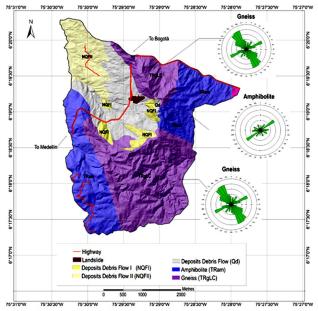
In the study area, the nearly vertical dip of the gneiss favours deep water flow in this rocky mass. By combining the sets of discontinuities, it is possible to establish a network of planes with north-west orientations which favours the hydraulic connection between the plateau and the failure zone (Fig. 8).

Figure 8. Directions of discontinuities for the two different lithological environments found in the landslide zone.
