### Extreme Testing of Guard Cables with Fiber Optics: A Case Study

Erick-Alejandro González-Barbosa<sup>1</sup>

**Context:** Optical fiber ground wires (OPGWs) sometimes melt and rupture when exposed to extreme conditions, such as atmospheric discharges, short circuits, and corrosive agents, that affect their electrical and mechanical properties. These conditions depend on the geographical area where the cable is installed, with the most critical being industrial and coastal zones as well as marine and mountainous environments. This research analyzes a cable rupture due to lightning strikes from a coastal zone.

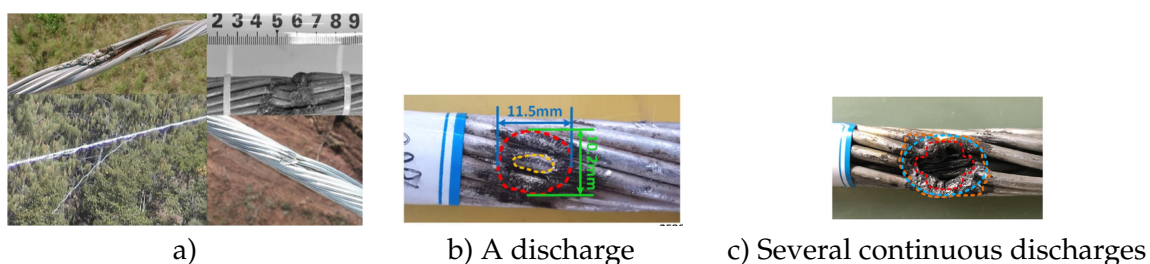
**Figure 2.** a) OPGW cable affected by an atmospheric discharge (Federal Electricity Commission) and guard cable with CFE optical fibers E1000-21. b) and c) Experimental results of controlled electrical discharges in the laboratory (11)

Fig. 2 shows the conditions potentially generated by atmospheric discharge in the cable, which involve high energy in short periods of time, or *vice versa*. It has been determined that the first case is associated with atmospheric discharges and the second with short-circuit conditions. The authors of (11) suggested that the damage increases linearly with the increase in charge transfer. As the discharge area increases, the intensity of the arc charge decreases. However, the volume of damage undergoes a non-monotonous change, which is due to complex variations in the area of attachment of the arc, regulated by the discharge space and the intensity of the current.

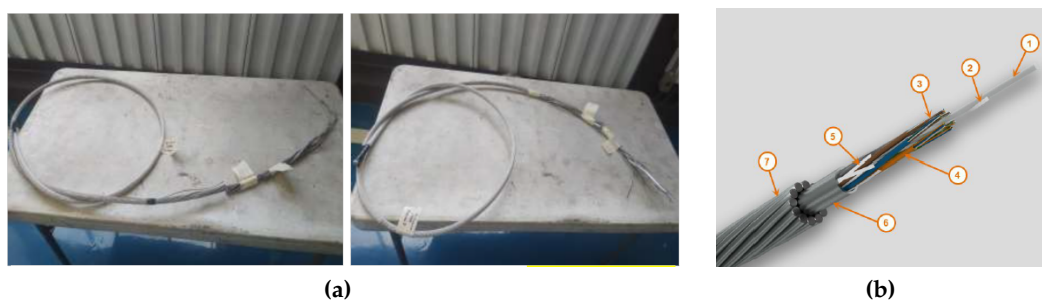
The analysis presented herein is based on 12 aluminum alloy wires surrounding the core of an OPGW cable, an element indicated as (7) in Fig. 3b. These aluminum alloy wires are made of 1350 aluminum-coated steel and support the OPGW's cable structure. The samples were tested according to regulations and were 0.30 m long. The failed OPGW was a 36-fiber cable with a diameter of 16 mm and an energy transfer capacity of 50 Coulomb (C). Details are shown in Fig. 3b.

**Figure 3.** 36-wire OPGW. (a) Analyzed samples, sections A and B. (b) Guard cable with OPGW optical fibers, 36 single-mode fibers of class 0 for atmospheric discharge, category A for thermal dissipation. (1) Dielectric central element. (2) Thread to block water penetration. (3) Single-mode optical fibers. (4) Three thermoplastic tubes filled against water, each with 12 fibers. (5) Threads for blocking water penetration. (6) Aluminum tube. (7) 12 aluminum-coated steel wires,  $\varnothing=2.92$  mm

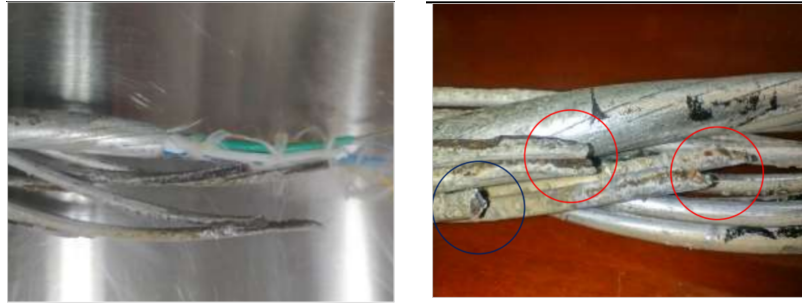
Section A comprises steel wires clad with aluminum, with deposits of corrosive agents exhibiting whitish and brown colorations due to the oxidation of the localized base material. In addition to the loss of material on the wire surface, the OPGW's 12 crown wires show melting of the material and loss of coating from the point of failure up to distances of 0.40 m. A visual inspection was carried out before cutting the 0.30 m sections for the tension test. The ends of the wires showed a reduced cross-section in the failure zone, and 11 out of the 12 wires had sharp tips due to the loss of material and the type of failure. Moreover, the aluminum tube where the optical fibers were located exhibited a transverse reduction in the affected area. Fig. 4 shows the steel wires with aluminum coating in the crown, which exhibit wear and melting of the base material as well as sharp points. For section A, the aluminum tube containing the fibers showed a reduced diameter in the affected area – the reader should recall that this section includes three filaments with 12 optical fibers each (Figs. 5c and 5d). As observed in a close-up of the OPGW, there are fractures in some of the wires in the fault zones, mostly ductile faults and smelting due to atmospheric discharge, in addition to wires and material detachment in the fault zone, with some elements of oxidation and coating loss (Figs. 5a and 5b). Oxidation is observed in Figs. 5a, 5b, and 5c, as well as pitting of the coating and loss of material. Fig. 5d shows the failed core tubing, which contains the optical fibers, in addition to a reduced cross-section due to mechanical stress. In the failed OPGW, clear signs of warming, short circuits, and cross-section reduction are also observed.

Section B of the failed sample indicates the loss of the aluminum-coated crown, which may be due to material melting. The tips of the wires have a reduced cross-section in the failure zone, and 10 of them have sharp points. One of the wires does not exhibit loss of area in its cross-section due to brittle fault, and one more suggests a tool cut.

**Figure 4.** Left: failed section; right: fracture and material melting zone. Marked in red, sharp points can be observed

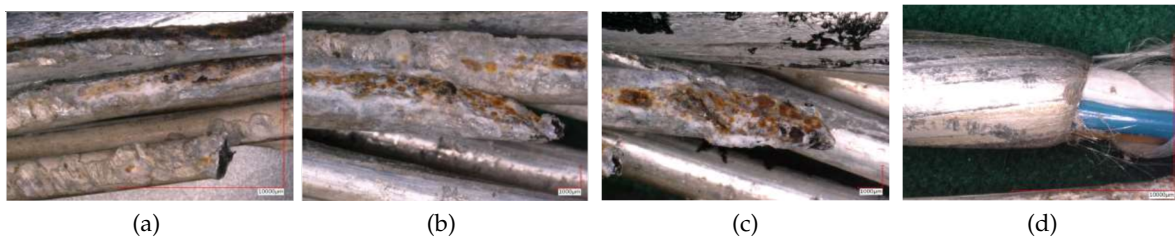
**Figure 5.** Affected area of the wires: a) oxidation and loss of material, b) loss of aluminum coating, c) oxidation and pitting of the coating as well as material loss, d) core tubing failure due to mechanical stress

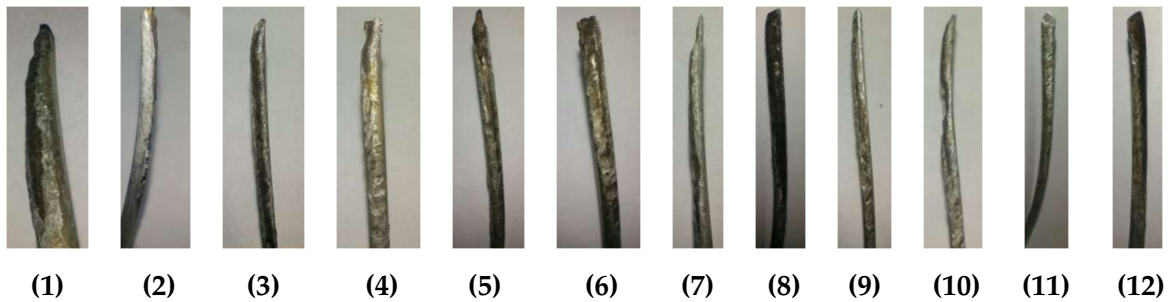
**Figure 6.** Failed OPGW crown wires, section B

Fig. 6 shows the 12 failed OPGW wires. The visual analysis of each wire is summarized below:

- Wire 1 has a reduced cross-section as well as a fragile fracture footprint.
- Wire 2 has a reduced cross-section and whitish deposits.
- Wire 3 has a material release on the tip, and a lack of aluminum coating can be observed.

- Wire 4 exhibits a fragile fracture pattern and temperature-induced material melting.
- Wire 5 has a reduced cross-section and an almost completely melted tip.

- Wire 6 exhibits a reduced cross-sectional area and fragile fault; coating loss is observed.
- Wire 7 shows a reduced cross-section, and the tip shows signs of brittle failure. Signs of aluminum coating loss and temperature melting are also observed.

- The cross-section and fragile footprint of wire 8 were minimally reduced, with minor deformation, but almost all of the aluminum coating was lost.
- Wire 9 exhibits a reduced cross-section, leaving the tip sharp. It shows whitish deposits and signs of material loss due to casting.

- Wire 10 shows a reduced cross-section area and a sharp tip. The observed material loss corresponds to more than 50% of its section. There is also a lack of coating, and even the loss of much of the base material.

- Wire 11 exhibits signs of tool cutting.
- Wire 12 shows a minimal reduction of its cross-section area and fragile footprint, with minor deformation, but it shows signs of material detachment caused by high temperatures.

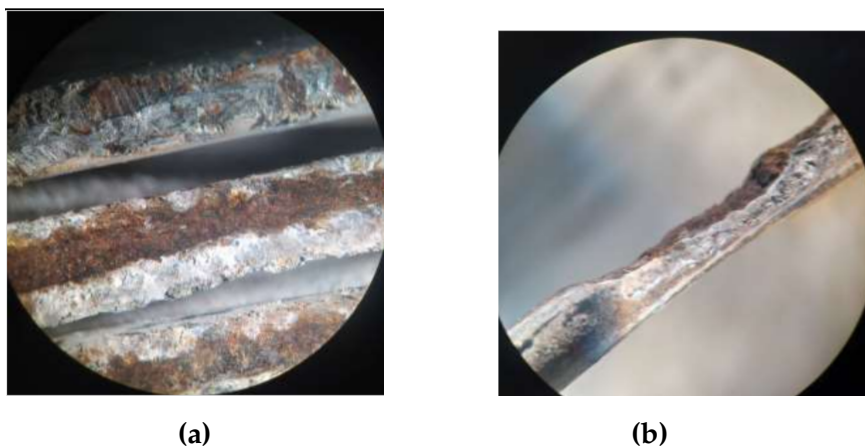
Corrosion zones were identified in the steel wires coated with aluminum, as well as embedded deposits of elements unrelated to the composition of the material. We also observed the melting and loss of material in the fault zone due to atmospheric discharge. Figs. 7a, 7b, and 14 show the close-up and microscopic inspection of the OPGW's critical zones.

**Figure 7.** a) Crown wires with wear areas; b) total loss of aluminum layer and oxidation of the steel core

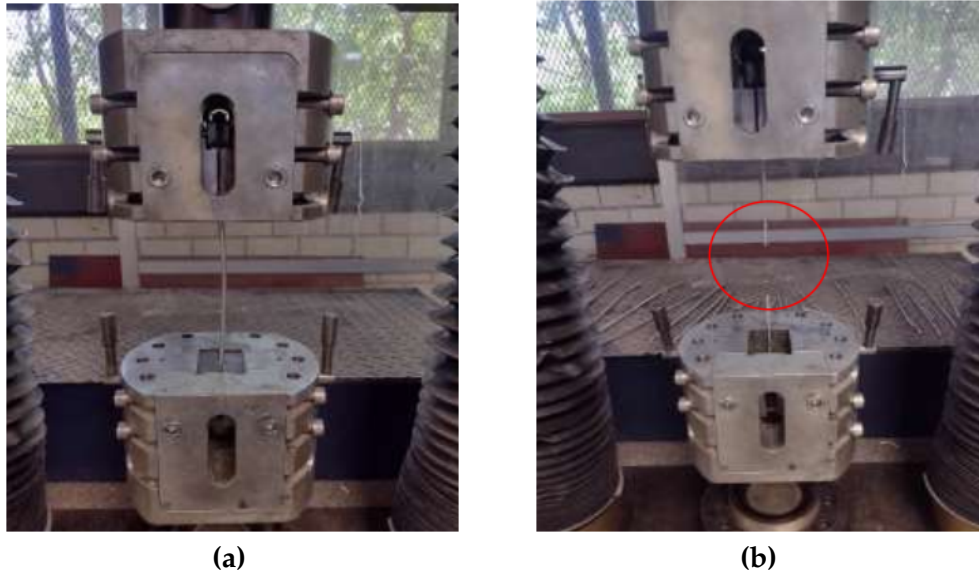
The test sequence was carried out using the JAUS universal machine (Fig. 9), applying a constant load at a speed of  $5000 N/min$ . Test runs were performed for each of the wires from sections A and B. Fig. 9b shows one of the OPGW cable wires, which fails upon reaching the limit of its mechanical resistance to tension. The 30 ton JAUS vertical machine was located in a mechanical testing lab, and it had been calibrated by the laboratory of metrology.

Figure 9. OPGW cable wire tension test: a) universal tension machine at the start of the test; b) end of test upon failure

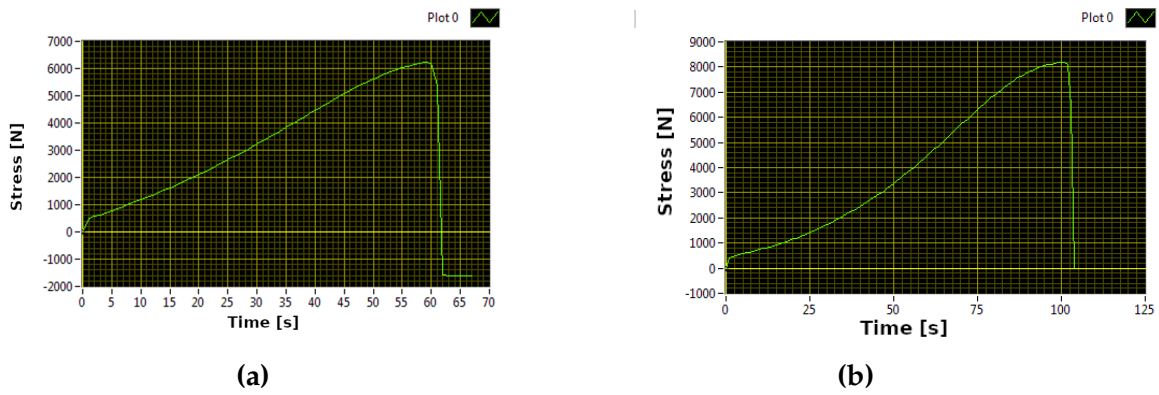
Figure 10. Point load vs. time graph for a) wire 1 and b) wire 11 of section A

The time until failure in most of the wires of sections A and B is close to 120 or 140 s, with some exceptions, such as wire 1 of section A, which failed within 60 s of applying the load according to the established parameters and execution speed. In both sections, a ductile and homogeneous failure behavior was observed, validating the quality of the analyzed cable.

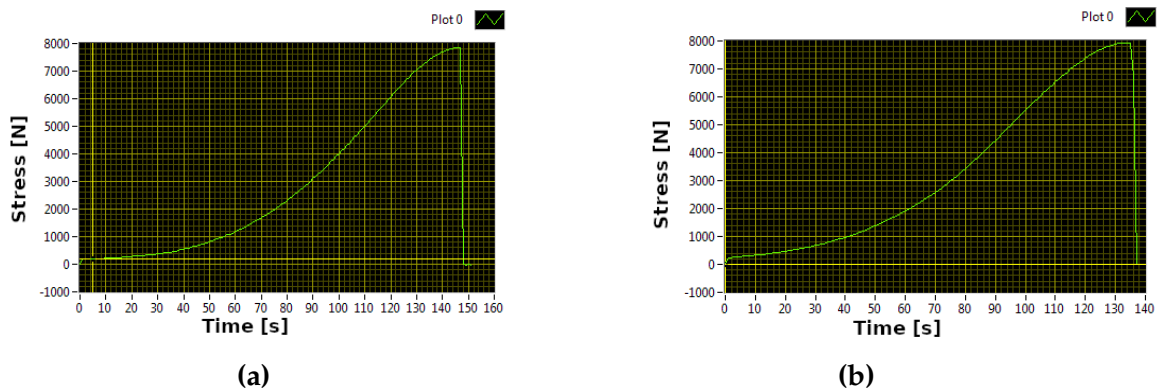
Figure 11. Point load vs. time graph for a) wire 1 and b) wire 11 of section B.

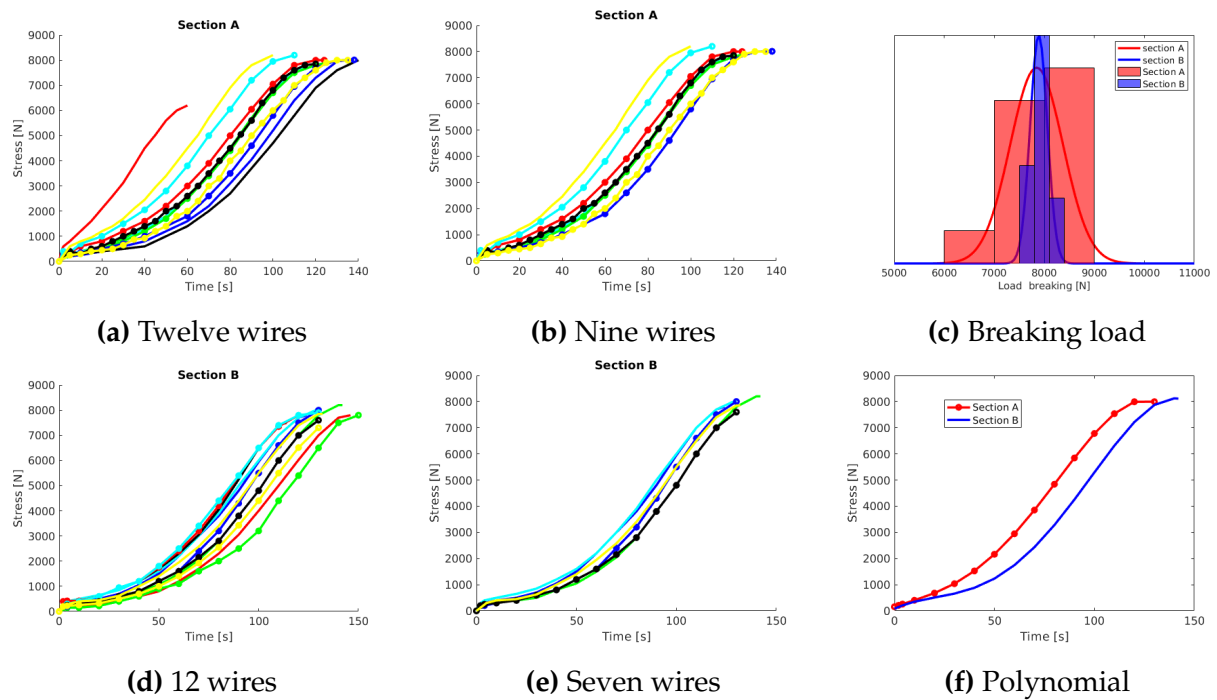
Eqs. (1) and (2) represent the polynomial approximation of stress *vs.* time for sections A and B, respectively. For these equations, we considered the curves shown in Figs. 12b and 12e, which correspond to the *SetRepresentative* variable in Algorithm 1. Fig. 12f shows the polynomial approximation of Eqs. (1) and (2). The behavior of the cables exposed to discharges changes considerably, while those with little exposure maintain a similar behavior.

**Figure 12.** Stress *vs.* time graph. (a) and (d) show the 12 wires of section A and B. (b) and (e) were generated by removing the curvy cables at the top and bottom of the graph. (c) corresponds to the breakdown load distribution in section A and B wires, and (f) represents the polynomial approximation using the curves (b) and (e)

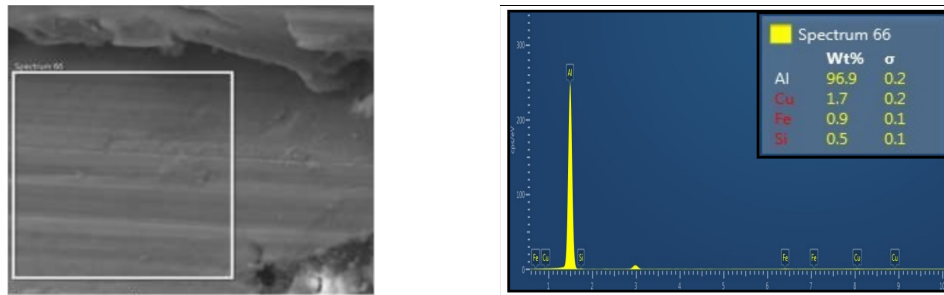
**Figure 13.** Elemental chemical analysis of the crown that makes up the OPGW

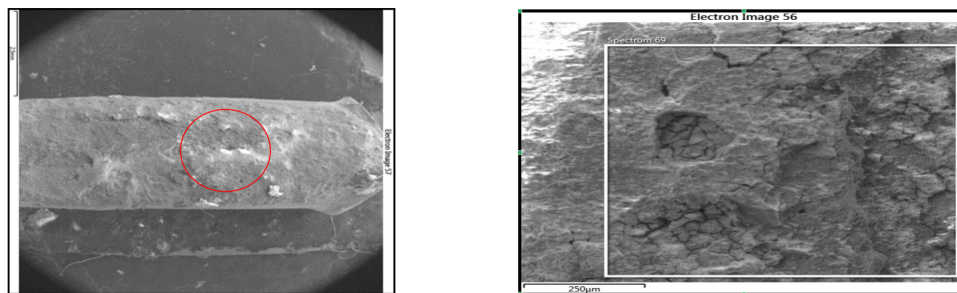
In the images of Fig. 14, a wire of the OPGW is seen to be visibly affected, with signs of pitting and a reduced cross-section. With prior verification through visual, dimensional, and microscopic inspection, a few bites were analyzed, corroborating the presence of corrosive agents, in addition to quantifying the loss of base material.

**Figure 14.** Zoom-in of the red zone of a visibly affected wire, with signs of pitting and corrosion. The chemical analysis of this zone is shown in Fig. 15

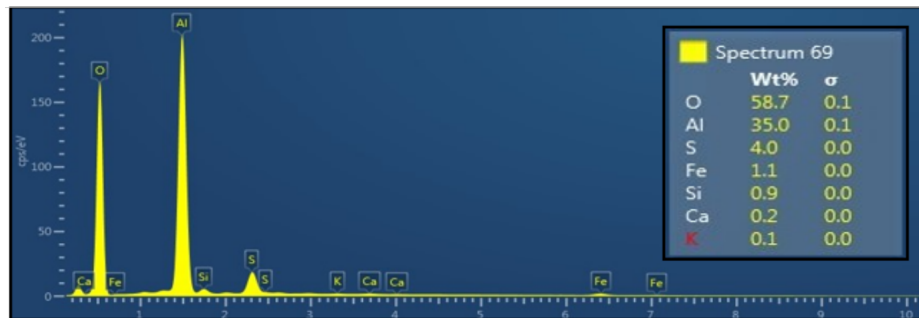
The chemical analysis of the pitting area defined as *Spectrum 69* can be observed in Fig. 15. The results indicate a high concentration of oxide due to the amount of oxygen recorded (58.7%), which suggests an accelerated process regarding the natural oxidation of the base material (Fe), observed in the form of a reddish-brown coloration. In this case, natural oxidation was mostly generated by humidity

and environmental conditions. The deposits attached to the wire's aluminum contained highly corrosive elements concentrated in the pitting area, such as sulfur (S), *i.e.*, up to 4%, which is a large amount of corrosive agent. The percentage of coating on the wire, which should remain above 90% (Al), was 35%, indicating losses. Therefore, the health of the element's coating was affected by the operating conditions. The guard wire with optical fibers exhibited reduced electrical properties and mechanics in this area.

The deposits adhered to the wires were also identified. The aluminum coating contained corrosive elements such as S and Na in the zone of base material loss, and we observed the loss of the covering layer and a significant percentage of oxygen due to the oxidation process caused by environmental and industrial impacts. The agents usually come from industrial areas and combine with oxygen and moisture in the environment, leading to the formation of acids and hydroxides that act as corrosive agents and accelerate the degradation of the material. These corrosive agents act mainly on the galvanized steel wires that make up the core of the cable, aggressively deteriorating their Zn layer, penetrating into the base material. With the above, a material loss process takes place, decreasing the wire's diameter and inducing a stress concentration on the driver element. The area decrease generates a temperature increase in the wires, as current is conducted through a smaller cross-section. Under these conditions, wires subjected to combined electromechanical and thermal stress can gradually yield, resulting in rupture.

Figure 15. Elemental chemical analysis of pitting in the OPGWs
