Geofísica internacional

# Electrical Resistivity Tomography for the detection of subsurface cavities and related hazards caused by underground coal mining in Coahuila

José A. Batista Rodríguez\*, Marco A. Pérez Flores, Yuri Almaguer Carmenates and Maximiliano Bautista Hernández

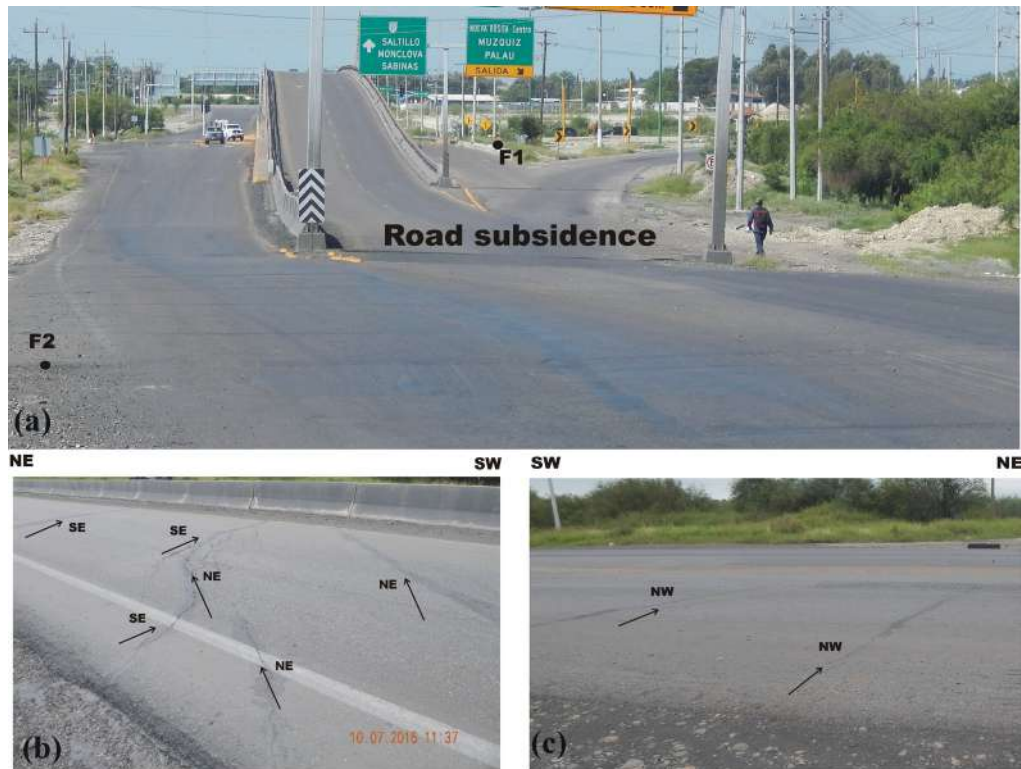
This sector contains both a road and a bridge support (Figure 5), with subsidence found on the road at the northeast end (Figure 9a), which could be related to the underground coal mining (Peng, 2008) due the shallower mining activities in this sector and its surroundings.

The northeastern end of Profile 2 covers the area of the road where subsidence is found (Figure 9a). Two possible cavities are identified with the ERT below the road, at 13 m depth, with both structures presenting different electrical resistivity, size and depth (Figure 10). It can be inferred from the resistivity image that the first cavity is smaller, larger resistivity and partially empty or filled with dry sediments. The second cavity is larger, lower resistivity and filled with either water or water-saturated sediments (Van Schoor, 2002; Zhou *et al.*, 2002; Martínez-López *et al.*, 2007; Putiska *et*

*al.*, 2012). Above these cavities, around 7 m depth, a small size aquifer is located within the Sabinas Conglomerates (CONAGUA, 2015). Above the area that covers both cavities, the road is highly fractured, with some fractures cutting across the entire road (Figures 9b and 9c). The electrical tomography suggests that some of these fractures penetrate into the subsoil, mainly in the area of the second cavity (see the inferred fracture in Figure 10).

**Figure 9.** Sector 1. a) Image showing the subsidence of the road. b) and c) Image showing fractures on the road surface in profile P2. Arrows indicate location and direction of the fractures. Reference points for the photographs shown in b) and c) are indicated as F1 and F2 in Figure 2, respectively. F1 and F2 also are indicated in Figure 9a.

These results suggest that special attention should be paid to both of these areas and to activate a system for monitoring the roads and the bridge integrity in order to avoid damage due the gradual or sudden land collapse.

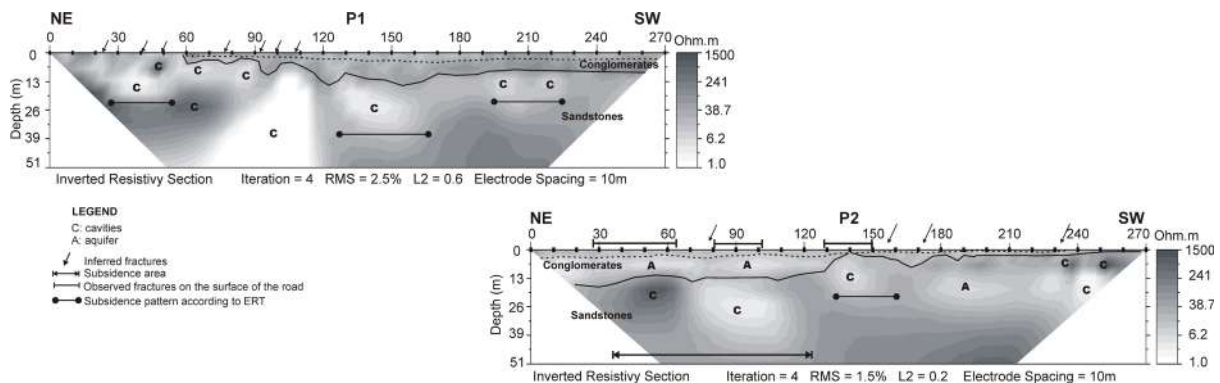
Four small cavities are found in the SW end of Profile 2 (Figure 10), located next to the bridge (Figure 5) with subsidence on the road (Figure 9). Two cavities have very low resistivity, while the other two are more resistive, smaller and shallower (approximately 7 m). The cavity found at the center of the profile is clearly the cause of fracturing on the road surface. Moreover, in this zone, the ERT results show at patterns that suggest subsidence, namely, zones of low resistivity (represented by the light gray color) with a convex form (Figure 10).

Profile 1 also shows several cavities from a depth of 7 m onwards, most of which present low values of resistivity and are small in size. Above these cavities water table of about 5 m inside the conglomerates is located. According to the ERT, the geometry of these structures shows patterns of probable subsidence, although no visible deformations are observed on the surface of the roads. These patterns were found in the ERT results for zones with low resistivity and convex shapes with respect to the surface (Figure 10). These zones resemble the characteristic descent into a small basin which is caused by the accumulation of sediments. Towards the northeast of the profile, a large cavity with very low resistivity was observed, extending from a depth of 10 to 50 m ( $x=110$  m). Above this cavity, the road presented no subsidence; however, the ERT showed that it is so close to surface that we expect possible fracturing on surface. We found, in some buildings adjacent to the road fractured walls. All fracture systems observed on the road are perpendicular and oblique to the highway (Figures 9b and 9c), following the probable galleries direction (Peng, 2008). The fracture systems follow three different directions: perpendicular to the road on a NW-SE direction; oblique on a NE-SW direction; and, a NW-SE direction.

**Figure 10.** ERT of Sector 1 (profiles P1 and P2). The section of P2 from 170 to 270 m is located next to the bridge. Continuous curved lines indicate boundaries between rocks and discontinuous curved lines indicate water table. The profiles are located graphically according to their position in the field (see Figure 5).

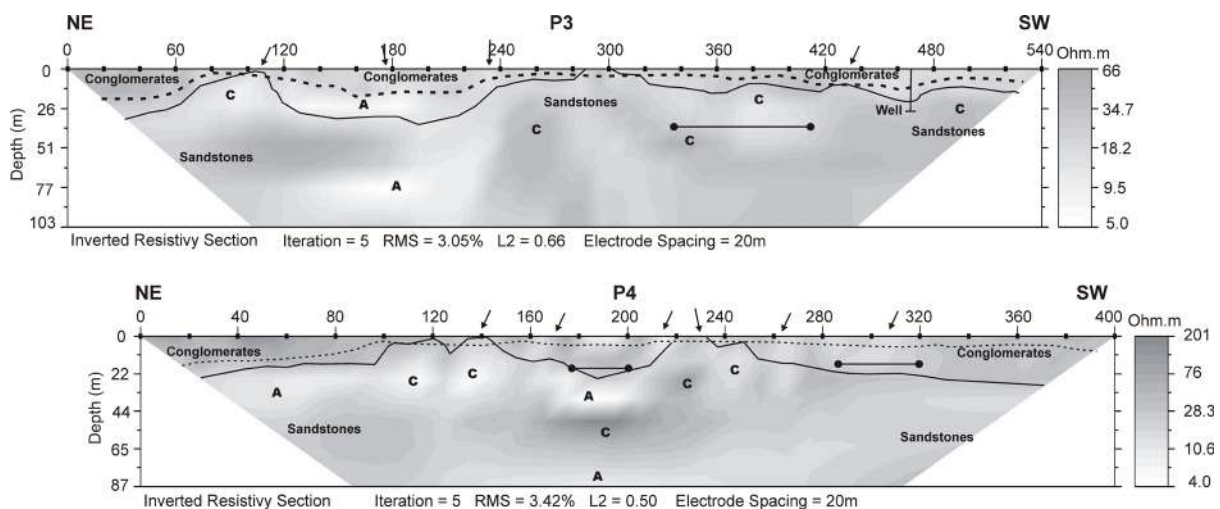
shape and they are located at two depth levels (approximately 22 m and 50 m). Some of these cavities were observed at both sidewalks, indicating that they are connected and cross under the road. All cavities identified are low resistivity (represented by the light gray color). Values lower than 10 ohm-m suggests that the cavity is water-filled (Van Schoor, 2002; Zhou *et al.*, 2002; Martínez-López *et al.*, 2007;

The larger cavities (30 m wide and 25 to 35 m high) identified at a depth larger than 30 m, do not produce visible road deformation; however, this is not a general rule. Some of the zones with probable land subsidence ( $x=360$  m in P3 and  $x=180$  in P4) are related to cavities deeper than the mentioned depth.

It should be noted that, most of the cavities identified are located on both sides of the bridge support. The bridge support itself is located in an area with a large hazard level.

**Figure 11.** ERT of Sector 1 (P3 and P4). The profiles are located graphically according to their position in the field (see Figure 5). Continuous curved lines indicate boundaries between rocks and discontinuous curved lines indicate water table. The section of P3 from 0 to 280 m and the section of P4 from 0 to 230 m are located next to the bridge. Vertical line indicate well.

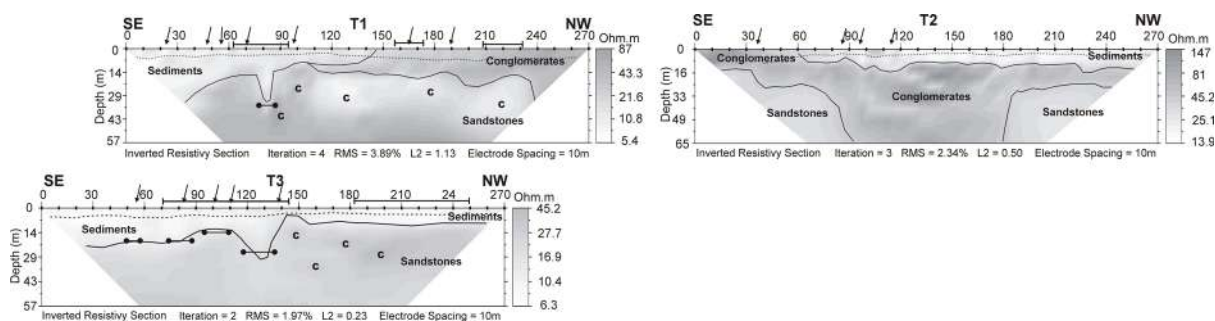
Sediments with a very low resistivity outcrop at the SE end of T1 and they extend to depths larger than 35 m (Figure 12). Electrical resistivity values suggest that these sediments are water saturated, in which the water table oscillates around 5 m, deepening to the NW of the profile T1, according to the resistivity values. Towards the SW end of the profile, conglomerates outcrop and extending to 14 m depth. Several cavities, beginning at a depth of 14 m, are identified in the sandstones underlying the sediments and conglomerates, all of which recorded low resistivity values (Figure 12), indicating that these structures are probably filled with water or water-saturated sediments.

This study identified several fracture systems on the road above the identified cavities (Figure 12), with most of these fractures running perpendicular to the road (Figures

**Figure 12.** ERT of Sector 2. The profiles are located graphically according to their position in the field (see Figure 6). Continuous curved lines indicate boundaries between rocks and discontinuous curved lines indicate water table.

Sediments and conglomerates outcrop in the T1 and T2 models (Figure 12), while ten meters depth, conglomerates cover almost the entire Profile 2 (T2) and raise a thickness of 50 m at the center. No cavities in the central part are identified in the ERT model. This explains why no fractures were found on the road.

Profile 3 (T3) is located on the opposite sidewalk (Figure 12). Only sediments outcrop in Profile 3 and the cavities identified in Profile 1 also appear, suggesting that they are located below the road.

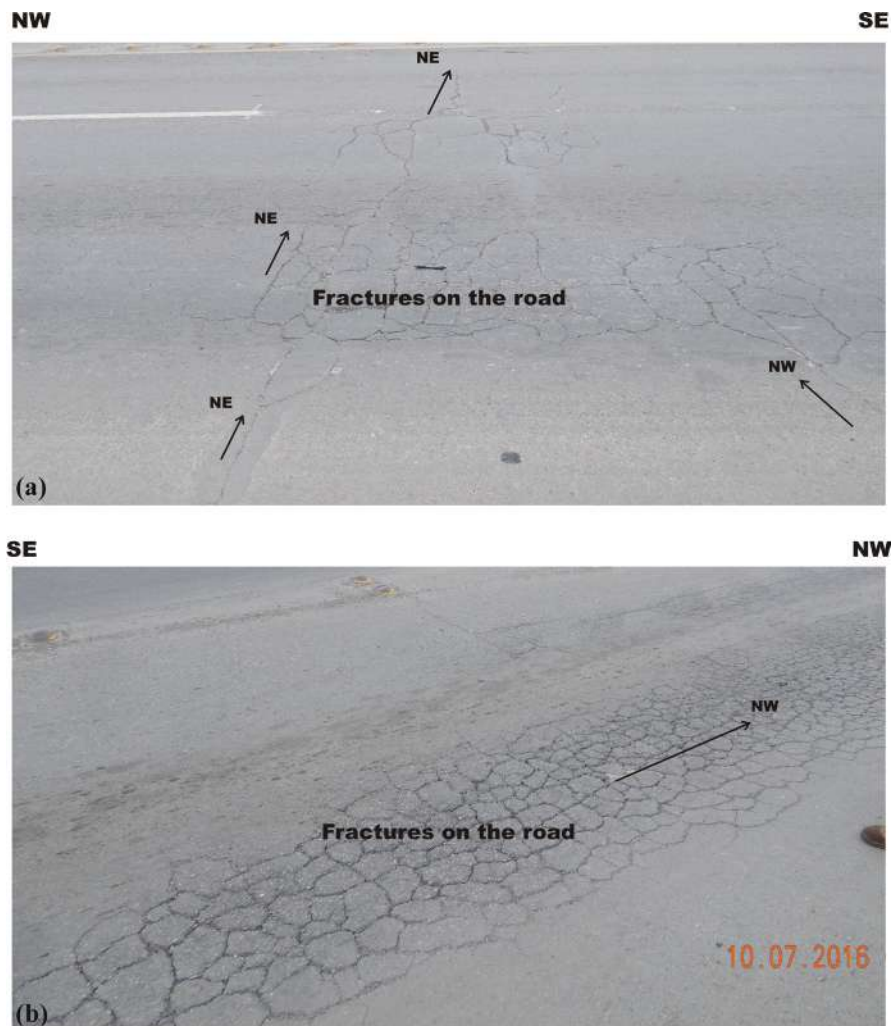
13a and 13b). The ERT models also present patterns that suggest deep extended fracture systems related to the cavities. Similarly, the ERT model for T1 shows a pattern of probable subsidence with low resistivity (represented by the light gray color) and a convex form, while on the road increases the density of fractures and decreases the spacing between them.

More road fractures were found on the east side than on the west (Figure 13b), which may be related to the outcrop of less competent materials (sediments) on the east side.

**Figure 13.** Images of fractures with signs of subsidence on the road surface in Sector 2. a) Profile T1. b) Profile T3. Arrows indicate location and direction of the fractures. Reference points for the photographs shown in a) and b) are indicated as F1 and F2 in Figure 6, respectively.

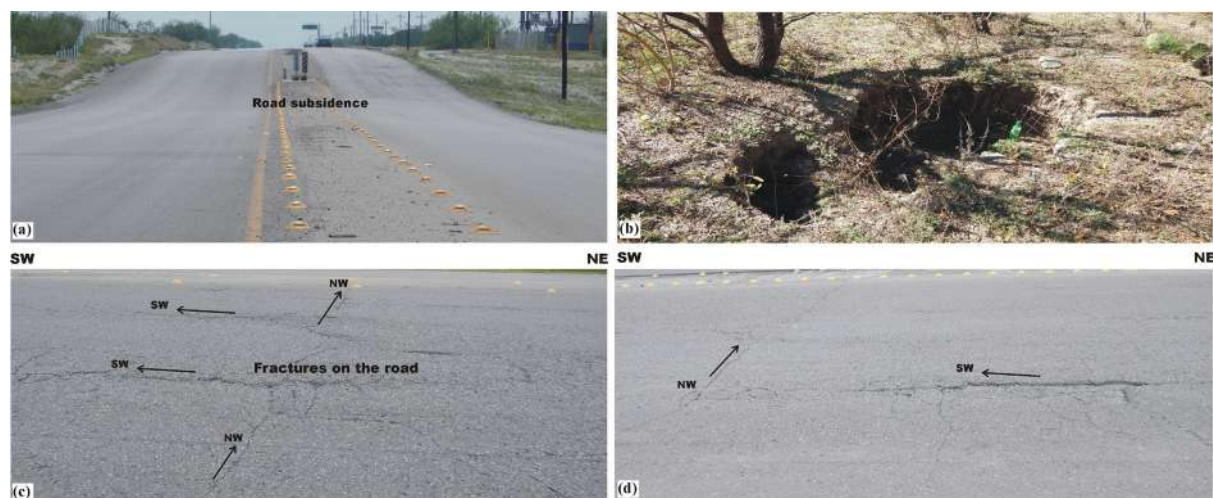
This sector includes a road which is located next to an abandoned underground coal mine (Mine 4 in Figure 7), which reached an approximate depth of 350 m. Two sections of extensive subsidence were identified on the road (Figure 14a), related, apparently, to underground mining.

findings indicate a high level of fracturing at depth, which was also identified on the road surface (Figures 14c and 14d). The two zones presenting subsidence on the road surface are located at  $x=200$  m and  $x=860$  m in G2.

**Figure 14.** Sector 3. a) Image showing the subsidence of the road. b) Image of a sinkhole next to the road. c) and d) Images of fractures on the road surface in Profile P1. Reference points for the photographs shown in c) and d) are indicated as F1 and F2 in Figure 7, respectively.

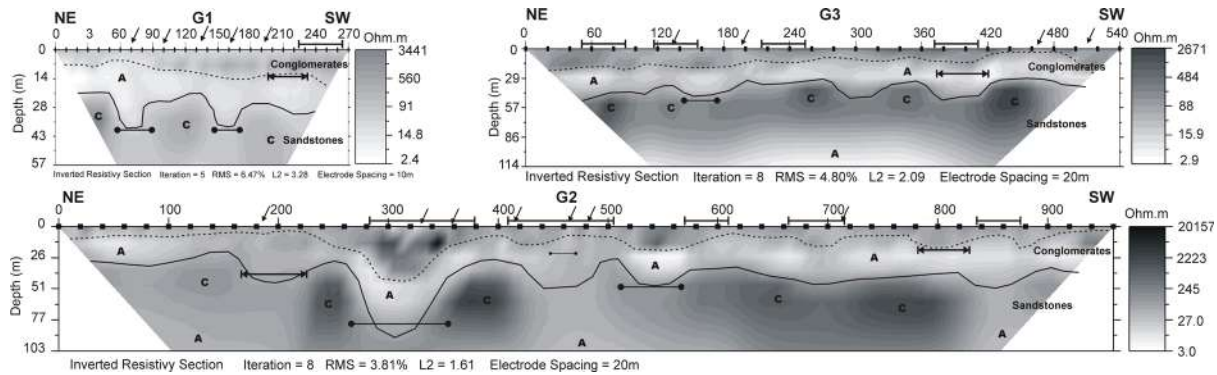
Figure 15 shows that, generally, the aquifer level becomes deeper in the zones between the cavities ( $x=60$  m,  $x=150$  m and  $x=200$  m in G1;  $x=200$  m,  $x=290$  m and  $x=440$  m in G2; and,  $x=300$  m in G3). Two of these zones are located just below the subsidence observed on the road (Figure 14a). One zone is located at the SW of G1 and another at around  $x=200$  m in G2, while a third is found at around  $x=800$  m at the SW end of G2 and at 380 m in G3 (Figure 15). In all the zones located between the cavities identified in this study, a high number of fractures were observed on the road (Figures 14b and 15).

Within the sandstones, another aquifer was found at a depth of 100 m below the cavities (Figure 15), in some areas connected to the upper aquifer located at  $x=200$  m,  $x=460$  m, and  $x=860$  m in G2. This finding concurs with the CONAGUA (2015) results, which indicate the connection, through fractures, between the shallow and deep aquifers. These ERT

**Figure 15.** ERT of Sector 3. The profiles are located graphically according to their position in the field (see Figure 7). Continuous curved lines indicate boundaries between rocks and discontinuous curved lines indicate water table.

The fracture systems on the road surface in Sector 3 are found above the depressed zones identified, indicating the relationship between the two processes. The cavities present high resistivity values, indicating that they were not flooded by water from the upper level aquifer. The movement of groundwater can occur at lower levels, where cavities are larger and are related to the deepest mining activities (located at a depth of 350 m). According to CONAGUA (2015), the aquifers embedded in the granular materials of the Cenozoic (e.g., the Sabinas Conglomerates) may be connected through fracture systems with the Upper Cretaceous Formations (e.g., the Olmos Fm.).
