Rehabilitation of Historic Masonry Bridges: Lessons Learned from a Medieval Bridge in
Northeast Spain

Revista de la Construcción, vol. 14, núm. 2, agosto, 2015, pp. 9-13

Sant Andreu de Terri gothic bridge is listed as a construction of historical, artistic and architectural interest by the Generalitat of Catalonia. It is adjacent to the town of the same name and the road over it connects Cornellà del Terri and Sant Julià de Ramis populations crossing the Terri River. The first news of the bridge is documented in 1220, when it was quoted in the Lord Dalmau of Creixell last will (XII-1219) (Palmada, 2008).

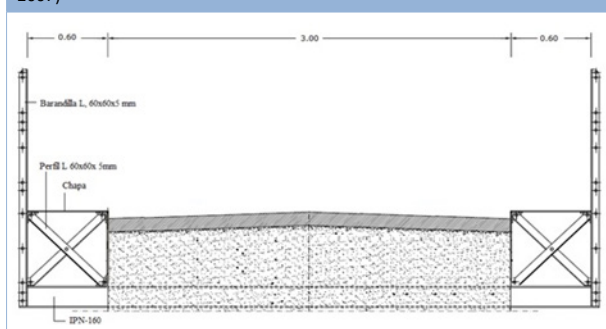
The bridge suffered in the late nineteenth and early twentieth century an expansion project consisting of iron railings, as referred in the files of the Architectural Heritage Service of the Department of Culture of the Generalitat of Catalonia. The road construction entailed the demolition of the original stone parapet and the destruction of the original pavement, making it accessible to vehicles (Palmada, 2008). The original parapet was replaced by current iron railings, allowing for gaining a passage width of 60 cm on each side increasing total width from 3 m to 4.2 m (Merino, 2003). To make this work IPN 160 section beams were placed over the board protruding transversely. On the sides of the bridge and over transversal beams, two squads of 60 cm and 80 cm were placed, supporting a cantilevered steel sheet. The stability of the whole rested on a set of St Andrew's crosses, joined like the rest of the structural elements by riveting (Figure 2).

Figure 2: Bridge section after modification in late nineteenth century. (Geocisa 2007)

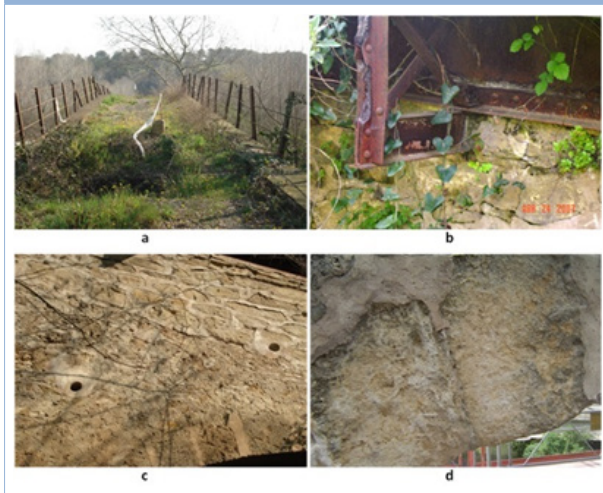
The bridge of Sant Andreu de Terri retained its bearing capacity before restoration but failed in safety and comfort conditions for pedestrians and cyclists (Figure 3-a). On the pavement there were holes covered by vegetation that had unveiled in specific areas the transverse and longitudinal metal sections. Possibly, holes were the remains of the archaeological surveys conducted in 2003.

All bridge railings were in very poor condition due to oxidation and deformation (Figure 3-b). Section losses were widespread due to corrosion in L-type profiles and numerous holes in the plates for the passage. Stone materials and walls showed normal degree of deterioration over time, being vegetation growth one of the most widespread problems.

Vegetation was present in the south-eastern cone of land, in several areas along the railing fixation, the bottom part of the western central arch in contact with the breakwater and at the end of the bridge in contact with the slope lands. The estimated vegetation cover was of 210 m² in each of the walls. Roots forced disintegration of the joints and in some cases small landslides were observed. Vegetation and punctual overloads appeared to be the origin of the cracks that ran through the vertical walls (Figure 3-b and 3-c). These horizontal cracks did not endanger the stability of the whole bridge but some of them reached a total crack length, on both sides, of 25 m. As a result of this diagnosis, vegetation was removed from the outer wall to prevent further disintegration and crack enlargement.

Walls presented many cavities, as explained above, made in order to evacuate water or to anchor machinery, as attested by the remains of mortar nearby to create a smooth surface. It was recorded a total of 20 holes on each of the north and south walls and an undetermined number of cavities in the vegetated areas (Figure 3-c). This set of cylindrical holes in some cases had led to the fall of the stones around them. It was decided to repair the cavities and find a solution to the drainage of waters

Figure 3: Previous damage status. a) pavement; b) steel structure and adjacent masonry; c) walls; d) ashlar (Conde-Salazar, 2007).

Some ashlar presented mass loss by disaggregation and arenisation, possibly due to porosity in conjunction with expansion by crystallization of the cypto-fluorescent salts brought by water infiltration, or by ice freeze-thaw cycles. Several ashlar stones were detached by hydraulic effects and lack of maintenance (Figure 3-d). A loss or weakening of the filling in the joints of the masonry affected the whole structure randomly, caused by the action of water and possibly by different river floods. Several colors were observed in the bonding mortar, which corroborated the fact that the top part, from the anchorage zone of the rails upwardly had been built in a different time period than the rest of the bridge.

safety. It was also secured access to adjacent properties affected by the works at all times. Vegetation clearing was performed by mechanical methods, as existing legislation banned the use of chemicals. Vegetation lying on the walls was totally removed and a treatment was applied to prevent its future growth.

This new pavement was continued, as well as the railing, by the slope up to the road. Substitution and replacement of masonry. Missing facing stones were replaced by others with the same stony features and were secured by lime mortar. Stones missing on the breakwater were replaced and also sealed with lime mortar. Treatment was topped off with a coat of mortar.

This phase and the following were subsequently conducted after the placement of transverse metal elements and prior to the placement of the rest of the metal structure and the floor pavement. Cleaning and filling of holes and cracks in walls. Cleaning of masonry joints was performed manually (Figure 8-a). Subsequently lime mortar was applied for grouting. In areas where it was necessary, lime mortar was injected in the cracks before sealing (Figure 8-b).

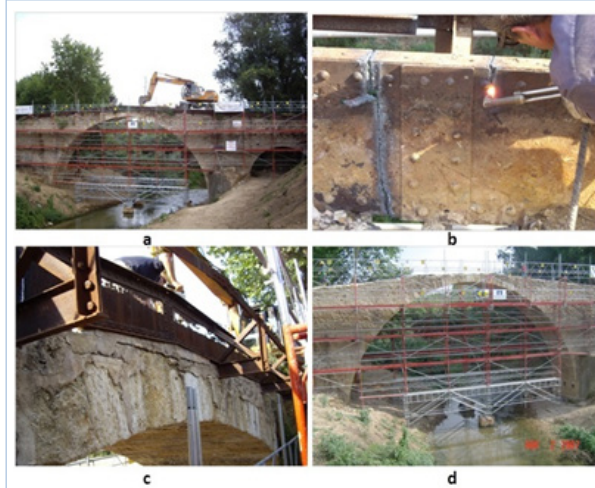
Figure 4: Pavement and metal railing removal (July-August 2007) a) rubble extraction from pavement; b) metal structure removal; c) bridge at its final stage. d) final bridge after removal (Conde-Salazar, 2007).

Filler was gradually withdrawn symmetrically in order to avoid any unbalance in the arches. Special care was taken with the central arch, as it presented the highest slenderness (Figure 4-a). The excavator machine was never placed in the middle third of the central arch and rubble removal in this area was performed by using only the blade. The reason for preventing access of the excavator to the middle third was to prevent the collapse of the structure. Previous studies on the Clare College Bridge showed that overloads over 39kN acting within 0.6 m of the key could lead to the collapse of a semicircular arch of 6.72 m span (Heyman, 1995). Elimination of existing metal railing. The removal was effected gradually, cutting items to avoid the transmission of vibrations to the structure (Figure 4-b 4-c)

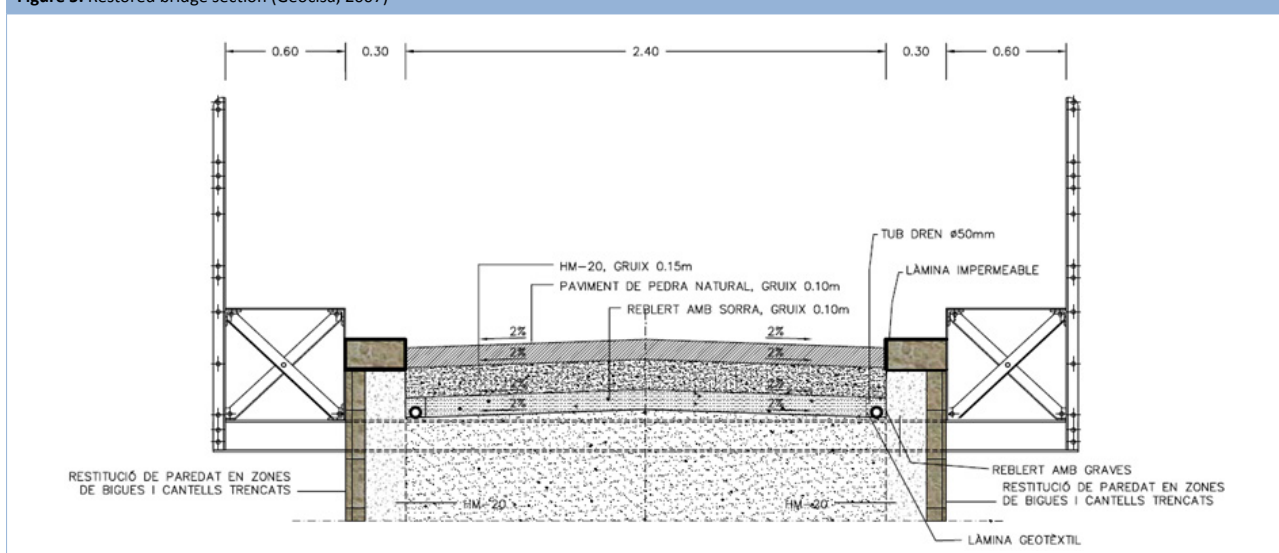
Figure 5. Restored bridge section (Geocisa, 2007)

Replacement of the metal structure. According to the modification made in the late nineteenth century to the original study, the metal frame should be replaced by one as close as possible to the existing one. The metal structure should be treated against corrosion and protected with glass sheet 6+6 prolonged to the earth slope bank with a stone wall which would replace the existing barrier rail and prevent the possible fall of pedestrians (Figure 5).

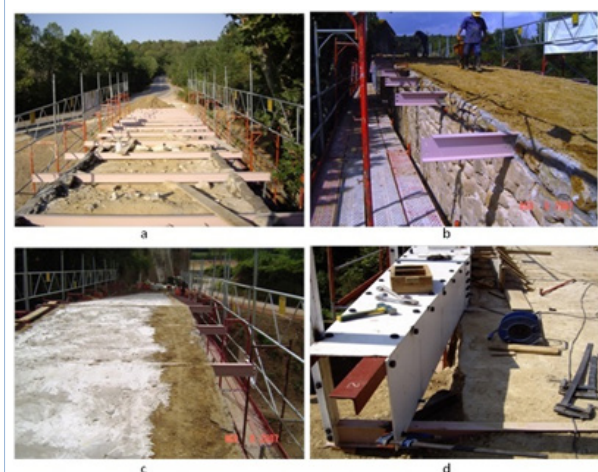
Figure 6: Placement of metal railing; a) metal beams and masonry placement; b) leveled sand; c) Hydraulic lime application; d) metal beam (Conde-Salazar, 2007).

The metal structure, all of it protected against corrosion by stabilizing oxide painting, is supported on IPN section transverse beams flying on both sides of the bridge. On these overhangs it was fixed the L steel plate. To stiffen the assembly formed by the rail, the cross beam and steel plate, angular pieces were placed at the four corners and, as in the original structure, St. Andrew crosses. All joints were bolted, unlike the original structure (Figure 6-a and 6-b).

Masonry removed during previous actions was placed between the transverse beams. Leveled and hydraulic-lime-irrigated sand screed was used for the filling (Figure 6-c and 6-d). This type of lime sets in the presence of water and develops short-term resistance. Construction of a new board. The board is a key element in the distribution of loads to the arches through the packing. The panel construction process was divided into stages (Figure 7):

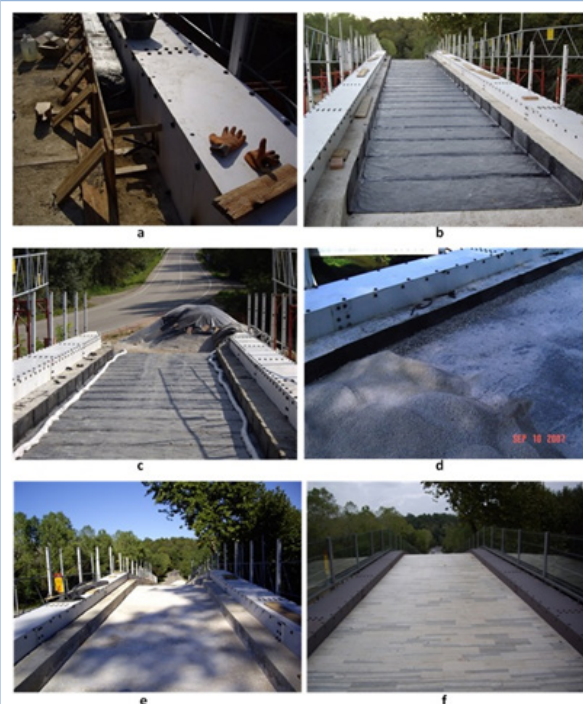
Figure 7: New board construction; a) longitudinal concrete walls; b) placement of waterproofing asphalt sheet. c) two longitudinal drainage pipes; d) two fine gravel layers over asphalt sheet; e) mass concrete; f) stones. (Conde-Salazar, 2007).

a) Construction of two longitudinal small concrete walls attached to the metal frame by soldering (Figure 5). These walls replace parapet masonry layers traditionally placed on stone bridges with tying function (Figure 7-a)./ b) Placement of asphalt waterproofing sheets, fastened to the longitudinal concrete beam until his coronation (Figure 7-b). Water, slowly but continuously, dilutes the mortars and in the presence of CO₂, ClNa,..., eliminates the binding between the mineral

components (Monjo et al, 1998). Waterproof fill is essential to control this process./ c) Placement of two longitudinal drainage pipes along concrete beams (Figure 7-c)./ d) Discharge of two layers of gravel over the waterproofing and compaction. Drainage pipes were covered with thicker gravel than the remaining bridge (Figure 7-d)./ e) Pouring a concrete slab mass (Figure 7-e)./ f) Pavement of the board with local stone to achieve the projected level, leaving a small step between the steel sheet and the board to keep the previous aesthetics of "sidewalk-driveway". The donkey-back profile yields the minimum longitudinal slope for drainage./ g) Gasket sealing resulting from this union with cement mortar. (Figure 7-f).

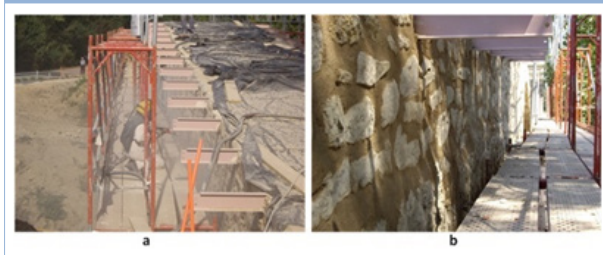
Figure 8: Holes and cracks cleaning and filling (Conde Salazar, 2007).

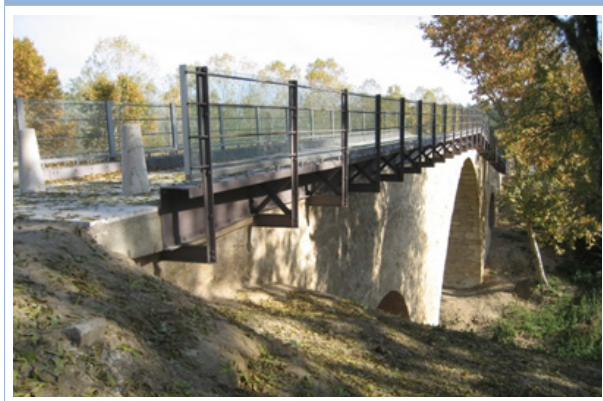
Figure 9. Bridge status after restoration. (Conde Salazar, 2008)

The restoration project was completed in September 2007 and had a final cost of € 284,568.47 and a duration of 5 months (Figure 9). The bridge is accessible, allowing the passage of people with different degrees of disability.
