Revista de la Construcción, vol. 16, núm. 1, 2017, pp. 145-157

Failure and damage determination of building roofs

Manuel J. Carretero-Ayuso (Main Author)

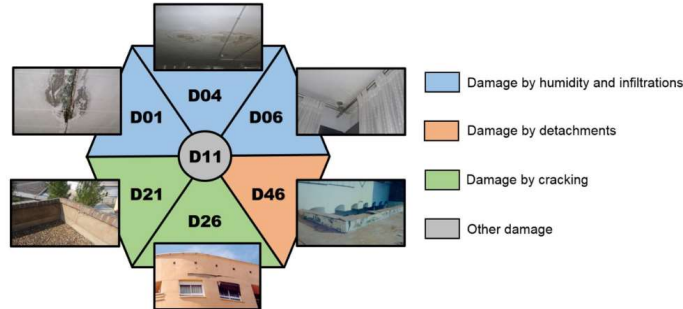
Figure 1. Graphical examples of the types of damage groups by similar anomalies. Source: images by Manuel J. Carretero-Ayuso.

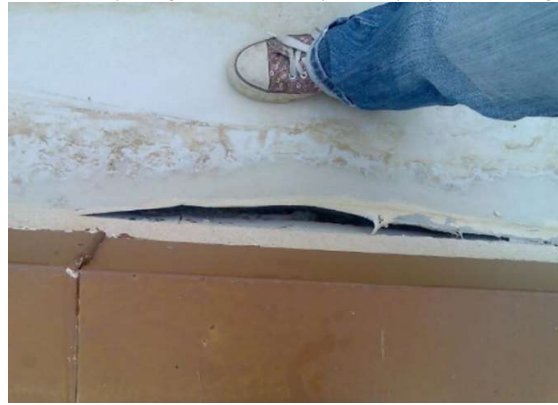
Figure 2. Deficient tail-end between the waterproofing membrane and the perimeter parapet. Source: image by Manuel J. Carretero-Ayuso.
