Jorquera, Natalia; Ruiz, Jonathan; Torres, Claudia
Analysis of seismic design criteria of Santo Domingo Church, a Colonial Heritage of
Santiago, Chile
Revista de la Construcción, vol. 16, núm. 3, 2017, pp. 388-402
Pontificia Universidad Católica de Chile
Santiago, Chile

Analysis of seismic design criteria of Santo Domingo Church, a Colonial Heritage of Santiago, Chile

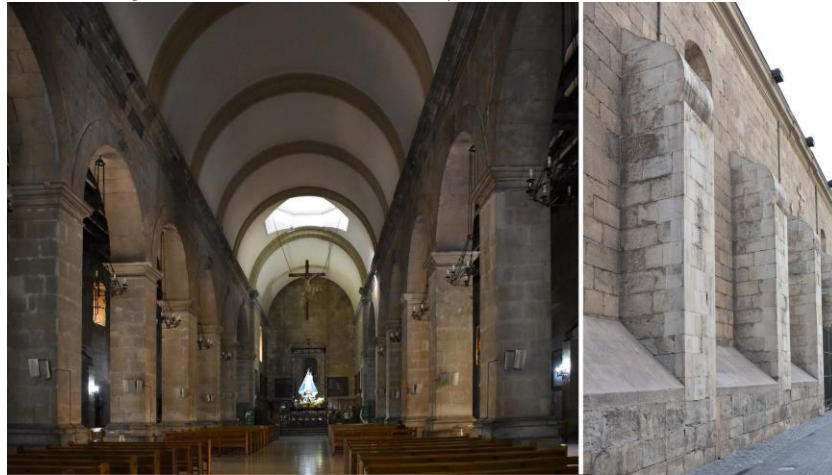
The longitudinal walls have external and internal stone buttresses (Figure 2) of 1.1 m x 1.3 m in plan and 8.3 m high (they are lower than the perimeter wall), which prevent out-of-plane flexing of the walls during seismic thrusts.

A base plinth is present along all longitudinal walls, which help lower the center of gravity and reduce the height of the walls subjected to out-of-plane mechanism (Figure 2).

Figure 2. Arcades and buttresses with base plinth of the church. Source: authors.

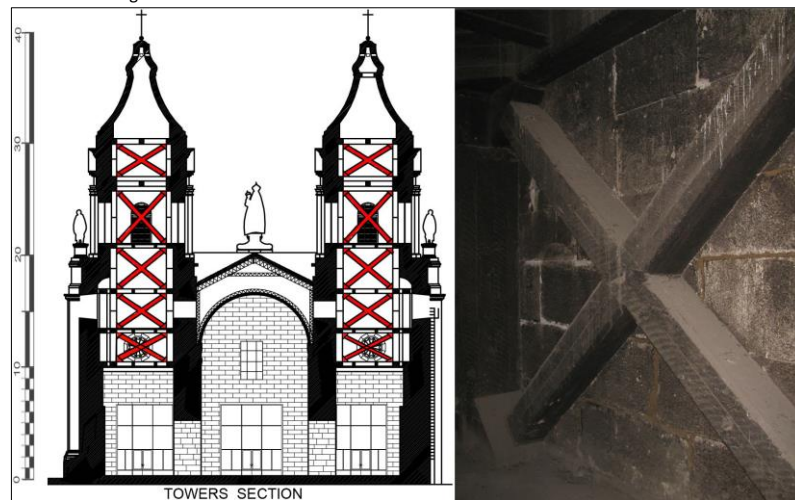
Concrete reinforcement of the towers starts at 9.6 m high, in the same position as the old choir. The reinforcement consists of beams, pillars and diagonals, semi embedded into the brick walls by their interior face, so they are not visible (Figure 3).

Figure 3. Scheme and image of towers reinforcements. Source: authors based on Ministerio de Obras Públicas de Chile plans.

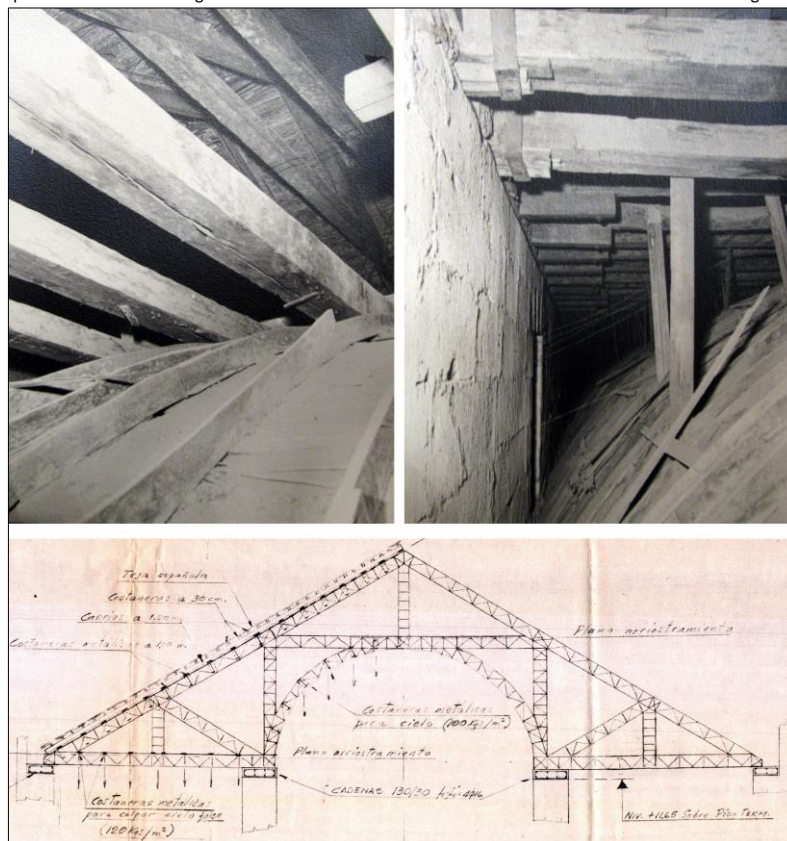
After a fire in 1963, the entire wooden structure was replaced by a new reticulated metal truss composed by steel bars forming an arch, tied longitudinally with beams of similar characteristics (Figure 4). The metal truss is a light structure with highly flexible behaviour and more strength than the old wooden structure. It rests on the

Figure 4. Comparison between the original wooden roof structure and the steel new truss Source: Santo Domingo's Church library.

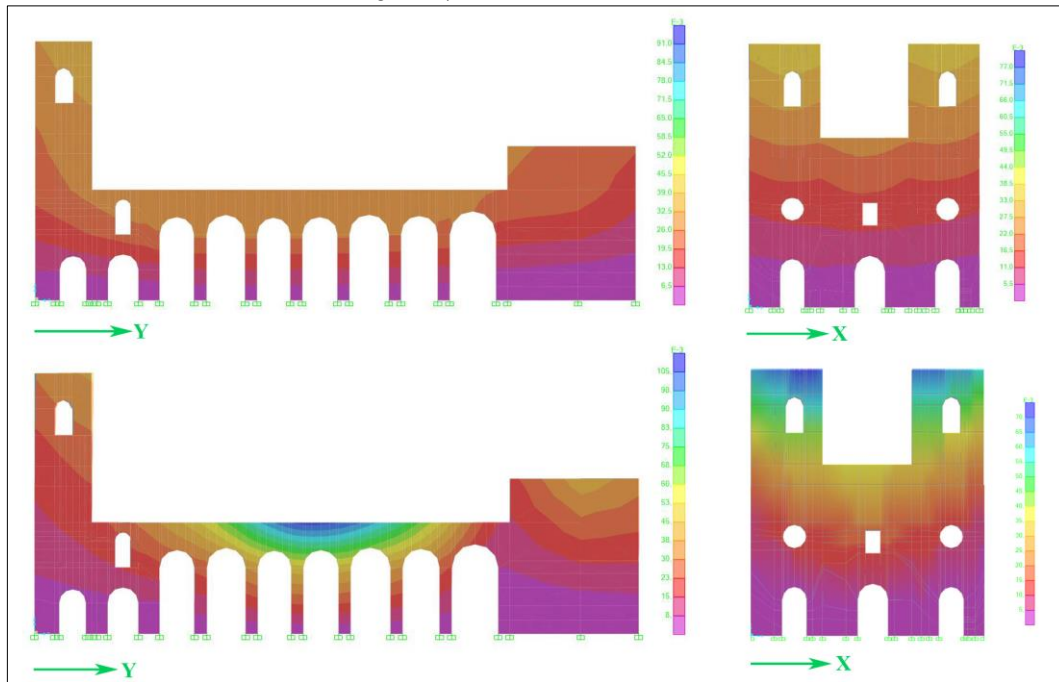
In order to identify areas where seismic loads produce maximum stress, the first step was to analyze the locations of maximum displacements. As expected, highest displacements were verified in the upper part of the towers (39 mm - X), in the central area of side walls and central arcade (33 mm - X), as well as on the steel structure of the skylight over the transept (315.7 mm - X). The high deformation shown by this element reinforces the idea of its local analysis. Moreover, to compare the bracing effect of elements such as the steel roof, concrete tower reinforcement or sidewall buttresses, the structure has also been analysed without taken them into consideration. Maximum displacements on the tower vary from 39 mm to 70 mm. Similarly, the displacement on the upper part of central arcade increases from 33 mm to 105 mm (Figure 5).

Figure 5. Displacements central arcade of the temple and main façade. Up: Displacement taking into account the bracing of the roof. Left: X Displacement under X seismic action; Right: Y displacement under Y seismic action. Down: Displacement without the bracing effect of the roof. Left: X Displacement under X seismic action; Right: Y displacement under Y seismic action. Source: authors

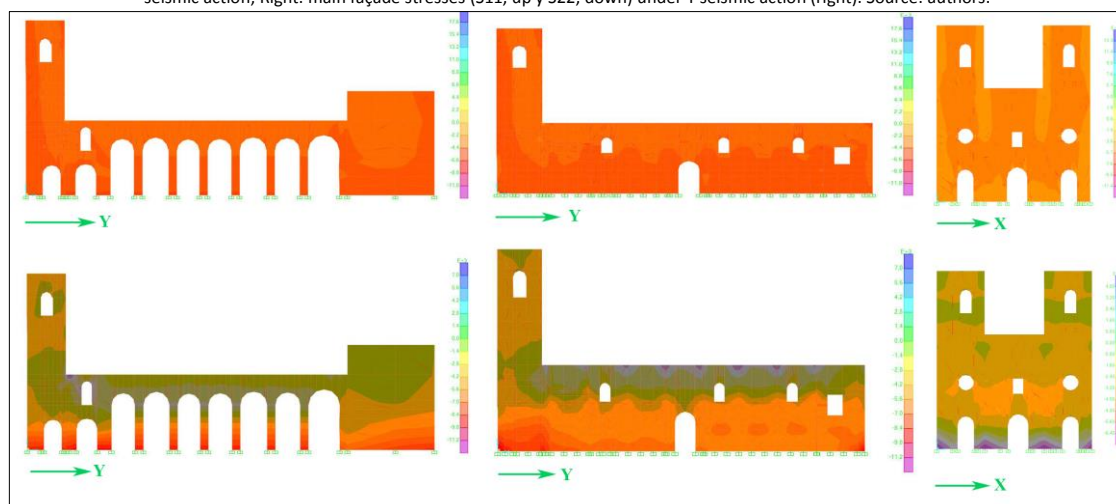
Maximum compression and tensile stresses caused by seismic actions are shown in Figure 6. By analyzing stress on the masonry it was possible to verify maximum admissible compression stress is not exceeded at any point of the structure. Conversely, there are several points where the value of admissible tensile stress is exceeded. In a probabilistic scenario, as defined by the NCh433-2009 Chilean standard (INN, 2009), an earthquake could produce cracking on these points, due to the appearance of tensile stresses. These points are located mainly at the base of the towers, at the intersection of the West and East walls façade. These tensile tensions appear even considering the concrete reinforcements. The stiffness of these elements reduces tower displacements but also causes distortion at a stress level, creating additional tensile stresses due to the disconnection effect between the masonry and concrete reinforcements (Vicente et al., 2012). This is especially significant on the main façade of the church where the effect of concrete columns is particularly meaningful. Moreover, it is relevant to highlight the interaction between old and new structural elements (since the XXth century): highest tensile stress appears on the capping of the West and East façade walls, showing the interaction between the anchorage of steel trusses of the roof and the concrete beam located over the walls. This effect can also be observed over the central arcade walls.

From the perspective of structural configuration, it is important to emphasize the positive effect of the bracing applied by the interior and exterior buttresses on the sidewalls. Its position reveals the limit where tensile stresses appear, additionally reducing wall displacement. Moreover, the arrangement of the walls at the head of the church, as well as in the chancel and transept, imply reinforcement against horizontal forces. The plan of the church (Figure 1) reveals an increasing thickness on the first two bays at the head of the naves where the height of the arches is also reduced, in comparison with the rest of the arcade. The thickness is maintained along the height of the walls. Similarly, the thickness of the walls increases at the end of the lateral naves in the “L” at the transept and chancel intersection. These solutions, together with the effect of the main chapel walls as a blind extension of the arcade, imply an increase of stiffness in weaker places against horizontal actions (Ruiz, Jaramillo & Mascort, 2014). This effect is augmented by the volume of the sacristy located next to the north-west transept, although this element was incorporated recently, in 1972. Removing the effects of these elements on the model, considering the same thickness as the remaining walls, it is possible to verify both the increase of displacements and stresses on the walls. This consequence is especially relevant regarding the head wall, which is one of the weakest points of the structure on account of the weakness of the façade wall, considering the thrust of arcade walls and the tower slenderness. The global consideration of these elements directly related to the design of the church allows to confirm their contribution to the box-behaviour of the building (Lourenço et al., 2011).

Figure 6. Left: Central arcade main stresses (S11, up y S22, down) under X seismic action; Centre: East façade main stresses (S11, up y S22, down) under X seismic action; Right: main façade stresses (S11, up y S22, down) under Y seismic action (right). Source: authors.
