Conservation of cultural heritage buildings: Methodology and application to case studies.

P. B. Lourenço ¹

¹University of Minho, ISISE, Department of Civil Engineering, Portugal, E-mail: pbl@civil.uminho.pt,
Web: <http://www.civil.uminho.pt/masonry>, <http://www.isise.net>.

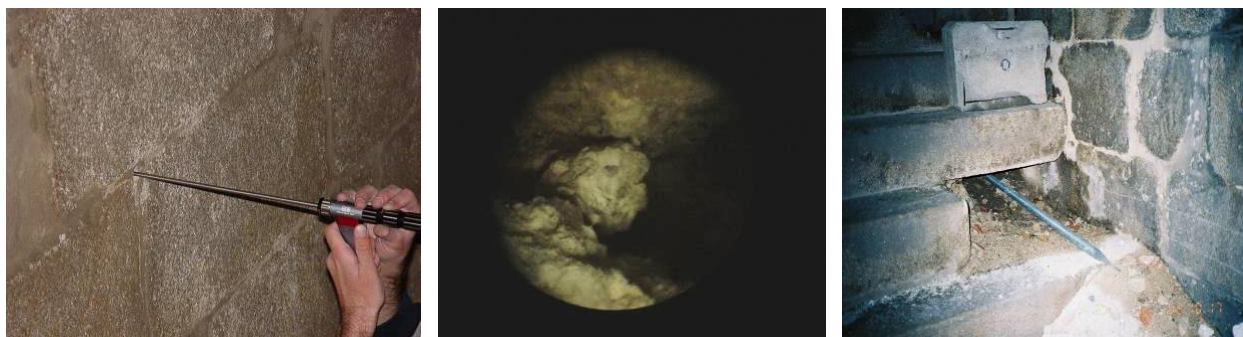
mid-level with stone slabs and architraves apparently supported in columns and stone struts. The South tower possesses an internal core with a staircase shaped helicoidally. The constitution of the masonry walls from the towers was characterized using visual inspection, removing stones of the outer leave in the interior of the tower and by using a boroscopic camera inserted in cracks or in holes drilled in joints, see Figure 4. From the inspection, it was possible to conclude that the three-leaf walls have external leaves of granite ashlars with a thickness ranging from 0.30 to 0.70 m, while the middle leave is made from loose smaller stones and silty soil. The combination of heavy rain in Porto, strong winds in the top of the hill where the Cathedral is located, and the open joints in the external masonry face, results in a wet infill even in the summer and the continuous washing out of the infill.

Figure 4. Visual inspection with boroscopic camera and inspection openings.

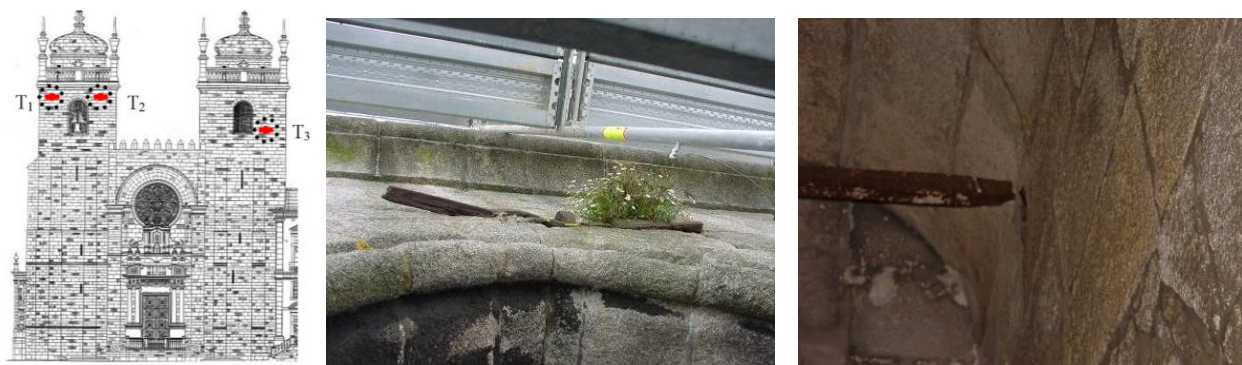
The towers exhibit distributed cracking and significant out-of-plane movements. The existing damage resulted in the past addition of three iron ties (date unknown), see Figure 5. Tie T_1 presents a severely deformed anchorage and tie T_3 is corroded and broken. The separation between the East and West façades of the South tower continued after tie T_3 was broken. The masonry walls in the vicinity of the anchorages are also deformed, as expected due to the application of a large point load. The South tower is more damaged than the North tower, with severe cracks and out-of-plumb walls. Separation between the internal and external leaves of the walls is confirmed by the longitudinal cracking observed in most of the openings, with a maximum width of some centimeters.

Figure 5. Ancient tower ties, with deformed anchorage (T₁) and broken tie (T₃).

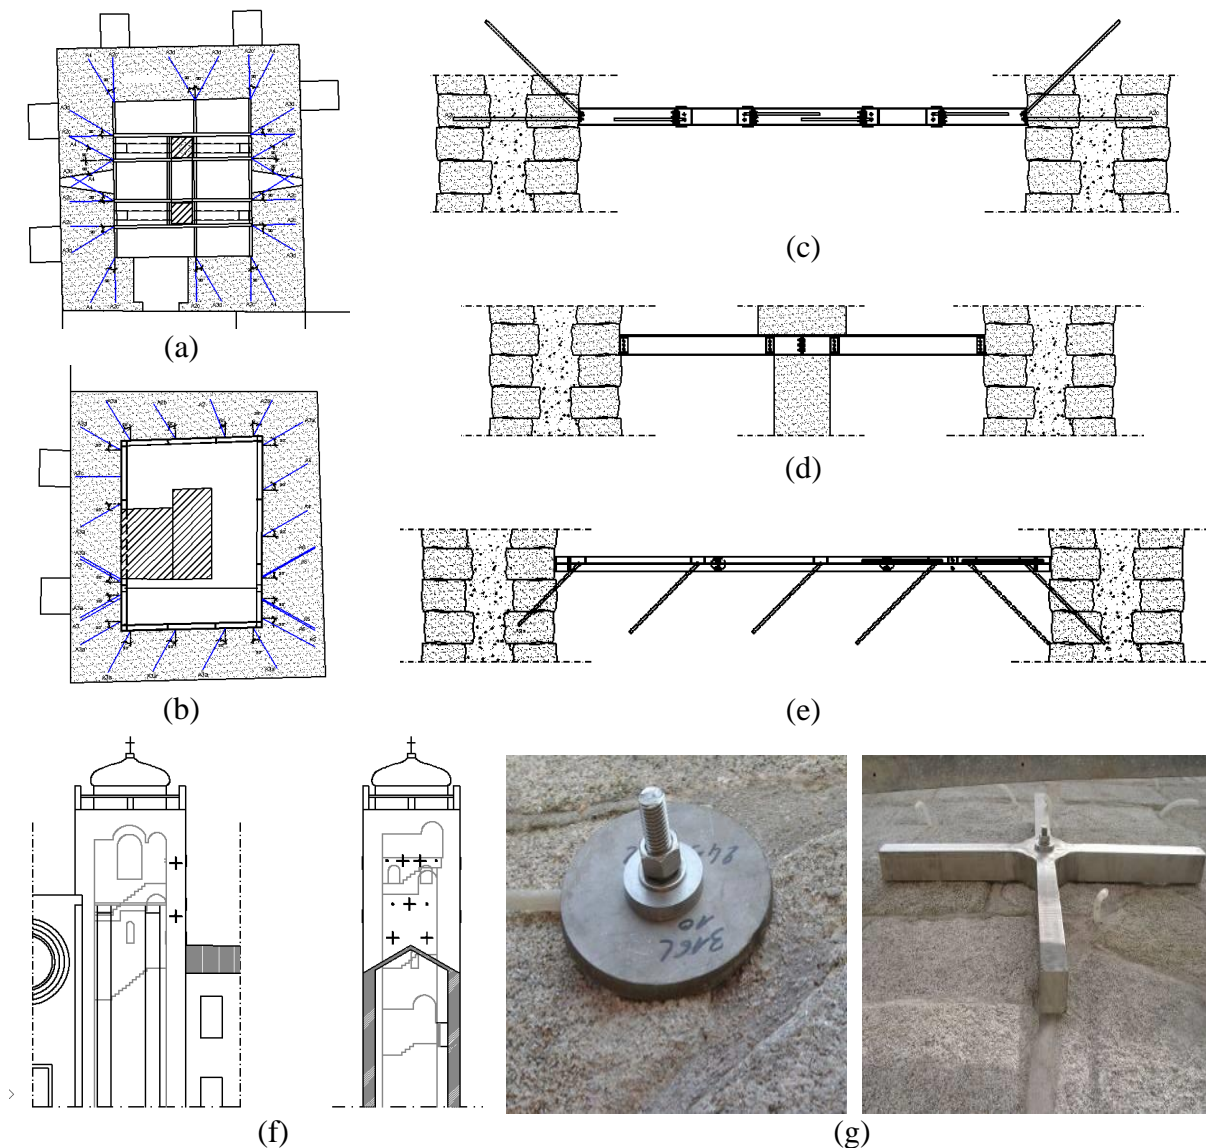
Figure 6. Aspect of the strengthening of the towers: (a) Ring for the north tower; (b) Ring for the south tower; (c) North-south section for north tower; (d) West-east section for north tower; (e) Typical section for south tower; (f) Additional ties in the west and south façades of the south tower; (g) Details of the anchorage plates.

The solution adopted for strengthening consists mostly of a steel ring in both towers, aiming at confining the structure along the two orthogonal directions, in the sole location possible, see Figure 6a,b. The rings are made with welded stainless steel plates (class AISI 316L), connected to the towers using long, inclined stainless steel anchorages inside of a cloth duct to prevent generalized injection, see Figure 6c-e. The length of the steel profiles is defined so that the elements can be transported to the location through the existing doors and can be easily assembled in situ, without any further welding. In the North tower, the ring also aims at providing a support for the stone pavement for the bells, as stone columns are much deteriorated and had no structural function and the stone struts have very deficient conception. The steel ring is made of channel profiles (240×120 mm and 200×100 mm height). In the South tower, a set of two ties was provided to the ring, because it was possible for aesthetic reasons and they are a testimony of the ancient broken tie. The ring must cross the staircase at a selected location because the complex internal structure of the tower does not allow otherwise. Due to the lack of internal stiffening elements, a much stiffer steel frame is needed and the steel ring is made of H profiles (180×180 mm). Due to the bulging outwards of the East and South façades, and the severe cracks in the corners, several short ties have been added to the structure to stitch the East and

South façades, and two long ties through the core of the South façade have been added to connect the West and East façades, see Figure 6f. Figure 6g presents details of the two types of anchorage plates adopted (circular plates and specially designed crosses).

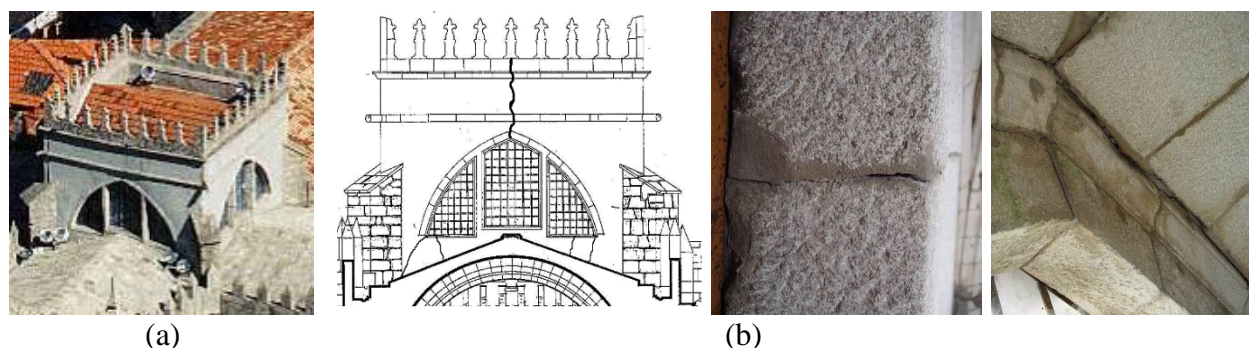
The skylight is located above the transept and presents different cracks, which occurred after the works carried out in the first half of the 20th century. In addition, infill material from the vault had recently fallen in the transept. The skylight is made of four walls supported in large arched windows opened in the 18th century, with the exception of the East façade with exhibits no opening, see Figure 7a. It has a square plan with 7.5 m side, walls with 6.5 height and 0.65 m thickness. The thickness is reduced to 0.4 m above the vaults and, again, to 0.2 m in the battlements. Buttresses can be found in each corner and a ribbed stone vault makes the ceiling, further topped by a timber double slope roof. The masonry in the walls is of very low quality, made of rubble stone and weak lime mortar. The openings form pointed arches, supported at the thirds of the span with T-shaped columns. The vault is made with stone slabs with a thickness between 0.14 and 0.54 m. Rubble loose infill was removed on top of the vault (about 10 m³).

The three walls with windows are cracked at the arch key, with maximum crack widths of 10, 1 and <0.5 mm, in the façades West, North and South, respectively. These walls are also bulging outwards. Figure 7b shows the main crack in the West façade, which crosses the entire section of the wall. Smaller cracks can be also observed closer to the buttresses, under the opening, together with horizontal cracks in the window columns due to bending. The most severe crack in the interior has a width of 25 mm and shows that the vault is separated from the wall in the West

façade. Due to this crack, the stone slabs of the vault are no longer supported in the side rib and a settlement of about 20 mm can be observed at the key of the vault.

The observation of the damage in the skylight, together with the local relief, the severe separation between the East façade and the chancel, the old documents indicating consolidation and enlargement of foundations and the bulging of the walls of the nave indicate that soil settlements and weak foundations can be the main cause of damage. A finite element model of the skylight was used to understand and justify the existing damage. The actions considered include the self-weight of the structure, the weight of the infill, the seismic action and differential temperature. The results for the combination of self-weight plus rubble infill provided a maximum tensile stress found lower than 0.1 N/mm^2 and located in the window-sills and ribs. The skylight should

Figure 7. Skylight: (a) Aerial view; (b) Cracks in façades, windows columns and vaults.

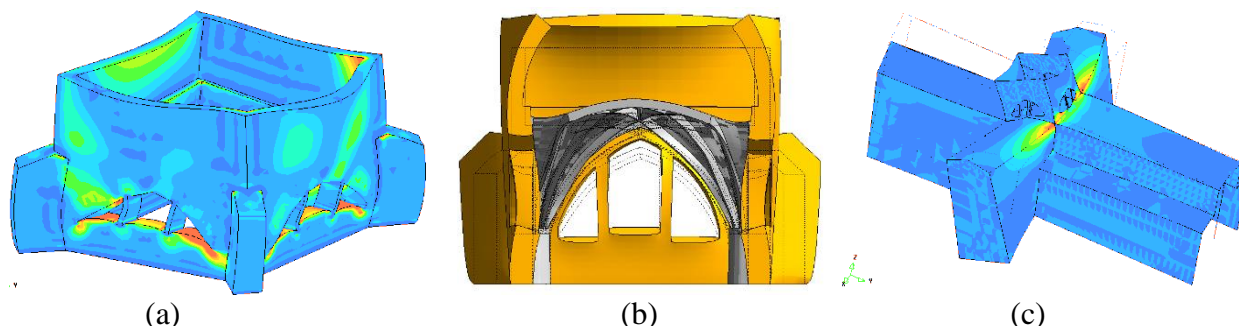
have minor or no damage under self-weight and infill. Seismic loading and temperature were then added to the structure, aiming at explaining the damage, see Figure 8a,b. Even if the deformation for seismic loading has some resemblance with the observed movements in the structure, the stresses found are too low to provoke any damage. The deformed mesh associated with the differential temperature indicates that the walls move to the exterior and suffer significant bending, with significant curvatures in the columns. Still moderate stresses are found and the deformation is not in agreement with the observed movements, meaning that the temperature effect is relevant but should not be the main cause of the damage. A full model of the church was then prepared to analyze the influence between the skylight, the adjacent structure and the soil, see Figure 8c. Very high tensile stresses are found in the skylight and the deformation is similar to the one observed in the structure, confirming that this is the major cause of damage. The remedial measures are given in Lourenço et al. (2004).

Figure 8. FEM analysis: (a) Live loads; (b) Temperature variation; (c) Dead load for full model.

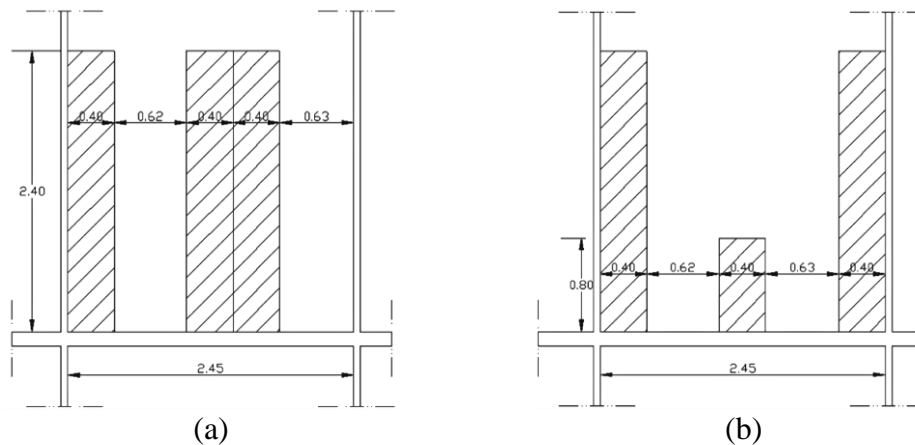
Figure 10. Proposal for book archive: (a) Original; (b) New.

The reinforcement that is present in the slabs is adequate for the previous loads but it is clearly insufficient for the new loads. The proposal of the architect responsible for the works was to adopt three archive shelves with a height of 2.40 m and a base of 0.40 m, see Figure 10, which implies a reinforcement amount twice the existing. The original proposal is possible with a new supporting structure of steel profiles HEB 100, placed transversally in the rooms, and supported by steel angles placed close to the walls. On top of this structure, an OSB new floor would be placed, with a total cost for the solution of about 100 USD/m^2 . The proposed alternative was to use two taller shelves close to the walls and a shorter shelf in the center, in order to reduce the bending moment, allowing even to provide more room for stocking.

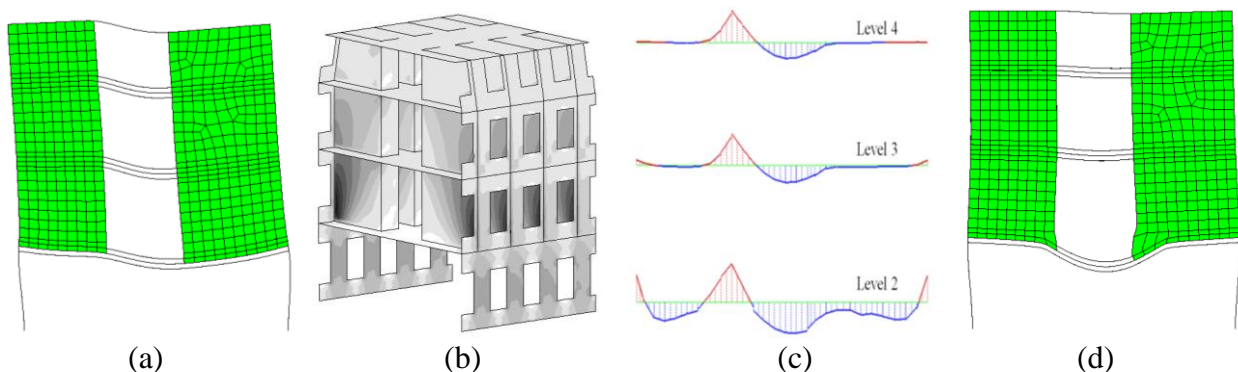
A finite element model was used for the global stability of the structure. The results allow confirming the large stiffness of the internal walls and the asymmetry of the response, see Figure 11a. The analysis of the principal compressive stresses shows that the load is transferred to the external walls, with a behavior similar to a deep beam and using the main beam of level 2 as a “tie” subjected to large flexure, see Figure 11b. The bending moment of the main beams obtained using a linear elastic approach and the failure of the structure using non-linear analysis is shown in Figures 11c,d. The asymmetric deformation and the large stiffness of the walls led to large bending moments producing tensile stress in the upper fibers (60 kN.m in the beam of level 2, in the connection with the left transverse wall). Therefore, the global stability is ensured by the flexural capacity of the nodes in the connection between beams and walls, in a zone where the amount of upper reinforcement is rather low. Figure 11d shows the attempt of the structure to follow a strong redistribution, with a fast progression of a horizontal crack between the walls and the beam in level 2. As the lower reinforcement in the beams is insufficient to carry out the load corresponding to the new use, the structure must be strengthened.

Figure 11. Results for the structural analysis: (a) Deformed mesh; (b) Compressive principal stresses; (c) Bending moments in main beams; (d) Failure from non-linear analysis.

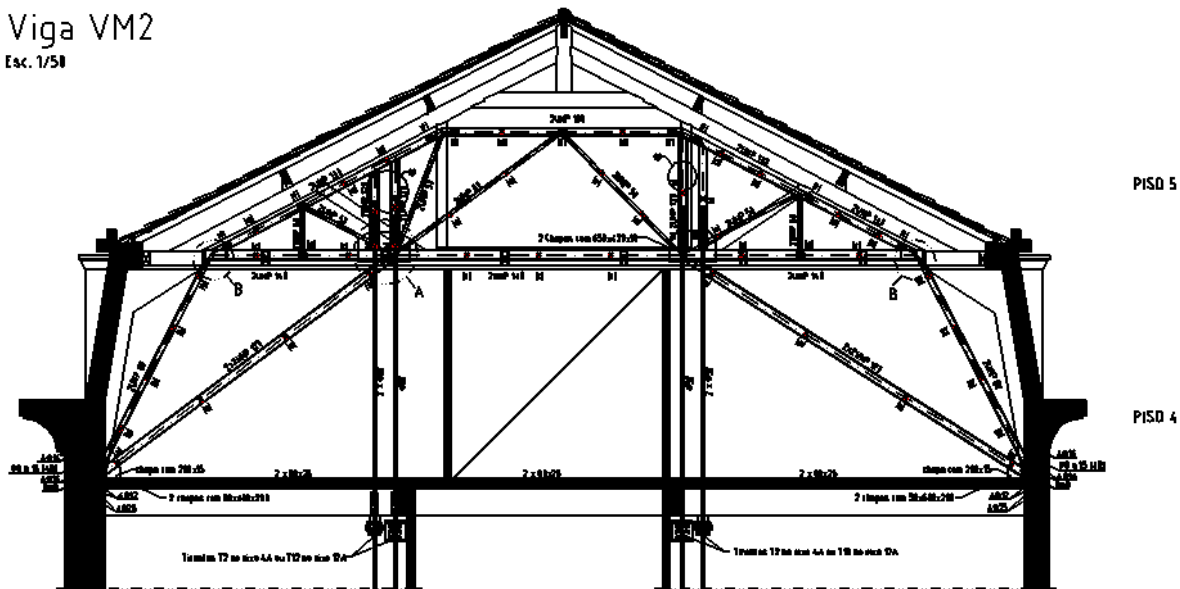
Figure 12. Adopted strengthening solution.

Two possibilities of strengthening were analyzed: (a) a steel beam grid and new columns supporting level 2; (b) a suspension structure for the main beams. Given the aesthetic implications, the usage limitation and the cost, the latter solution was adopted, see Figure 12. Truss steel structures have been added between level 4 and the roof, in between the existing
