CENTRIFUGAL FAN IMPELLER FAILURE ANALYSIS USING FINITE ELEMENTS
Ingeniería. Revista de la Universidad de Costa Rica, vol. 16, núm. 2, 2006, pp. 55-62

CENTRIFUGAL FAN IMPELLER FAILURE ANALYSIS USING FINITE ELEMENTS

This article shows the failure analysis assisted with finite element modeling of a centrifugal fan impeller that was originally part of the burner of a 1175 kW [120 bhp] saturated steam boiler. The linear stress and vibration modes model pointed to the origin of the apparently sudden failure.

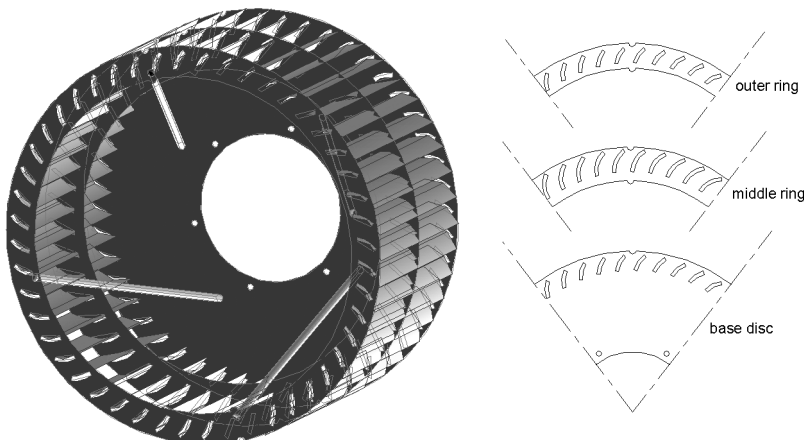
Figure 1. Geometrical configuration of the impeller

coincided (see figures 1 and 2), but FE modeling does not point directly to the failure itself.

The geometry of the impeller (figure 1), about 300 mm in diameter and 150 mm wide consisted of one base disc and two perforated rings to hold forty-eight blades. The disc and rings are pressed from 1 mm (0,05 in) galvanized steel; the backward curved blades are pressed from 0,6 mm (0,025 in) galvanized steel. Four 178 mm [7 in] steel bars (6 mm [0,25 in] in diameter) give the assembly rigidity. Assembly is mechanical, except for the 6 mm bars, which are welded to the outer ring and base disc as shown. The housing had a clearance of about 10 mm [0,5 in] relative to all edges of the impeller.

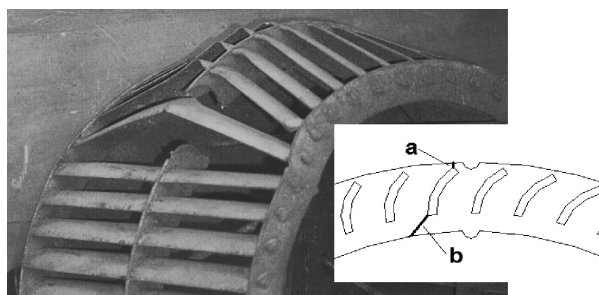
Figure 2. Impeller failed section

low load. As described above, the misshapen impeller did not affect low load operation. The boiler was stopped and the fan disassembled due to high noise and vibration. Figure 2 shows the failed impeller; note how the middle ring failed at the point where a notch and a space for the blade coincided. The secondary failure is the buckling of two of the four support bars.

In addition, there is a layer of rust on all non-galvanized surfaces: all edges, notches and holes were rusted as if the impeller had been in operation for years. The boiler operates at a facility near the sea, with a high relative humidity and occasional salt air. The section of failure deserves special attention: rust covered most of point **a** of failure with no ductile deformation (see figure 2), suggesting a crack that could have been present since manufacture or that could have grown longer during operation of the fan. Failure at point **b** was free of rust and presented typical ductile behavior.

Corrosion. Since none of the edges were galvanized, corrosion had built up noticeably on all of them, including of course the blade spaces on the middle ring. The accelerated corrosion near zones with a high stress concentration could have caused a crack to form and grow at point **b**, starting at the inside of the blade spaces where the higher stresses appear (see figure 5b). Normal vibration could have contributed to failure, but not necessarily be the origin.

4. Once there was a small gap at failure point **a** with all stresses concentrated on point **b**, overall failure was gradual, and evolved over the course of a few days. Corrosion could have initiated or accelerated failure of point **a**, and it could have been present since the fan was new. Point **b** evolved similarly: corrosion, accelerated by high stresses, led to the formation and growth of a crack that further stressed the remaining material and ended with a sudden rupture.

In addition, it is important to note that the new impeller has an identical geometrical configuration, was properly balanced and has no visible cracks at the critical sections. It was also spray-painted with two coats of anticorrosive paint. After more than 6500 h of operation, there have been no other problems related to the fan.

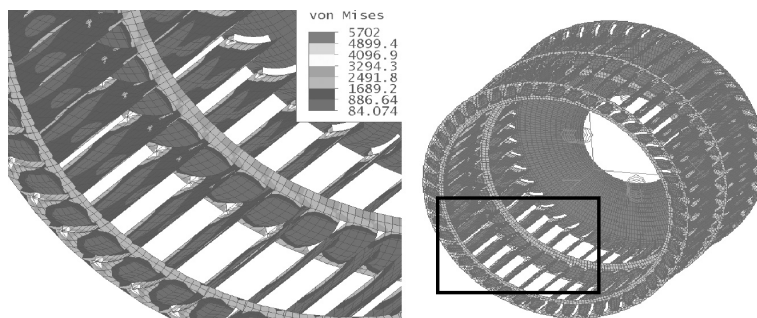
Figure 4. Von Mises stresses for the impeller assembly

Results show relatively low stresses. The areas with the higher values are all found near the union of a blade and a ring due to the chosen modeling of mechanical unions. This distortion does not render the analysis invalid; even if the higher

stresses evident in figure 4 were true (Von Mises maximum stress is 57,0 MPa [8270 psi]), they are still lower than the yield stress for many common steels. In fact, the real, less rigid structure will probably present low stresses. The truss elements (bars) all are loaded with low tension stress according to the FE calculations.

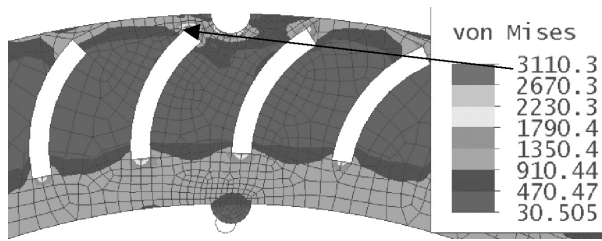
Figure 5a. Von Mises stresses for the middle ring (without a crack)

Since this middle ring also contained the main failure point, two runs were completed: one with and one without the crack at the first failure point. Figure 5 shows the segment of interest for both cases.

The run executed without the crack shows that the maximum stresses are even lower (311 MPa [4510 psi]) than the equivalent section on the complete assembly. This result is expected; the rigid union with the blade (in the FE model) generates flexure stresses additional to those due to centrifugal forces. Such flexure stresses do not exist when the union is a simple contact, which is the case of the real impeller.

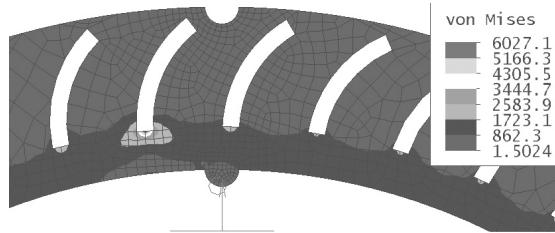
Figure 5b. Von Mises stresses for the middle ring (with a crack)

The presence of the crack at point **a** obviously increases the maximum stress, present at the base of the blade hole with the crack. Stresses are almost twice as high, but values still are low at 62,7 MPa [9090 psi].

Faulty manufacture. The presence of rust at the surface of the failure, low calculated stresses and no plastic deformation at point **a**, suggest that the crack had been present since the boiler was installed. According to calculations, maximum Von Mises stresses would be around 62,7 MPa [9090 psi] and little deflection would occur. The presence of the crack at **a** basically does not affect the operation of the fan unless an additional crack forms at point **b**.

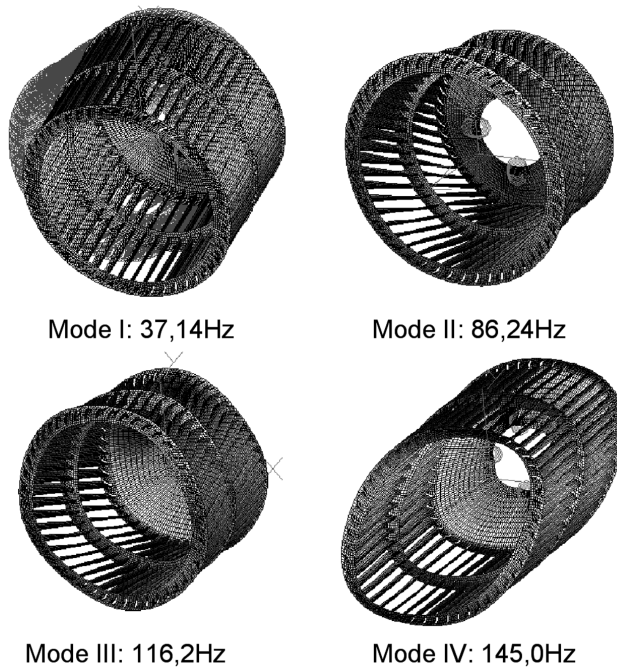
Figure 6. First four main modes of vibration

fifteen modes of vibration starting at 0 Hz and 40000 Hz as a cutoff frequency. The main modes of vibration were identified between 37,1 Hz and 145 Hz (2226-8700 cpm), and are shown in figure 6.

occur at frequencies too high to be of any interest for the present case. None of these frequencies are in phase with the 1650 rpm (27,50 Hz) impeller speed, and only in modes III and IV does important middle ring deformation occur.

Resonance. The possibility that resonance eventually led to the failure of the middle ring was eliminated. The first mode of vibration (deformation of the base disc) takes place at 2226 cycles per minute, and the fan operates at 1650 rpm. Rotor imbalance also would lead to the deformation of the base disc similar to that of Mode I, but would not be related to middle ring failure, so this possibility also can be ruled out.
