Marín Córdova, Salvador; Campos Enríquez, Oscar; Herrera Moro Castillo, Mario
Neotectonic related geological risk at dams in the Mexico Basin: Guadalupe dam
Geofísica Internacional, vol. 43, núm. 3, july-september, 2004, pp. 435-443
Universidad Nacional Autónoma de México
Distrito Federal, México

Neotectonic related geological risk at dams in the Mexico Basin: Guadalupe dam

Guadalupe Dam case is an example of risk from geological structures defined in the tectonic models. History records three stages of repairs of damage due to settlement and cracks that occurred in the dam wall.

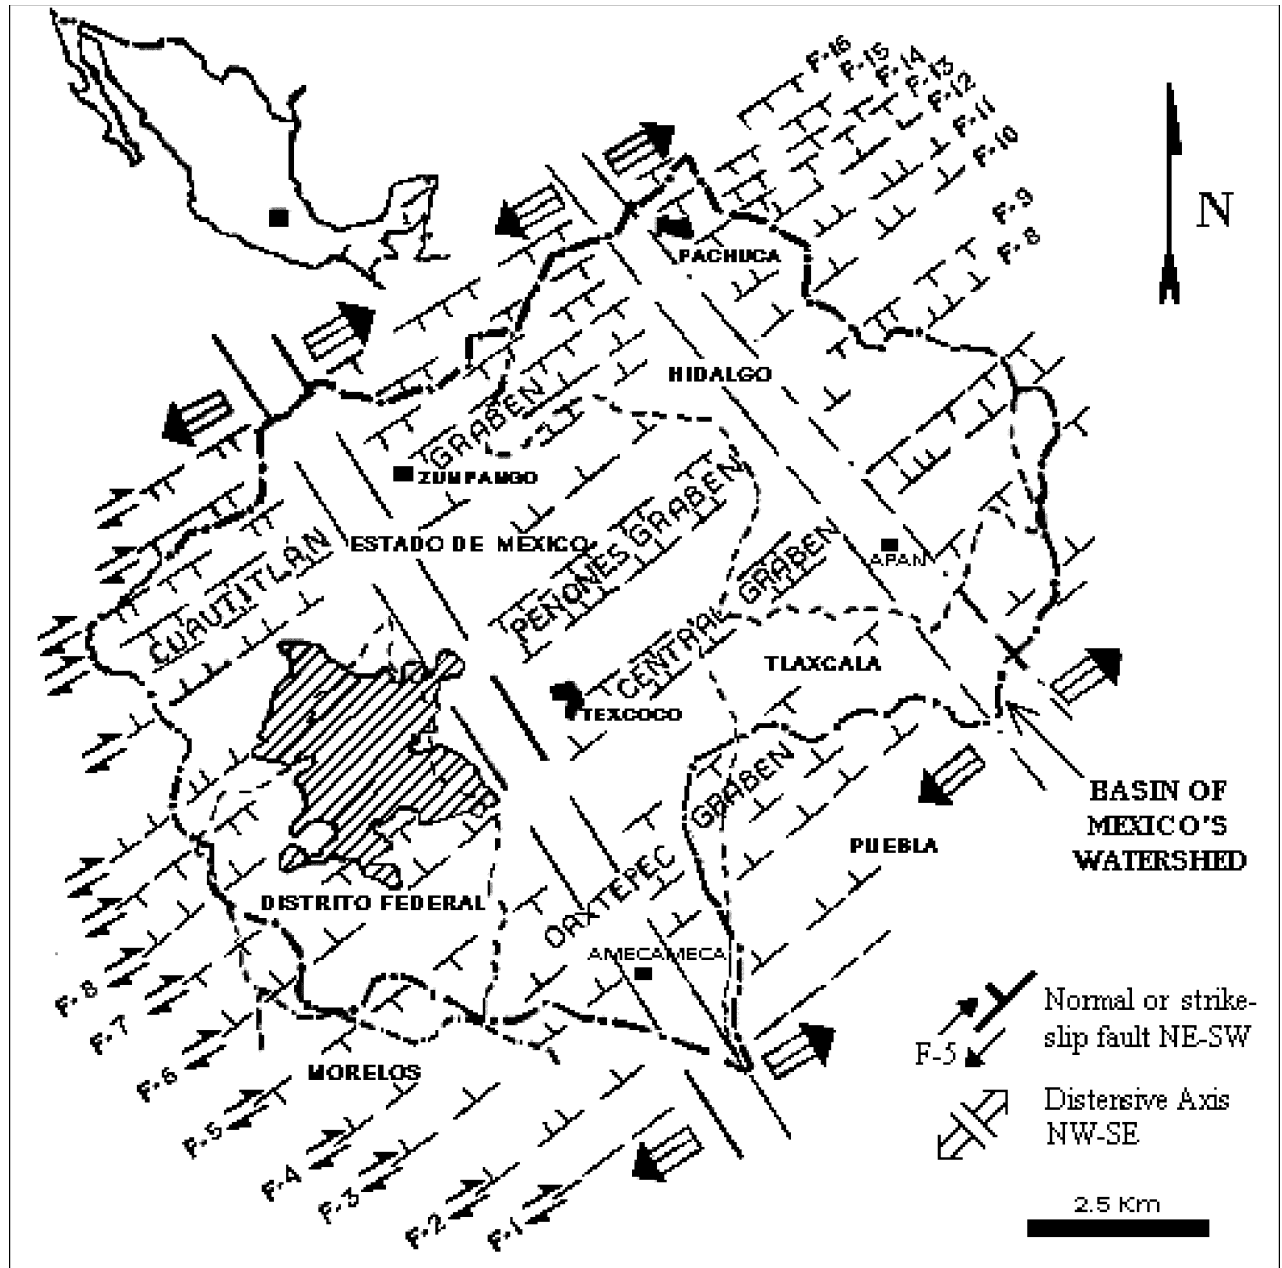
Fig. 1. Location of sixteen faults within the Mexico Basin after Marín-Córdova *et al.* (1986 b).

pyroclastic and lacustrine deposits appear fractured, faulted and folded as well as fissured (Figure 1).

The analysis and correlation of all this information enables us to propose a geological and structural framework for the Mexico Basin and surrounding areas (Figure 1), where sixteen main faults are illustrated and which delimit fifteen blocks.

As shown in Figure 1, the main normal or strike-slip faults crossing the southwestern portion of Mexico Basin are located between the F-7 and the F-14 faults. Many of them coincide with river beds that drain the zone. These features are summarized here:

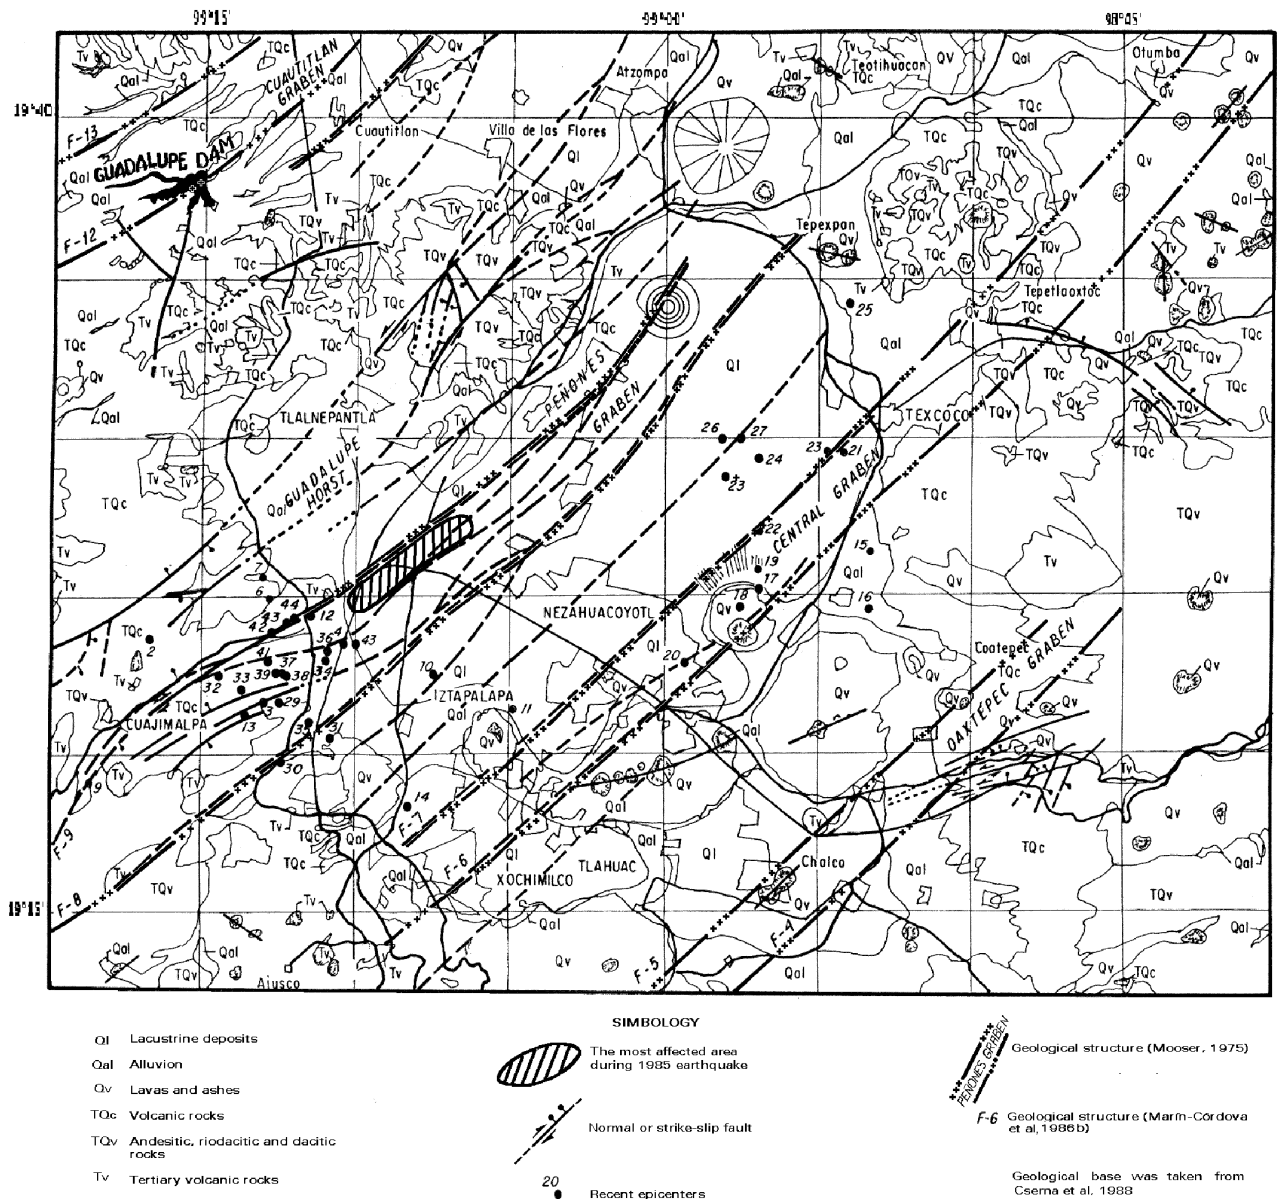
Fig. 2. Schematic map with structural integrated models after De Cserna *et al.* (1988).

Thus three structural models are similar in the main. They differ in coverage of the basin and in the objective of the study. These three studies are synthesized in Figure 2.

Guadalupe Dam was considered here for geologic risk, because there are extensive operation reports, where settlements and cracks are described. It was built on Cuautitlán river that, according to the geological – structural studies, is located on one of the main fault alignments (F-12). It had not been considered because it was unknown at construction time (Figure 2).

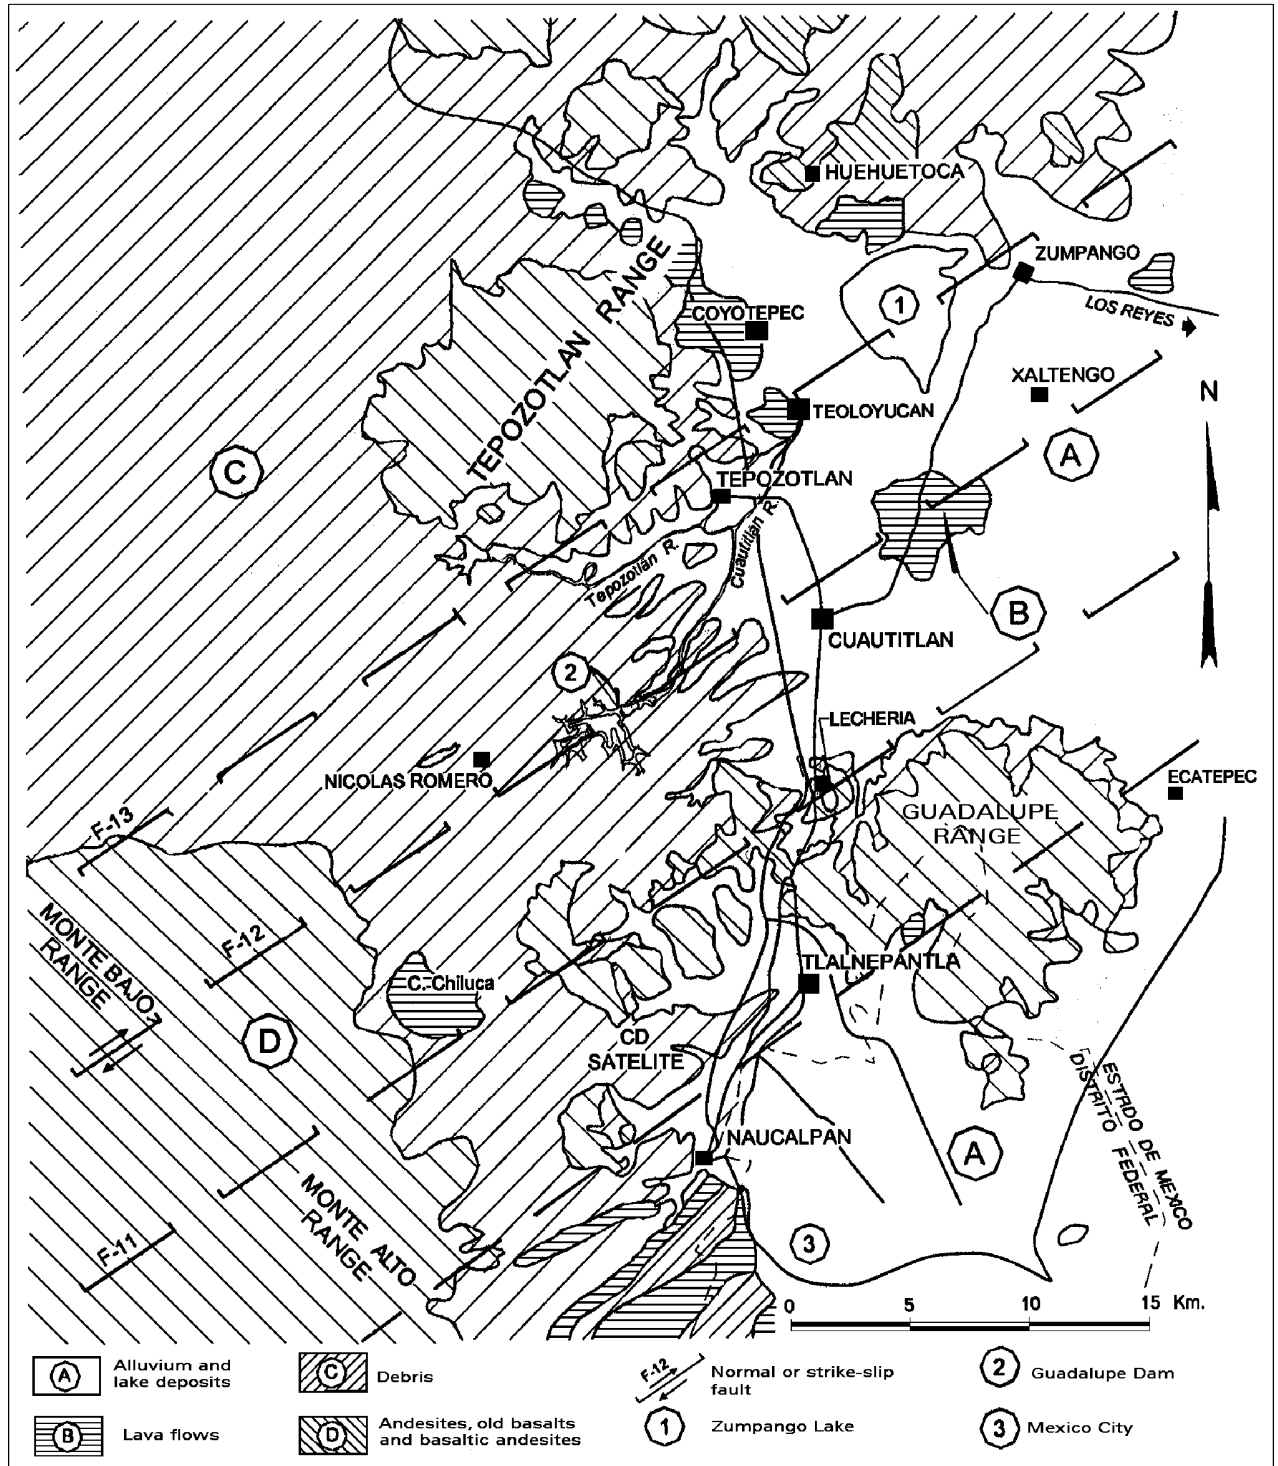
Fig. 3. Geological map.

Figure 3 presents the simplified geology of the area. The volcanic units and alluvial and lacustrine outcrops are Tertiary and Quaternary.

The dam foundation rests on heterogeneous deltaic alluvial deposits, in a valley probably drained by an ancient river bed. Because of this setting differential settlements caused effective tensional stresses in the structure. Several SSW - NNE and WNW - ESE, fractures affecting the Tertiary units have been documented (Alberro *et al.*, op.cit.).

This geological anomaly may correspond to the trace of the F-12 fault, as shown in Figure 3 which, according to the definition of Slemmons and McKinney, (1977), may be considered an active fault.

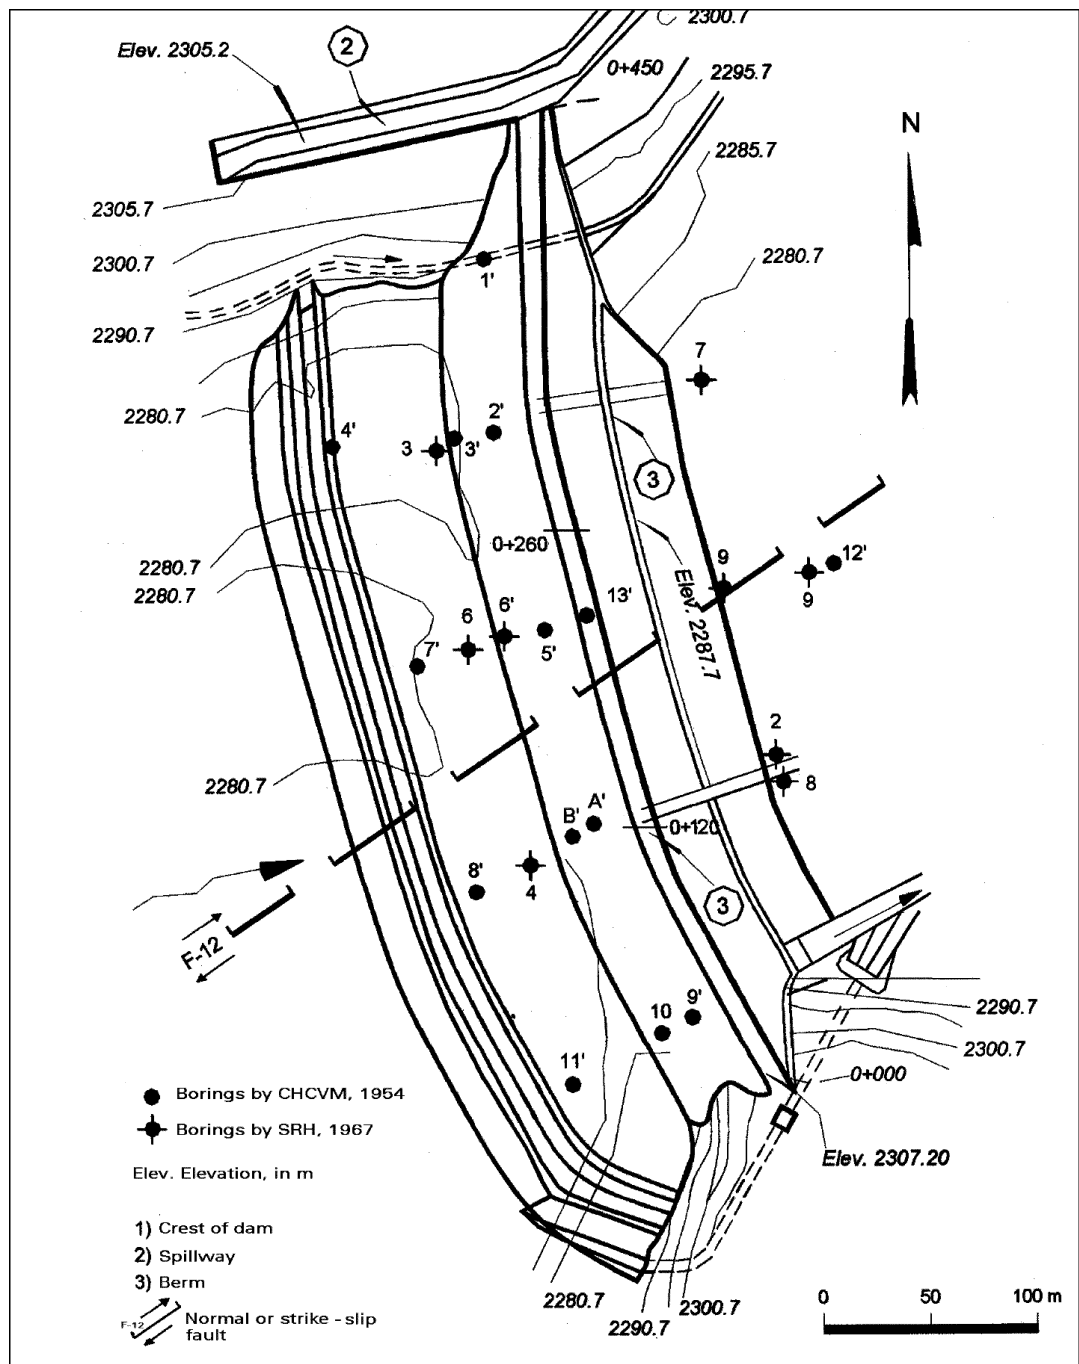
Fig. 4. Boring location and transtensional fault at Guadalupe dam, after Marín Córdova *et al.* (1986 b).

Measurement devices were installed mainly at the stations 0+120 and 0+260. This instrumentation included pressure cells, piezometers and longitudinal extensometers, as well as surface bench marks and inclinoimeters. They were installed both up and down stream. The purpose was to observe the behavior of the dam (Figure 4).

Alberro *et al.* (op.cit.), concluded that, after the construction, the core and the downstream back of the dam, at the station 0 + 150 underwent settlement and were displaced

towards a zone of the foundation that coincides with the zone of thicker sediment carried. The embankment and the trench upstream from the cut-off were displaced upstream.

Alberro *et al.* (op. cit.) reported that the NNE - SSW axis of maximum thickness seems to be oblique to the axis of the dam and parallel to the tectonic fractures within the

area. It might constitute an ancient river bed before the sedimentation of alluvium and the deltaic generation originated at this basin during the Early Quaternary.

After repair (1948), there were a longitudinal cracks, reported in 1952, and a 2 x 3 x 5 m cavity. Later, revision undertaken at the 0 + 120 and 0 + 260 stations reported cracks transversal to the dam axis.

Based on the behavior of Guadalupe Dam and its relation to the geological-structural frame of the Mexico Basin, we note the effects originated by its emplacement on granular materials, with a coincidence between the direction of the cracks of the dam and that of the F – 12 strike-slip fault.
