# INVESTIGATION OF THE ENERGY EFFICIENCY OF THE MILITARY MUSEUM BUILDING BY INFRARED THERMOGRAPHY

Slavica S. Ristić, GOŠA Institute, Belgrade,  
Suzana R. Polić-Radovanović, CIK – Central Institute  
for Conservation, Belgrade,  
Bore V. Jegdić, GOŠA Institute, Belgrade

FIELD: Energy Efficiency  
ARTICLE TYPE: Professional Paper

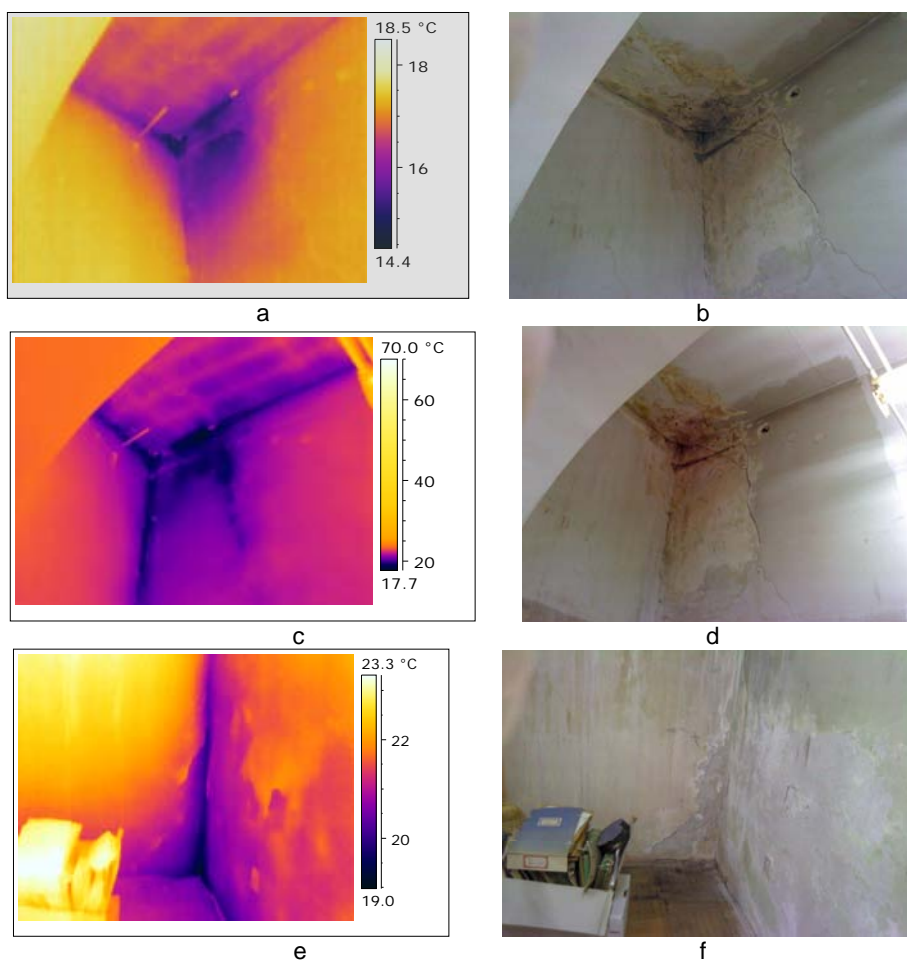
perature falls to 10.8°C. The analysis of the thermogram shows that optically visible stains on the wall are larger than the area of the currently active moisture. In this corner, an electrical wire is surrounded by a wet wall (Fig.1).

The next thermographic inspection was done at the end of November, two days after a heavy rain, at the following conditions:  $T_{ou}= 5^{\circ}\text{C}$ ,  $T_{in}= 11^{\circ}\text{C}$ , weather conditions: Overcast, no wind (Figs.1c and 1d). Active, visible moisture and leakage through the building originated from the terrace above this part of the room, covering the big wall area.

*Figure 1 – Moisture in the far left corner of the library in relation to the front door, a,b-thermogram and the photo in the October test, c,d-thermogram and the photo in the November test, e and f- the lower part of the same corner during the second test*

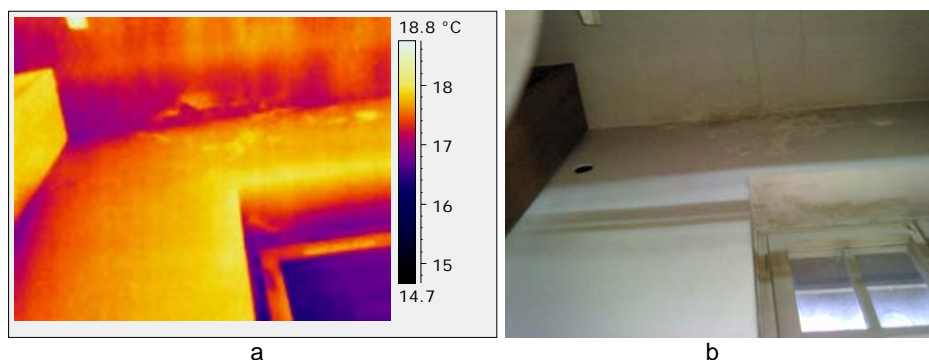
The moisture was not detected in the wall above the first (from left) window (Fig.2a). Poor sealing of the windows was recorded. Brighter parts of the thermogram represent the parts of the wall with a layer of plaster disbonded. The air under the plaster is a good insulator; therefore, these parts were warmer (brighter) than the rest of the wall.

Figure 2 – Part of the wall above the first left window  
Slika 2 – Deo zida iznad prvog levog prozora

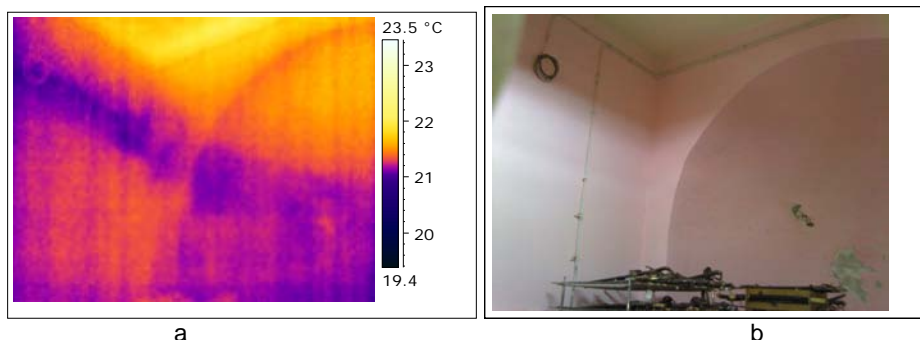
In the weapons depot, the temperature during the October test was  $T_{in} = 21^{\circ}\text{C}$ , humidity 60%. Under these conditions, the dew point would be when the temperature reaches  $13^{\circ}\text{C}$ . The concrete bridge (Fig.3a) is colder than the rest of the wall. It is a potential place for the condensation of moisture.

Figure 3 – Visible cold zones and the concrete beam in the weapons depot  
Slika 3 – Vidljive hladne zone i betonska greda u depo naoružanja

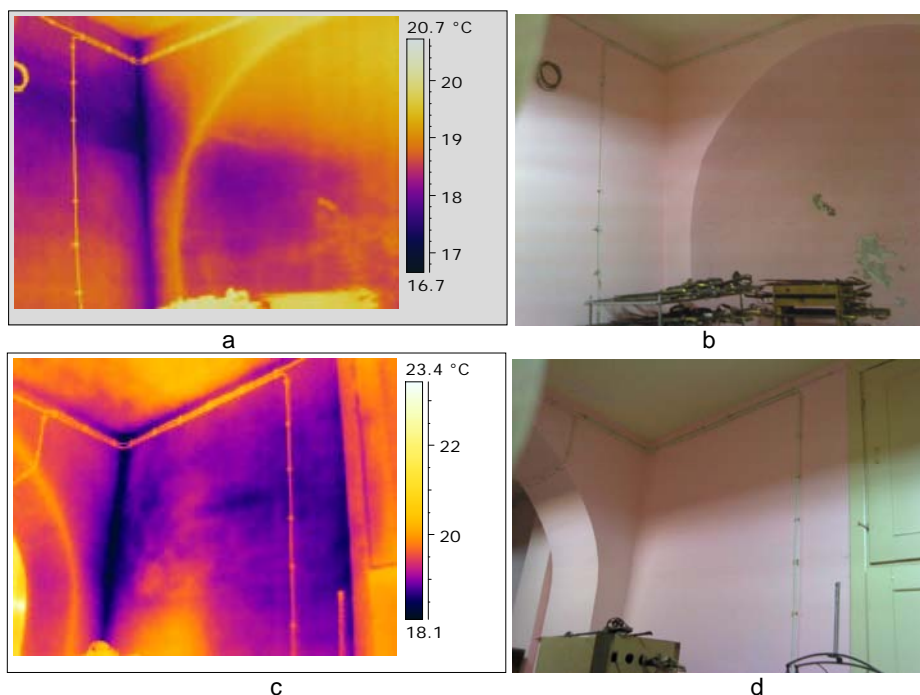
The second set of thermographic tests, performed two days after a heavy rain, ( $T_{ou} = 5^{\circ}\text{C}$ ,  $T_{in} = 20^{\circ}\text{C}$ ), displays the extent of the moisture intrusion in the weapons depot (Fig. 4). In the upper left corner (Fig. 4a), beside the cold concrete bridge, there was damp penetration since the depot is in the basement, below the ground level. A similar case is in the right corner, too. The electrical installations are visible as bright lines on both thermograms.

Figure 4 – Thermograms and the photos of the weapons depot with visible moisture  
Slika 4 – Termogrami i fotografije depoa naoružanja sa vidljivom vlagom

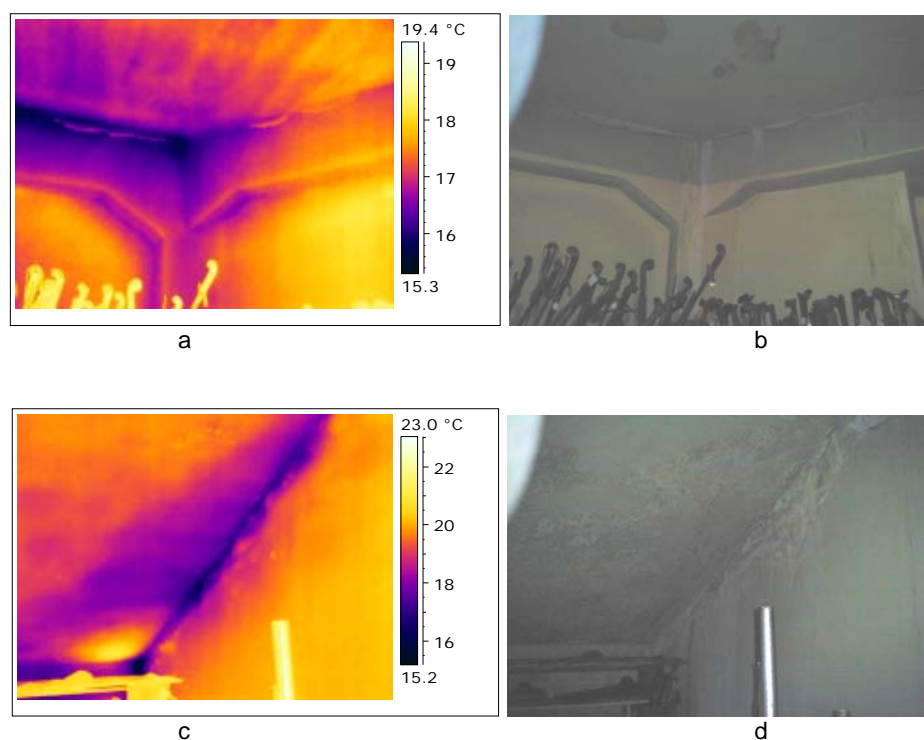
The presence of moisture in the depot where old metal artifacts are kept, contributes to the acceleration of corrosion and deterioration of exhibits. The thermographic inspection shows that moisture is penetrating from the roof and from the poor leakage location (Fig. 5).

Figure 5 – Some details of the old metal artifacts depot  
Slika 5 – Nekoliko detalja depoa sa zbirkom starih metalnih eksponata

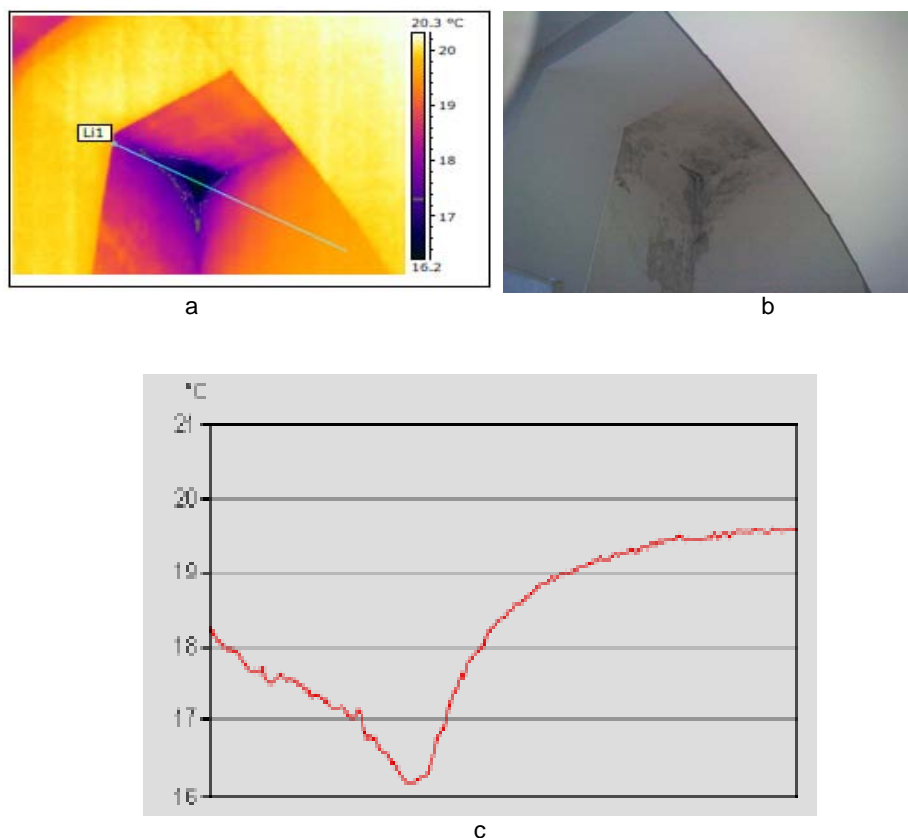
Moisture intrusion was detected in most of the inspected museum depots and other rooms,. The active moisture was detected in the depot of gifts, too. During the thermogram recording, the measured temperature was  $T_{in}=20.8^{\circ}\text{C}$  and moisture was 53.7%. If the measured moisture retains, and the temperature lowers to  $T_{in}= 10.8^{\circ}\text{C}$ , then the condensation of moisture from the air appears on the walls. Figs. 6 show a part of the ceiling in the right upper corner with a-thermogram, b-digital photo and c-diagram of the temperature changes along the line tool.

Figure 6 – Part of the gifts depot  
Slika 6 – Deo depoa sa zbirkom darova

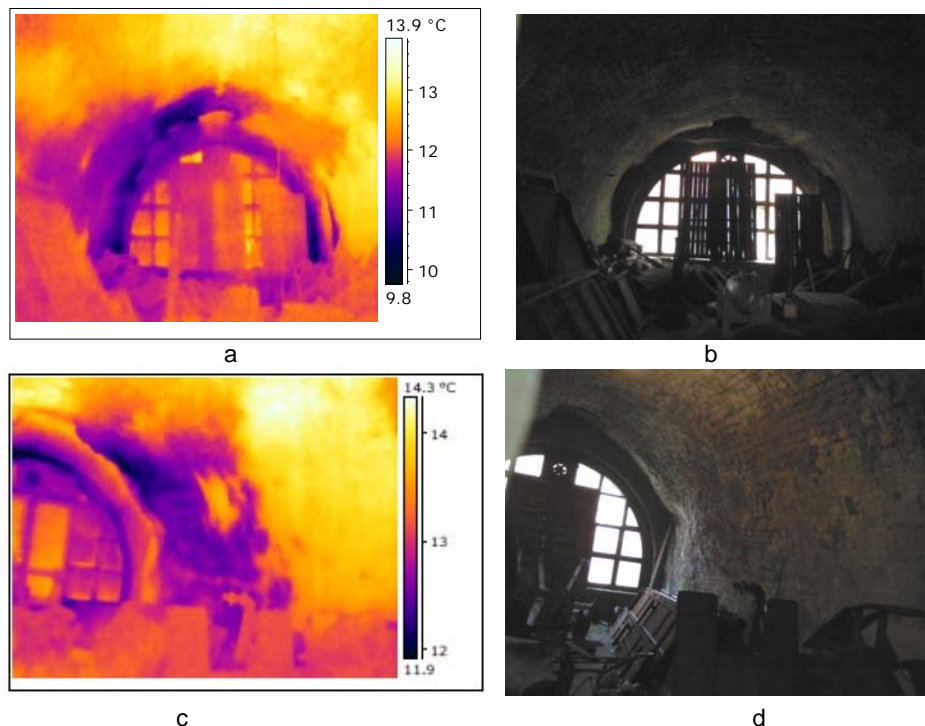
Fig. 7 shows the presence of moisture in the museum Casemates. The inspection was performed under these meteorological conditions:  $T_{ou}=19^{\circ}\text{C}$ ,  $T_{in}=15.4^{\circ}\text{C}$ , humidity of 67%, dew point temperature  $9.3^{\circ}\text{C}$ . Metal objects have been kept in the dungeons of the Military Museum at Kalemegdan, and the present moisture has a beneficial effect on the development of corrosion (Polić-Radovanović, Ristić, Jegdić, Nikolić, 2010), (Polić-Radovanović, 2010, p.161), (Jegdić, et al, 2011, pp.50-56), (Jegdić, et al, 2012, pp.169-182).

Figure 7 – Moisture in the museum Casemates, a,b – the first casamate  
c,d – moisture in the second one  
Slika 7 – Vlaga u muzejskim kazamatima, a, b – prvi kazamat,  
c,d – vlaga u drugom kazamatu

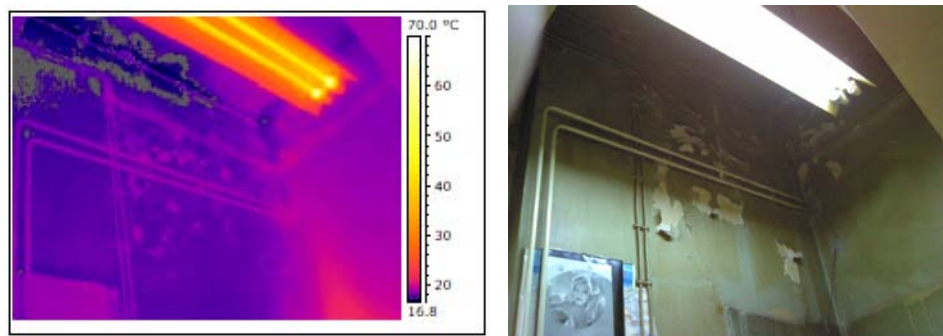
The workshop for metal conservation was investigated by thermography. The cold and damp workshop walls are presented in Fig. 8, (a thermogram-, b-digital photo, c-isotherm indicating that moisture covered the area).

Figure 8 – Appearance of the cold wall in the workshop for metal conservation  
Slika 8 – Izgled hladnog zida u radionici za konzervaciju metalnih eksponata

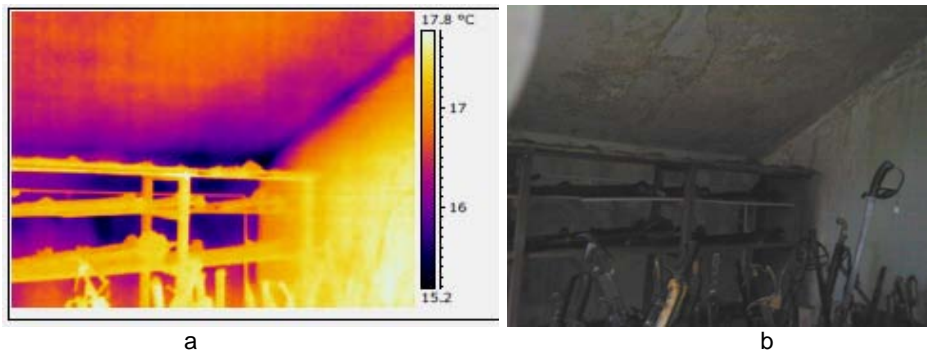
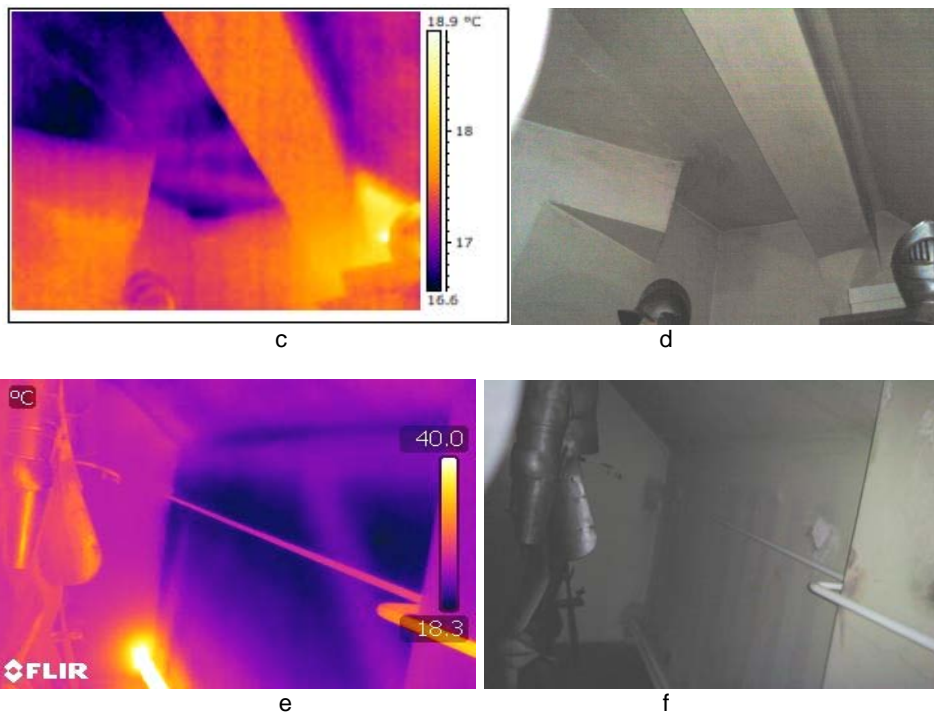
The collection of old metal artifacts is stored in the depot where the wall and the roof have poor thermal insulation. Figs. 9a to 9c show the

right corner of the depot. There are stains, but currently there is no moisture in the walls. The wall behind the shelves which restrict the access for thermographic inspection is colder than the other walls because of poor thermal insulation. The part of the door and the poor roof insulation are shown in Figs. 9c and 9d. The same situation is in the depot with the collection of non-European weapons.

Figure 9 – Depot of old metal artifacts, a,b – side wall, c,d – roof, e,f – wall of the depot with the collection of non-European weapons

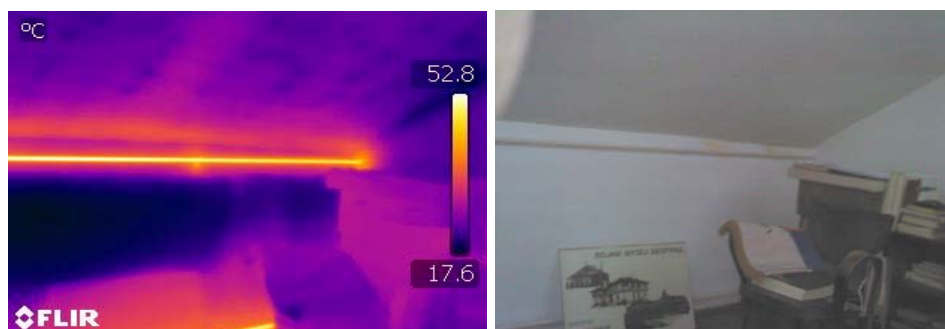
The thermal insulation is also very poor in the museum offices. Fig. 10 shows the thermogram and the photo recorded in the museum office located in the attic.

Figure 10 – Office in the attic, poor thermal insulation  
Slika 10 – Kancelarija u potkrovlju, loša termalna izolacija

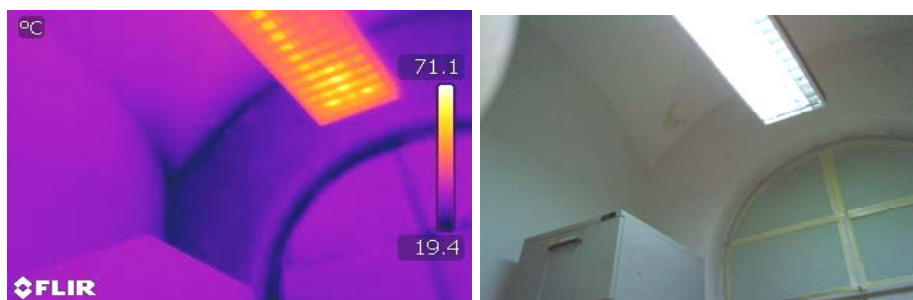
The thermographic tests of the photo collections depot confirm that there is no potential leak, penetration or condensation of moisture, only poor thermal insulation (Fig.11).

Figure 11 – Poor thermal insulation in the photo collections depot.  
Slika 11 – Loša termička izolacija u depou sa zbirkom fotografija

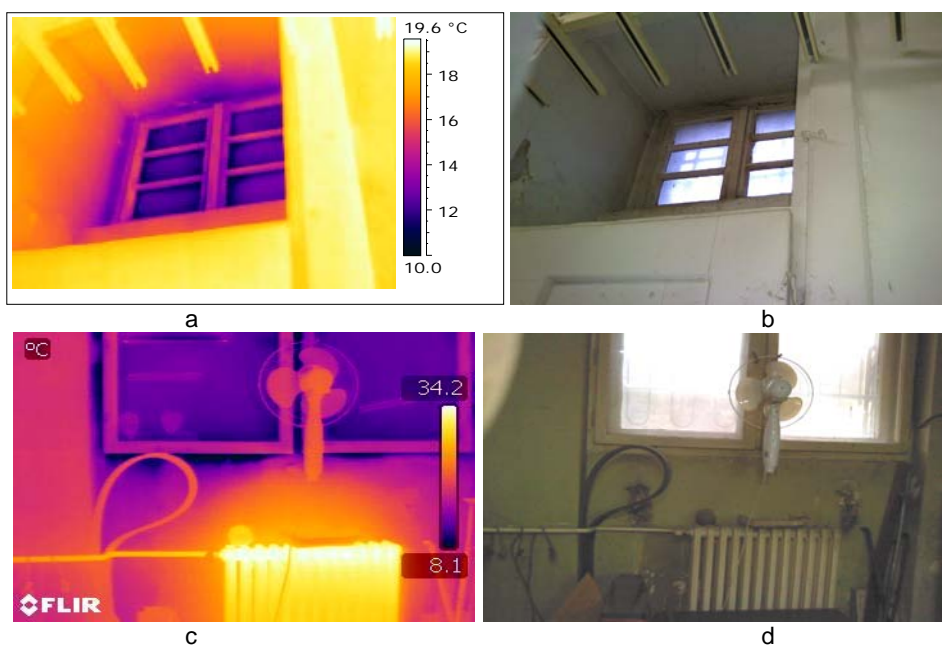
Visual and infrared images of some windows and doors of the museum building show the poorly sealing windows, with an air leakage. This is a very important malfunction for the energy efficiency of the building (Fig 12).

Figure 12 – Poorly sealing windows, cold air leakage, a,b – banners depot and c,d – in the workshop for metal conservation  
Slika 12 – Lošo zaptivanje prozora, prodor hladnog vazduha, a,b – depo sa zbirkom ratnih zastava, c,d – radionica za konzervaciju metalnih eksponata
