Ponce L., Ernesto; de la Vega, José
Restoration of ancient bronze bells. Part I: powder metallurgy
Ingeniare. Revista Chilena de Ingeniería, vol. 22, núm. 4, octubre, 2014, pp. 460-468
Universidad de Tarapacá
Arica, Chile

Restoration of ancient bronze bells. Part I: powder metallurgy

Ernesto Ponce L.¹ José de la Vega¹

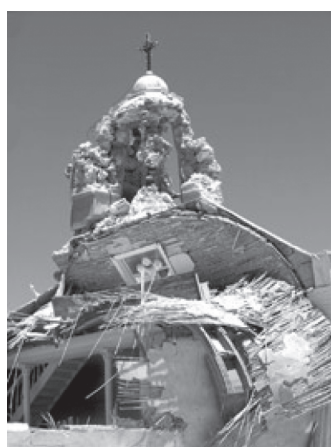
In cases of fall by an earthquake, as in Figure 1, bells tend to fall to the tower floor, which is generally made of stone. Bells tend to deform and their slope usually becomes damaged by the impact, as in Figure 2. The beauty of some of bells justifies restoration, as in Figure 3.

Figure 1. Bell tower in Northern Chile collapsed by an earthquake in 2005.

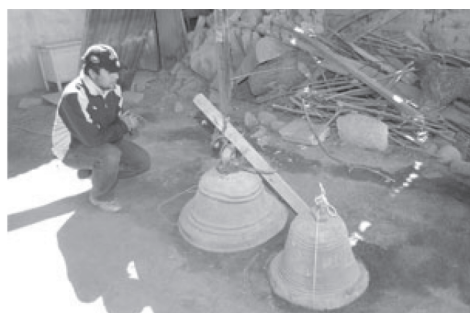
Figure 2. Bells collapsed by an earthquake in 2005.

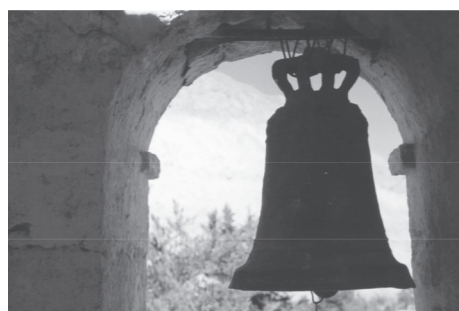
Figure 3. Bell found in Northern Chile.

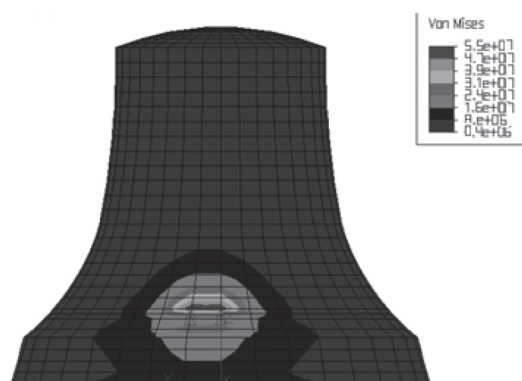
Figure 5. Lateral view showing external stresses of the bell when receiving the clapper strike with a force of 408N. Stresses are in N/m².

Finite elements predicted a stress of 0.055 GN/m^2 for a clapper impact of 408 N. This stress is lower than the rupture stress in traction of commercial cast bronze (0.37 GN/m^2).

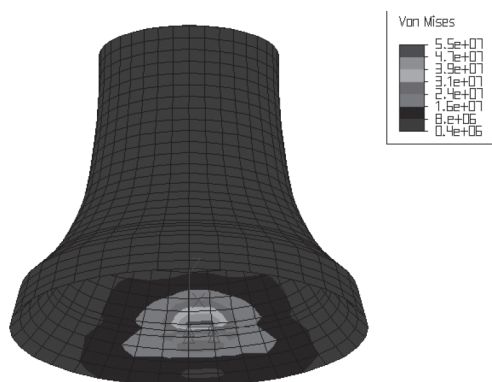
Figure 6. Interior view of the bell indicating the stress map when receiving the 408 N clapper strike. Stresses are in N/m².

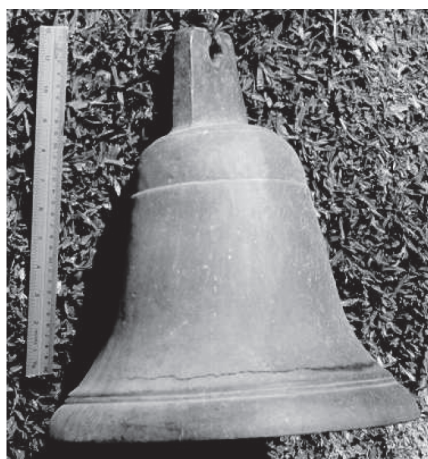
Figure 7 shows the crack that surrounds the slope of the bell, and that is found behind the area of clapper striking, forming a line around the perimeter.

Figure 7. Fissured church bell.

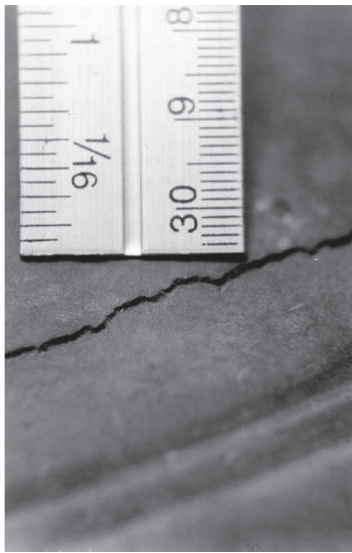
Figure 8 is an amplification of the external area of the bell, the crack having a dimension of around 1 mm.

Figure 8. External side of a transverse crack.

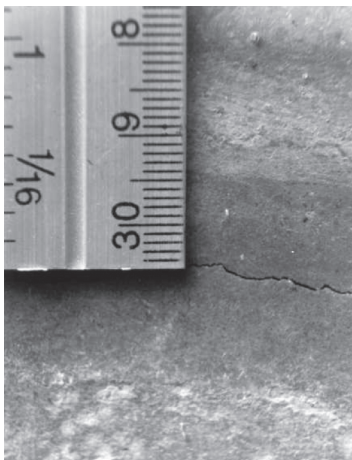
Figure 9 shows the internal side, the area of the clapper strike, where the crack measures less than 1 mm.

Figure 9. Internal side of a through-wall crack.
The wear caused by the clapper can be observed.

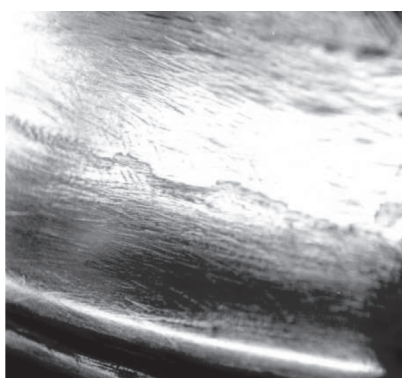
Figure 11. Amplified crack repair. The surface has been polished.

Figure 10 shows repair of the crack with powder metallurgy welding; no polishing. ASTM 100-mesh Cu powder and powder Sn were used. The crack was previously cleaned with acid and then tin-plated, the two sides of the crack being separated from each other. The crack was filled with the powder mix to be then fused with a butane torch. Figure 11 shows the image of the piece polished and amplified; a thin scar signals restoration.

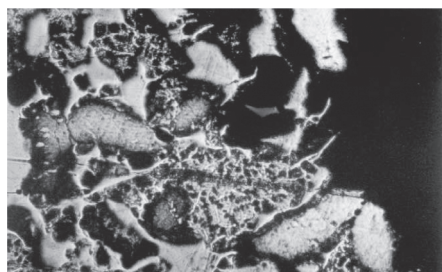
Figure 12. 100-mesh powder Cu and Sn mix. Incorrect joint is shown in big cavities (dark-colored right side). 50X amplification. Untinned crack contours. The edges of the crack were not tin-plated.

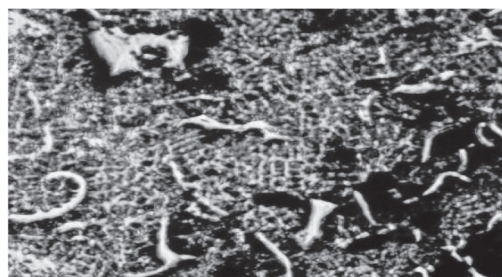
Figure 13. 100-mesh Brass and powder Sn, and Sn welding. The big number of dark-colored impurities creates a bad joint. 50X amplification.

Fusions tried with a powder combination of 75% powder brass and 25% powder Sn failed due to formation of impurities when welding. When trying to apply the butane torch flame, a significant amount of slag was formed, and this prevented a good joint.

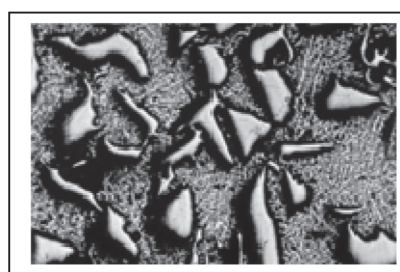
Figure 14. 60-mesh Cu and Sn, and Sn welding. 50X. Tin-plated crack. Good Cu anchors can be observed in the Sn matrix. 35-mesh and 100-mesh copper micrographs are similar, except from the size of Cu particles.

Micrographs of joints indicate the existence of material composed of a Sn matrix and Cu chips that creates an anchor in it. Brass is neither formed nor sintered powder metallurgy material.
