Ponce L., Ernesto

Restoration of ancient bronze bells. Part II: welding

Ingeniare. Revista Chilena de Ingeniería, vol. 23, núm. 1, enero, 2015, pp. 30-37

## Restoration of ancient bronze bells. Part II: welding

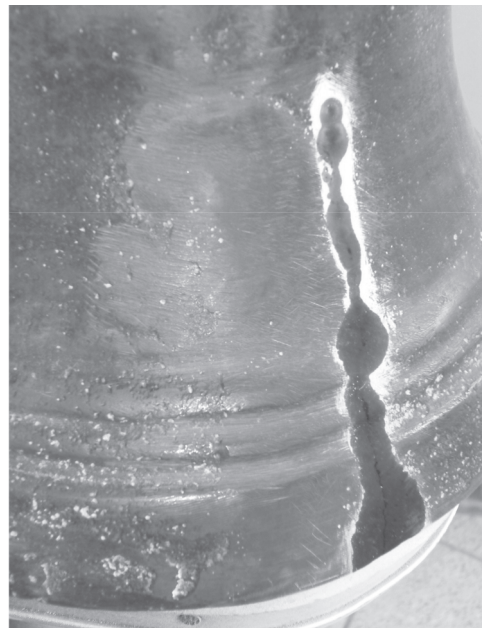
The area to be welded must be first heated in order to avoid sudden cooling that can create cracks. The weld can well resist works loads, but a crack can occur in the bell, just next to the weld bead [3]. Figure 1 shows penetrating liquids, and the crack location next to the welded area.

Figure 1. Crack highlighted by penetrating liquids, on the right side of the welded area.

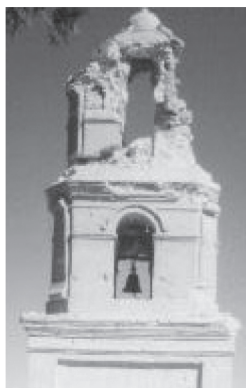
Figure 2. Bell tower in Northern Chile, damaged by an earthquake in 2005.

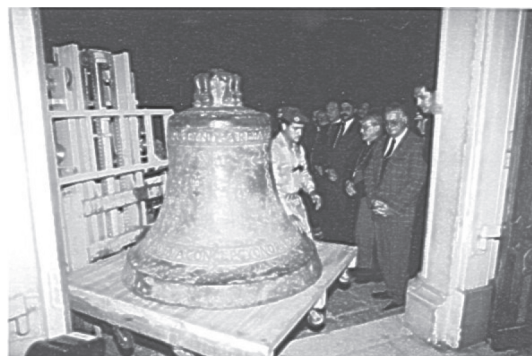
Figure 3. Bell fallen and damaged during the 1866 earthquake in Arica, Northern Chile.

during the 1866 earthquake in Arica. In the upper circular perimeter is the inscription “MARTYN DE AREBALO ME FECY AÑO DE 1729”, and in the lower circumference is “NRA. S. DE LA CONCEPCYON ORA PRONOBYS. LA MANDO HAZER D. PEDRO BELARDE” (Martyn of Arebalo made me, in 1729. Our Lady of Conception, pray for us. Don Pedro Belarde ordered it) [5].

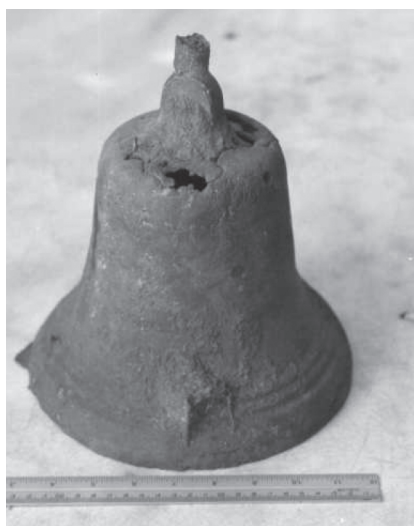
Repaired piece. A bronze copy of a steam locomotive bell of a model similar to that of H.K. Porter & Co's Locomotive Works (H. N. Sprague Supt.) N 1323 Pittsburgh P.A. 1891, had smelting defects in its crown with material missing in areas of this flat surface.

Figure 4. Bell with holes in the crown.

The repaired bell lacked some pieces in the crown area, covering an area bigger than the crack being problematic. Given the difficulties known for some cases of propeller and bell repair by means of conventional welding and commercial filler welding, the method employed was an alloy similar to that of the piece under study, which eliminated the issue of material incompatibility between the filler and the bell. In order to do this, a sample of the repair zone was analyzed, and a sufficient amount of bronze, of the same composition as that of the original piece, was smelted in the crucible. Bars of 8 mm diameter and flat plates, of the same thickness as the missing parts, were cast from the crucible. The interior of the bell was filled with compacted foundry sand to prevent spilling into the weld. The plates, cut with the geometry of the cavity, were mounted in the spaces to be covered. The repair area was placed horizontally, the areas surrounding the joint were pre-heated, and welding was performed with an oxyacetylene torch.

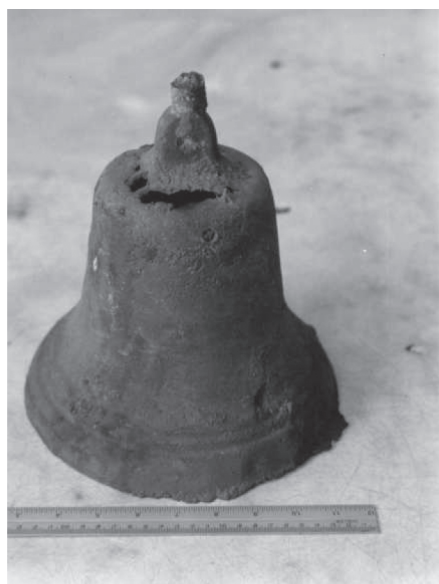
Figure 5. Opposite side of the bell.

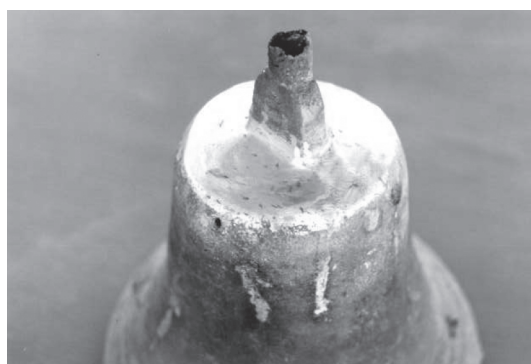
Measurements from the ultrasound equipment indicated uniform thickness welding, no internal cracks or metal separations were detected. No external cracks, searched by penetrant liquids were found.

Figure 7 shows the two types of restoration by welding: The frontal side, in dark color, is bronze of the same composition as the bell. The sides and rear are whitish; Ag-Sn filler material.

Figure 7. Restoration with bronze similar to that of the bell. The front side is dark, whereas the rear part is Ag-Sn welding.

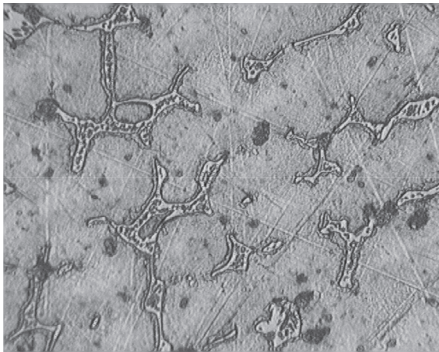
Figure 8 is a 200X micrograph resulting from the fusion of the filler bar and the bell (bar of similar chemical characteristics as the bell metal). It can be observed that copper acts as the matrix surrounding the soft metal. By slowly lowering the lens, the first thing to stand out is the darkest metal (bronze), with some blurry white dendrites, which indicate that dendrites were more worn down during test tube polishing. A 3-second potassium dichromate attack by rub was used.

Figure 8. Welding of the same material as that of the bell. 200X.

Analyzing Figure 8, three phases appear: Tin copper crystals the 1st, 2nd zinc-copper crystals and 3rd a possible eutectic tin-lead, with a coating possibly lead (as indicated in the literature [6]).

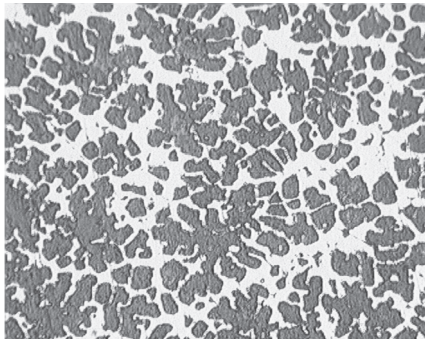
Figure 9 also shows a 200X micrograph, resulting from the bell metal fusion with 50% silver-tin filler material. The alloy matrix surrounding bronze is observed to be white, as opposed to what can be observed in Figure 8. As in the previous case, attack by rub with potassium dichromate was used for 3 seconds.

Figure 9. 50% Ag-Sn welding. 200X.

Two phases formed by liquid-liquid alloys appear when analyzing Figure 9. Bronze solidified first, which appears then embedded in a silver and tin matrix. Temperatures near 3000 °C may have volatilized part of the tin. There are no impurities. Bronze grains appear separate but are equidistant. There was a primary formation with a copper dendrite tendency. Finally, the silver-tin matrix penetrates the alloy eliminating the dendrites.
