Mota, Andre Lupp; Gaia, Diego Felipe; Fonseca, José Honório Palma da  
Ring Fracture of Brazilian Aortic Valve Bioprostheses Using Non-  
Compliant High-Pressure Transcatheter Balloon, an *Ex Vivo* Test  
Brazilian Journal of Cardiovascular Surgery, vol. 37, no. 3, 2022, pp. 301-305  
Sociedade Brasileira de Cirurgia Cardiovascular

# Ring Fracture of Brazilian Aortic Valve Bioprostheses Using Non-Compliant High-Pressure Transcatheter Balloon, an *Ex Vivo* Test

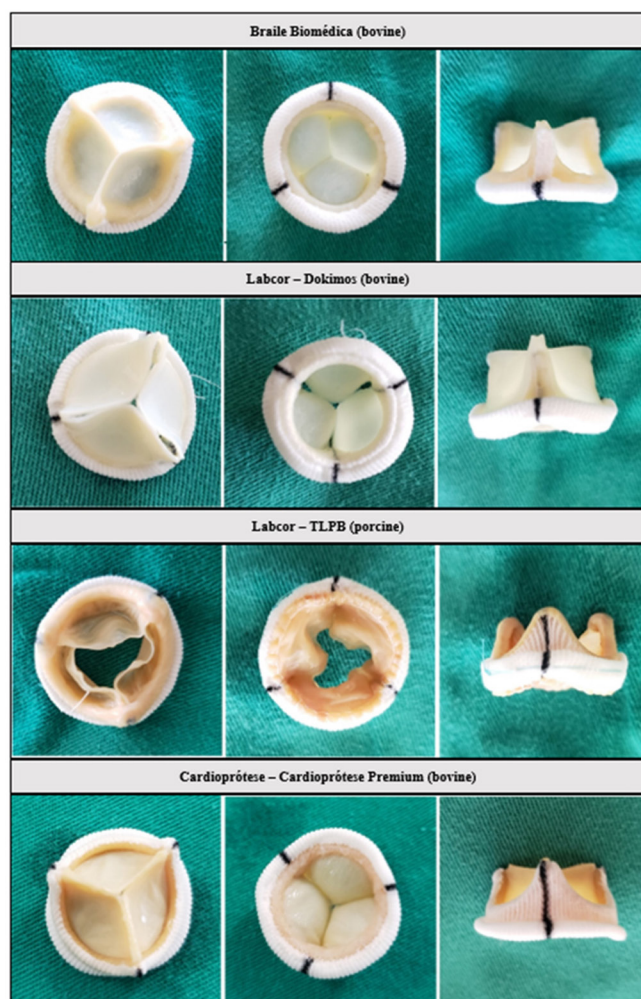
The photographs and radiographs before the test allow the identification of the metallic ring in the models manufactured by Braile (Figures 1 and 2). After fracture, in all prostheses it was possible to evidence the site of the ring discontinuity, characterized by local deformity, which was more evident in the model with metallic ring (Figures 3 to 6).

**Fig. 1** - Photographs of the prostheses used in the test in their upper, lower, and lateral aspects.

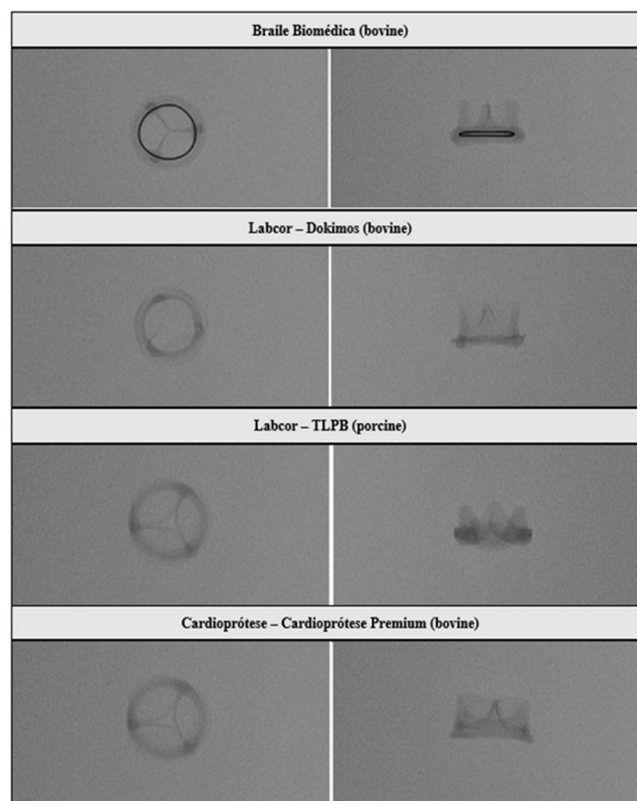
**Fig. 2** - Radiography of the prostheses used in the test. Superior - inferior and lateral projections.

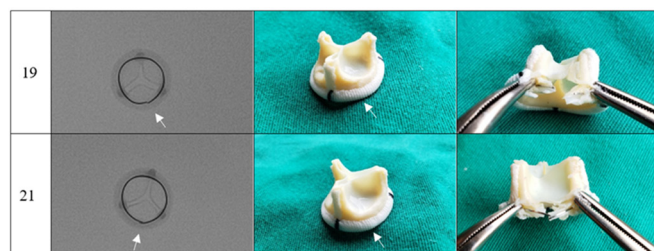
A slight deformity in the ring structure was identified on palpation, keeping the Dacron reinforcement intact; no spicules were observed. After removing the Dacron lining and exposing the fracture site, linear discontinuity of the ring and absence of fragments were observed.

**Fig. 3** - Braile prosthesis after fracture, sizes 19 mm and 21 mm. Radiography (superior-inferior projection) and photographs (intact lining and dissected lining). Arrow corresponding to the fracture site.

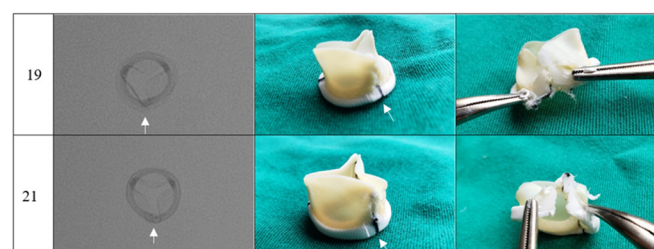
**Fig. 4** - Labcor Dokimos prosthesis after fracture, sizes 19 mm and 21 mm. Radiography (superior-inferior projection) and photographs (intact lining and dissected lining). Arrow corresponding to the fracture site.

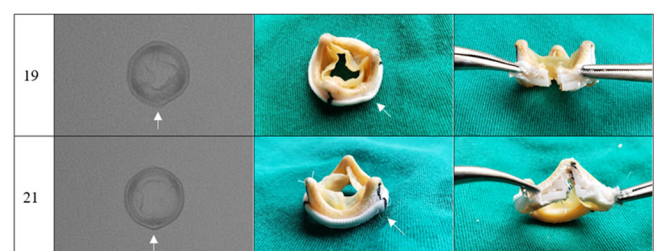
**Fig. 5** - Labcor TLPB prosthesis after fracture, sizes 19 mm and 21 mm. Radiography (superior-inferior projection) and photographs (intact lining and dissected lining). Arrow corresponding to the fracture site.

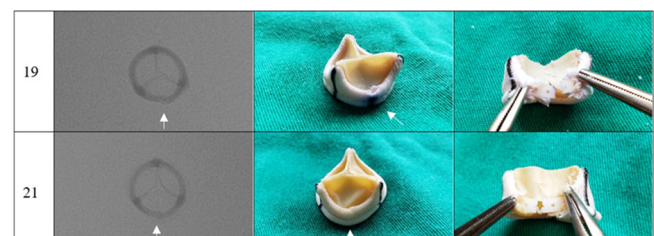
**Fig. 6** - Cardioprótese Premium prosthesis after fracture, sizes 19 mm and 21 mm. Radiography (superior-inferior projection) and photographs (intact lining and dissected lining). Arrow corresponding to the fracture site.
