Gelamo, Rogério Valentim; Venâncio de Sene, Eva Cláudia; Paiva, Luciana; da Cunha Hueb Barata de Oliveira, Cristina; Maltos, André Luiz; Schreiner, Wido H.; Bica de Moraes, Mário; Vaz, Alfredo R.; Moshkalev, Stanislav A.; Ferreira da Cunha, Daniel Effects of reprocessing on chemical and morphological properties of guide wires used in angioplasty

Revista Brasileira de Cirurgia Cardiovascular/Brazilian Journal of Cardiovascular Surgery, vol. 28, núm. 3, julio-septiembre, 2013, pp. 331-337

# Effects of reprocessing on chemical and morphological properties of guide wires used in angioplasty

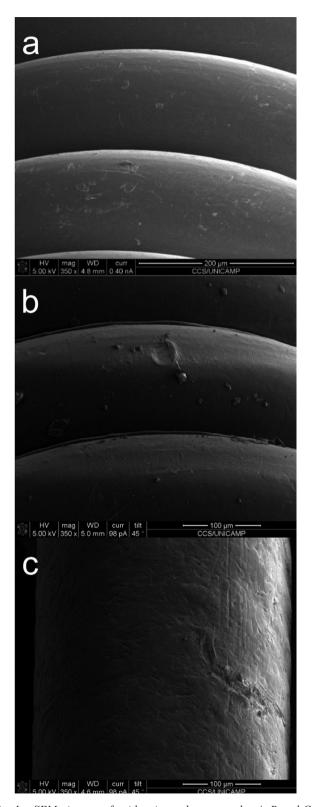
The SEM images of surfaces of the polymeric coatings of pristine guide wires A, B, and C are shown in Figure 1. Fairly uniform surfaces are revealed by the three micrographs. The small irregularities observed in the three pictures are typical of pristine guide wires and were considered normal.

Fig. 1 – SEM pictures of guide wire catheter samples A, B and C. All surfaces with few small irregularities, considered normal for this material. Small artifacts from the manufacturing process are seen in Figure B.

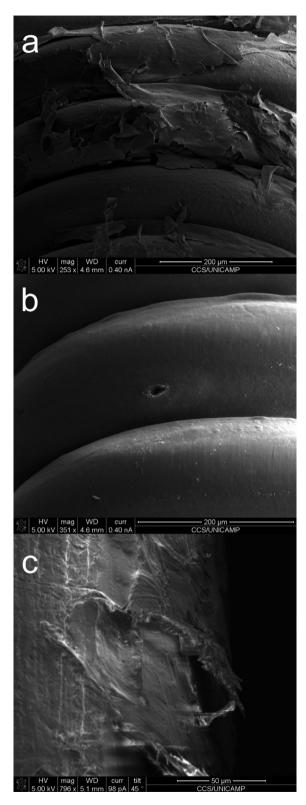
The effect of ultrasonic and enzymatic detergent cleaning treatments of the three samples can be seen in the SEM images (Figure 2), which depict the surfaces of the samples after a single cleaning. Pronounced surface damage is observed in samples AU1 and CU1 while damage is less significant in sample BU1. Sample AU1 was the most affected, as seen in Figure 2.

The persistence of debris larger than 200  $\mu m$  can be observed at the surface of guide wires after the washing procedure using ultrasound. Sample BU1 shows defects in the PTFE structure, including holes and bubbles, that were not observed in the pristine material. A marked roughness in the polymer coating surface is seen in the CU1 sample, with some holes in the microstructure and micrometric flakes, smaller than those observed in sample A.

Fig. 2 – SEM images of guide wires AU1 (A), BU1 (B) and CU1 (C), washing 1X using enzymatic detergent in ultrasonic bath. Debris and holes of considerable size are observed mainly in Figures A and C, while bubbles and a non-conformal surface are observed in Figure B.

By carefully observing the SEM images (Figure 2), it becomes apparent that blocks of PTFE 40 to 300 micrometers in length were removed from the surface of the guide wire catheters after only one washing procedure. In addition to eventual occurrence of embolization of distal coronaries or other systemic arteries with surface detached debris, accompanied or not by tissue infarction [3], changes in wettability and in the electrical charge of catheter surface are major factors in additional platelets aggregation and thrombosis formation [11]. The chronic fate of this PTFE debris in tissues is also not known, but potential

The treatment of the catheters with ethylene oxide was not associated with morphological or chemical changes, and it seemed appropriate to maintain guide wire coating integrity. However, the ultrasonic cleaning was not suitable for polymer-coated guide wires, and a combination of chemical reaction with mechanical vibration may have resulted in the further deterioration observed. Therefore, the reuse of these devices is not recommended.

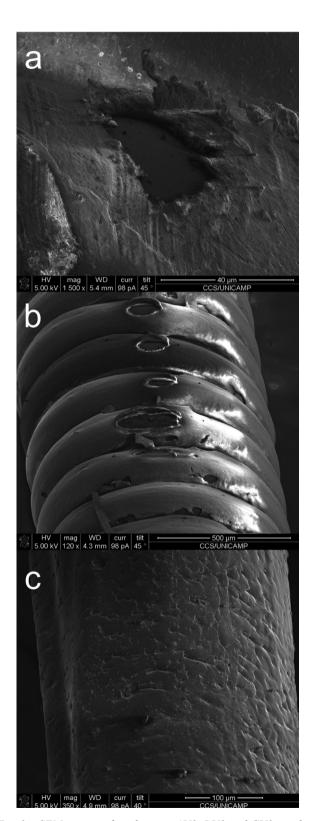
At naked eye, the catheters washed only once showed slight color changes, varying from green to a yellowish-green color, a phenomenon which is markedly observed after the second washing (samples AU2 and BU2). The intense modifications are best observed through scanning electron microscopy, which allows for viewing at the micrometric level (Figure 3).

Fig. 3 – SEM images of guide wires AU2, BU2 and CU2, washing 2X using enzymatic detergent in ultrasonic bath. Persistence of debris and holes in Figures A and B and an increase in roughness is observed in Figure C.
