Anais do Museu Paulista: História e Cultura Material, vol. 30, e12, 2022

# The production of protective earth-based mortars for earth constructions in southeastern Brazil during the 19th century coffee economy

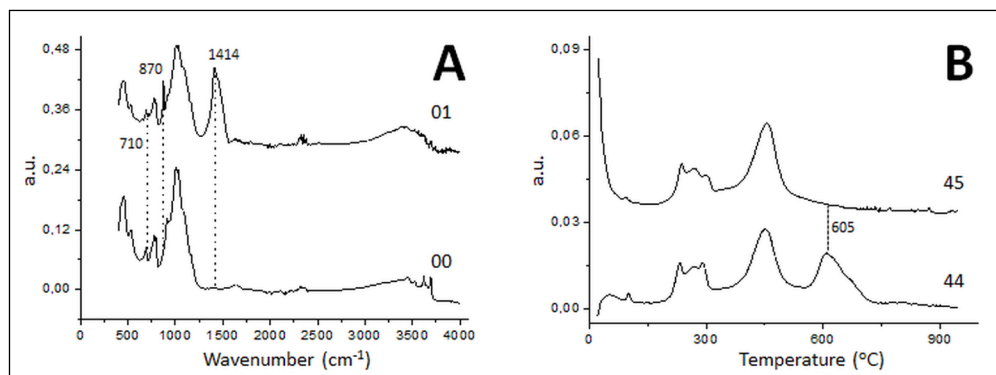
Figure 1 – Typical examples of FTIR spectra (A) and differential TGA curves (B) of mortars exhibiting (01 and 44) and not exhibiting (00 and 45) carbonate characteristics, that is, bands at 1400, 870 and 710 cm⁻¹ (FTIR) and mass losses at T>600 °C (TG).

Since local soils have an insignificant presence of carbonates,<sup>20</sup> the use of lime could be inferred from the calcium carbonate (CaCO<sub>3</sub>) content that is formed from lime (CaO) upon reaction with CO<sub>2</sub>. This was performed in two steps: all mortar samples were analysed using FTIR (see Figure 1A) and those revealed to have typical CO<sub>3</sub><sup>2-</sup> bands at 1400 cm⁻¹ (asymmetric stretching), 870 cm⁻¹ (out-of-plane bend) and 710 cm⁻¹ (in-plane bend) had the carbonate content accurately assessed by TG (see examples in Figure 1B) as a function of CO<sub>2</sub> formation.

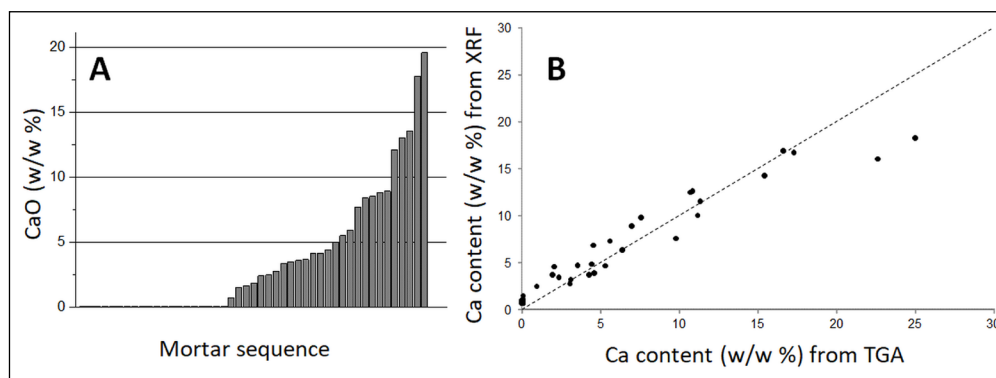
Figure 2 – A: Distribution of theoretical CaO amount used in mortar manufacturing calculated from CO<sub>2</sub> loss by TGA; B: correlation between Ca amount measured from TGA data (assuming the only Ca compound is CaCO<sub>3</sub>) and from XRF spectra.

The combined approach to assessing the use of lime in mortar manufacturing resulted in the bar graph in Figure 2.

Calculation of the CaO used in mortar formulation surmises total transformation of calcium oxide into calcium carbonate upon reaction with CO<sub>2</sub>, an assumption that, to a good extent, is confirmed by the results in Figure 2B, which shows the

correspondence between the Ca concentration calculated from TGA data and its content obtained from XRF measurements of elemental Ca. The linear correlation between the two data sets with unit slope is notable, within a reasonable margin of error, except for two observations in which the presence of carbonates other than  $\text{CaCO}_3$  is likely (although  $\text{MgCO}_3$  alone does not account for the difference).

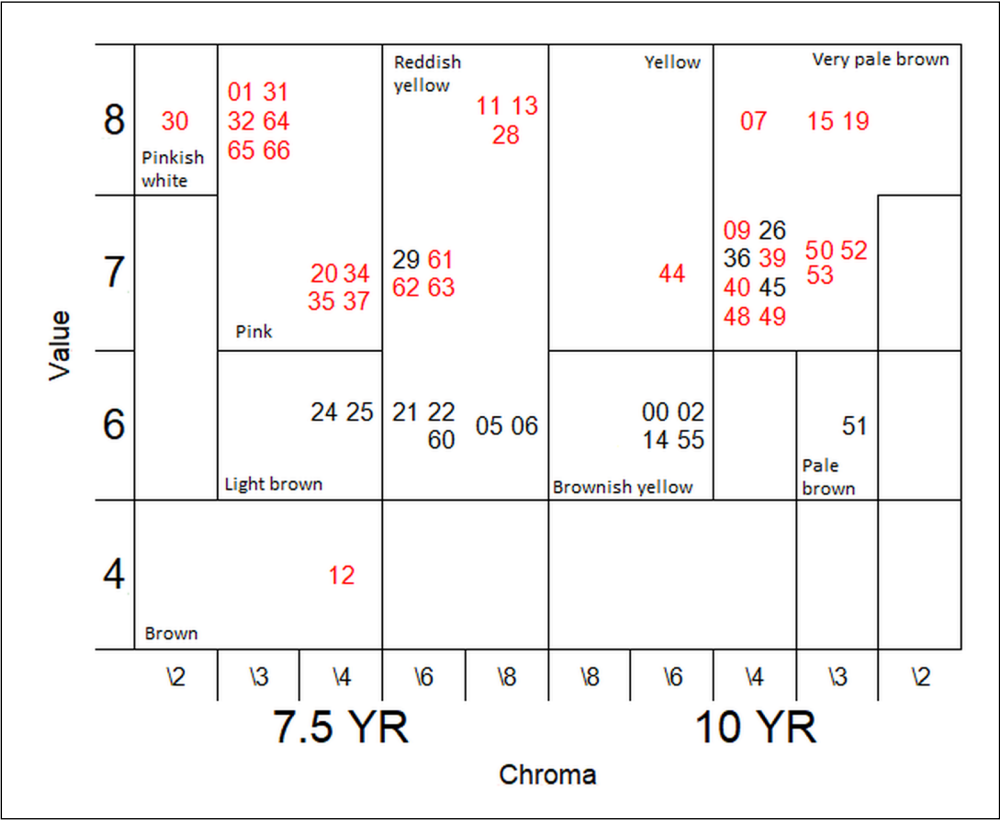
Figure 4 – Colour distribution of mortars (red numbers indicate carbonate-rich materials).

Two aspects should be highlighted in the interpretation of colours. First, all samples (except sample 10, which is a Portland cement-based mortar) belong to yellow-red domains, and were therefore all produced using soil as raw material. Although only part of them could be confirmed as original from when the historical earth structures were built, the general presence of an earthen substrate suggests that the practice of using soil in mortar formulation has been customary in the region for quite some time. The transition to more modern solutions has probably been gradual and may have continued for some time after the introduction of burned clay-based building technology.

A second aspect to be highlighted is that the range of hues covered by the mortars is considerably narrower than the general range of soils found in the historical valley and described by Cavicchioli, Sant’Anna, and Perroni (2018).<sup>32</sup> While in soils the colours range from 2.5 YR to 10 YR hues, with a predominance of 5 YR (therefore with a stronger reddish character), mortars are concentrated in a more yellowish area (between 7.5 YR and 10 YR). Consequently, colour might have been a factor in soil selection in the practice of vernacular mortar

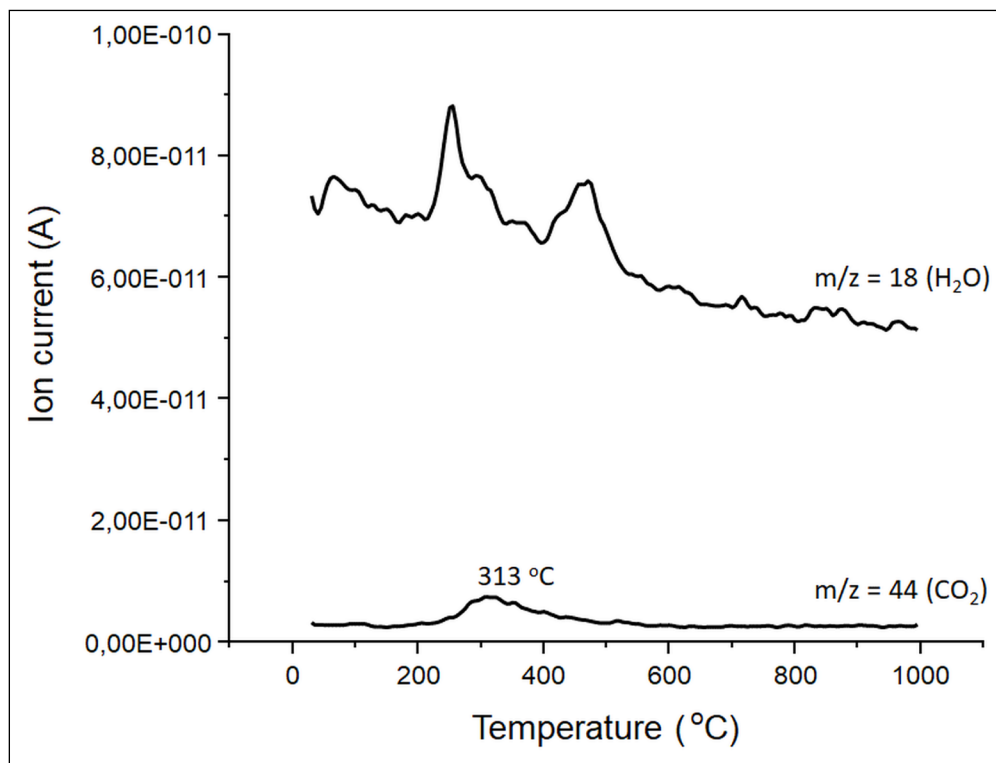
Figure 5 – Evolution of gases during TGA/DSC analysis of mortar no. 00: H<sub>2</sub>O (m/z=18) and CO<sub>2</sub> (m/z=44).

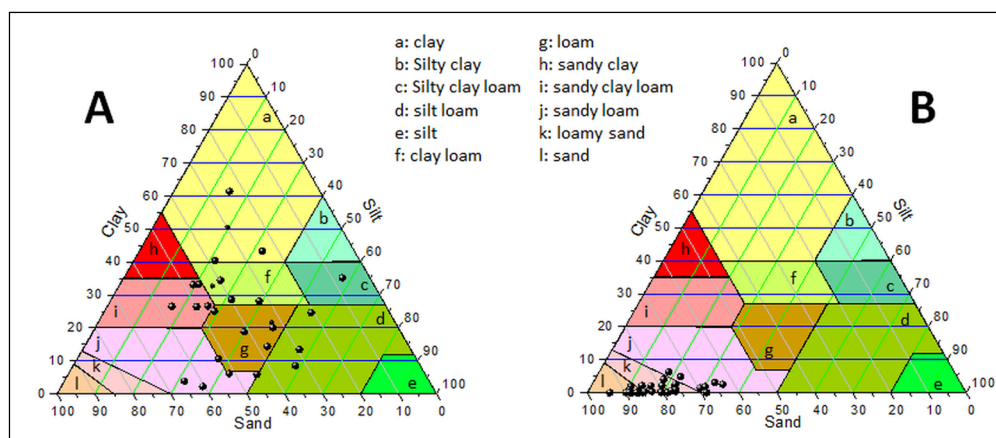
Figure 6 – Tertiary graphs indicating the volume % of clay, silt and sand content in soils (A) and mortars (B) and classification of each sample in USDA-NRCS texture classes.<sup>36</sup>

Grain size distribution, on the other hand, shows a completely different scenario. Both mortars and soils were characterised in terms of grain size distribution and the proportion of clay, silt and sand found in the set of samples is illustrated in Figure 6.

Soils are distributed across seven texture classes, concentrated mainly in the middle section of the graph, with most showing concentrations of three textures that are quite similar. Mortars, on the other hand, are markedly concentrated in the sand-rich corner of the graph, with very low clay concentration (<10%) and sand concentration ranging from 60 to 100% (although most are concentrated in the 75-90% range).

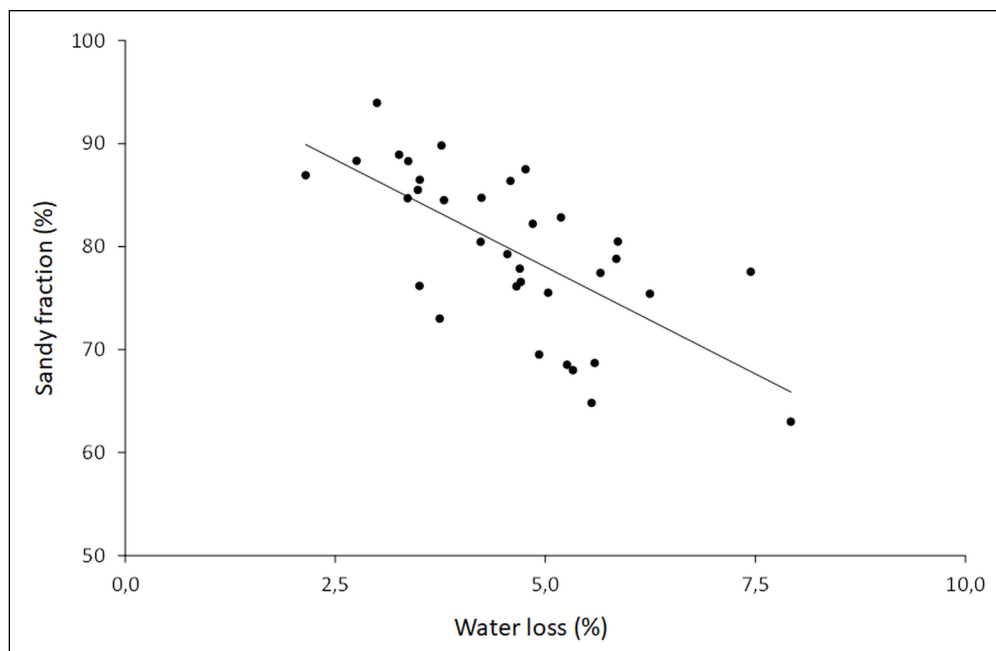
Figure 7 – Correlation between the proportion of sandy fraction of mortars and water loss in the 120-550°C range obtained by TG curves.

Figures 7 and 8A indicate the existence of a good anti-correlation between the proportion of sandy fraction and water loss in the 120-550 °C temperature range obtained by TGA (Figure 7), and the amount of elemental aluminium (Figure 8A). Both parameters are associated with the content of clay minerals that are mainly aluminosilicates, with a predominance of kaolinite ( $\text{Al}_2\text{Si}_2\text{O}_5(\text{OH})_4$ ) in the case of the study area (Figure 10). As expected, therefore, the search for and use of coarser raw materials correspond to mortars relatively poor in clay minerals. On the other hand, Figure 8B indicates that the correlation between the proportion of sandy mortars and Si content is practically non-existent, thus suggesting that, to obtain the desired texture, the common practice was not to add sand, which is largely composed by quartz grains ( $\text{SiO}_2$ ). At least, this is not expected to be the

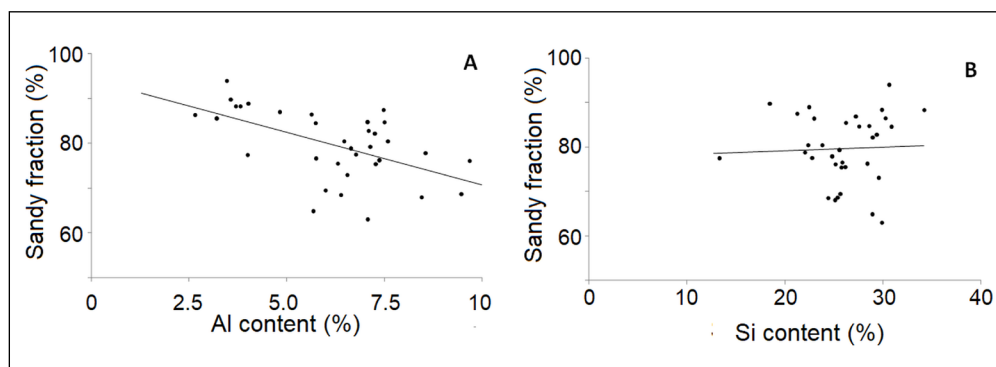
Figure 8 – Correlation between the proportion of sandy fraction of mortars and (A) Al and (B) Si.

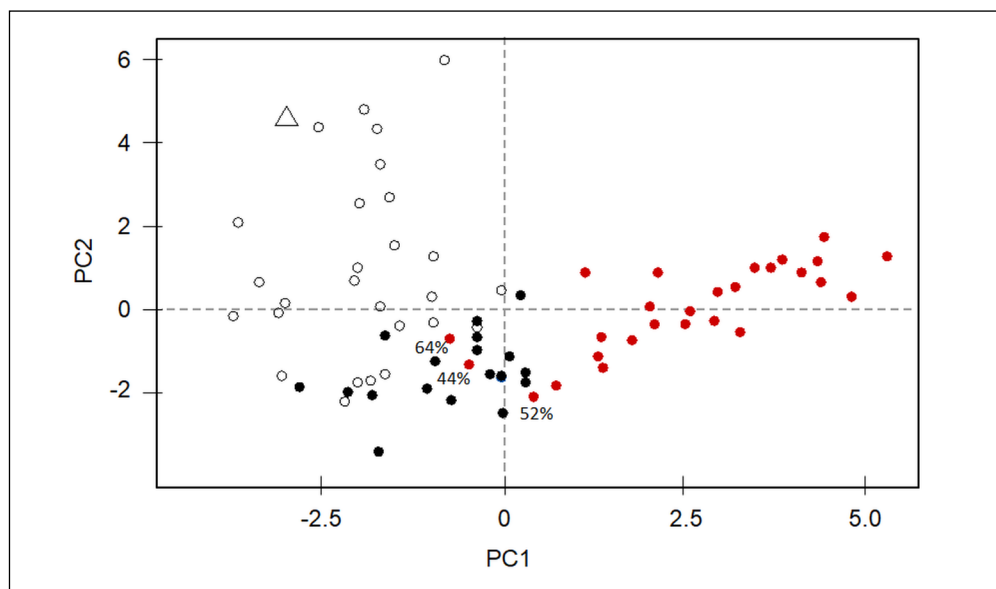
Figure 9 – Bidimensional score plot of each PCA1 and PCA2 (all variables except Ca) analysis. Soils are marked as red circles, mortars without carbonate in their composition are marked as black circles, mortars with carbonate in their composition are marked as void circles and triangles (triangle indicates a mortar manufactured with Portland cement). Separation between the two groups of mortars (with and without lime) occurs along the PC2 axis, which is overwhelmingly ruled by Ca content.

Two main arguments support this assumption. First, considering the chemical distribution map of the soils and mortars based on the bidimensional plot of the first and second principal component scores (Figure 9) obtained by Principal Component Analysis (PCA) of the original elemental composition data, there is a distinct separation between most soils and the group of mortars. Although lime-free mortars

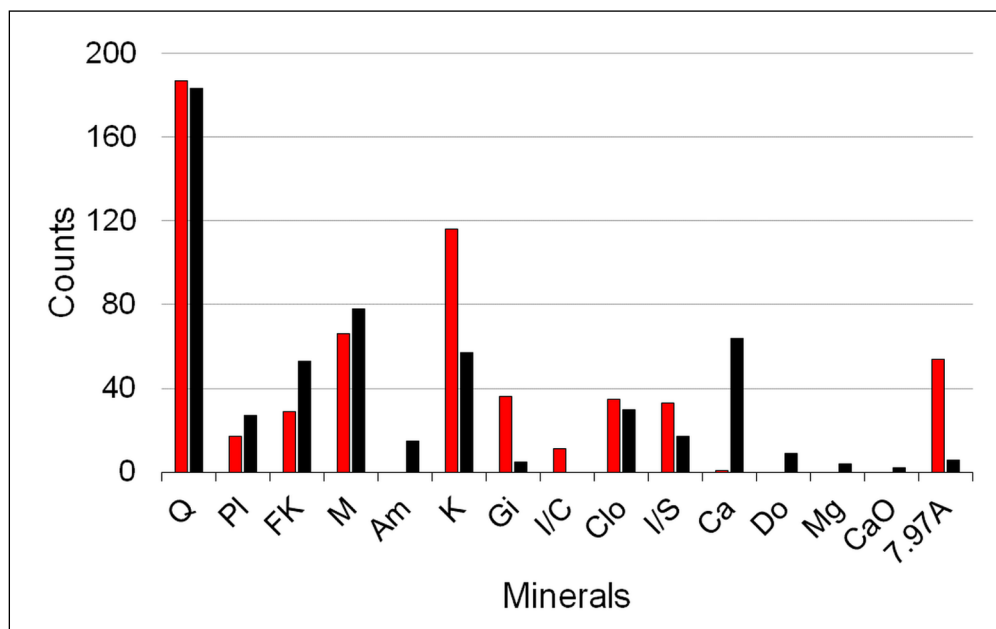
Figure 10 – Estimated relative abundance of bulk minerals identified in the general group of soils (red) and mortars (black). Q: quartz; Pl: alkaline plagioclase; FK: potassium feldspar; M: mica; Am: amphibole; K: kaolinite; Gi: gibbsite; I/C: illite/chlorite; Clo: chlorite; I/S: illite/smectite; Ca: calcite; Do: dolomite; Mg: magnesite; CaO: calcium oxide (peak 7.97 Å was not identified).

Among the higher abundance minerals, it is significant that the overall abundance of quartz between soils and mortars remains similar, thus indicating that mortars are not particularly richer in river sand. On the other hand, both groups show important differences regarding the frequency of feldspars (Pl and Fk), mica (M) and amphibole (Am)—all more abundant in mortars—and clay minerals, mainly kaolinite (K), but also gibbsite (Gi), illite/chlorite (I/C), chlorite (Clo) and illite/smectite (I/S)—all less abundant.

All these mineralogical aspects (similar Q content, increased abundance of Pl, FK, M and Am and reduced clay components such as K, Gi, Clo, I/C and I/S) support the hypothesis of a mortar production practice in which less weathered, coarser soils with reduced clay content are preferred and where correction of grain size distribution by river sand is not as common as in current masonry. This form of soil selection may be due to: i) a reduced labour activity required by the extraction and treatment of river sand, and ii) the presence of coarse particles with better mechanical properties in less weathered soils. In fact, quartz particles from river sand are expected to have rounded shapes, whereas rock fragments are usually irregular, angular particles with a larger surface area.<sup>37</sup> This characteristic was confirmed in the mortars that were analysed by SEM-EDS (Figure 11). The images show that, in general, coarser particles do not have the typical spherical shape of river sand and are often rich in K, Ca or Na, as expected from alkali or potassium feldspars.

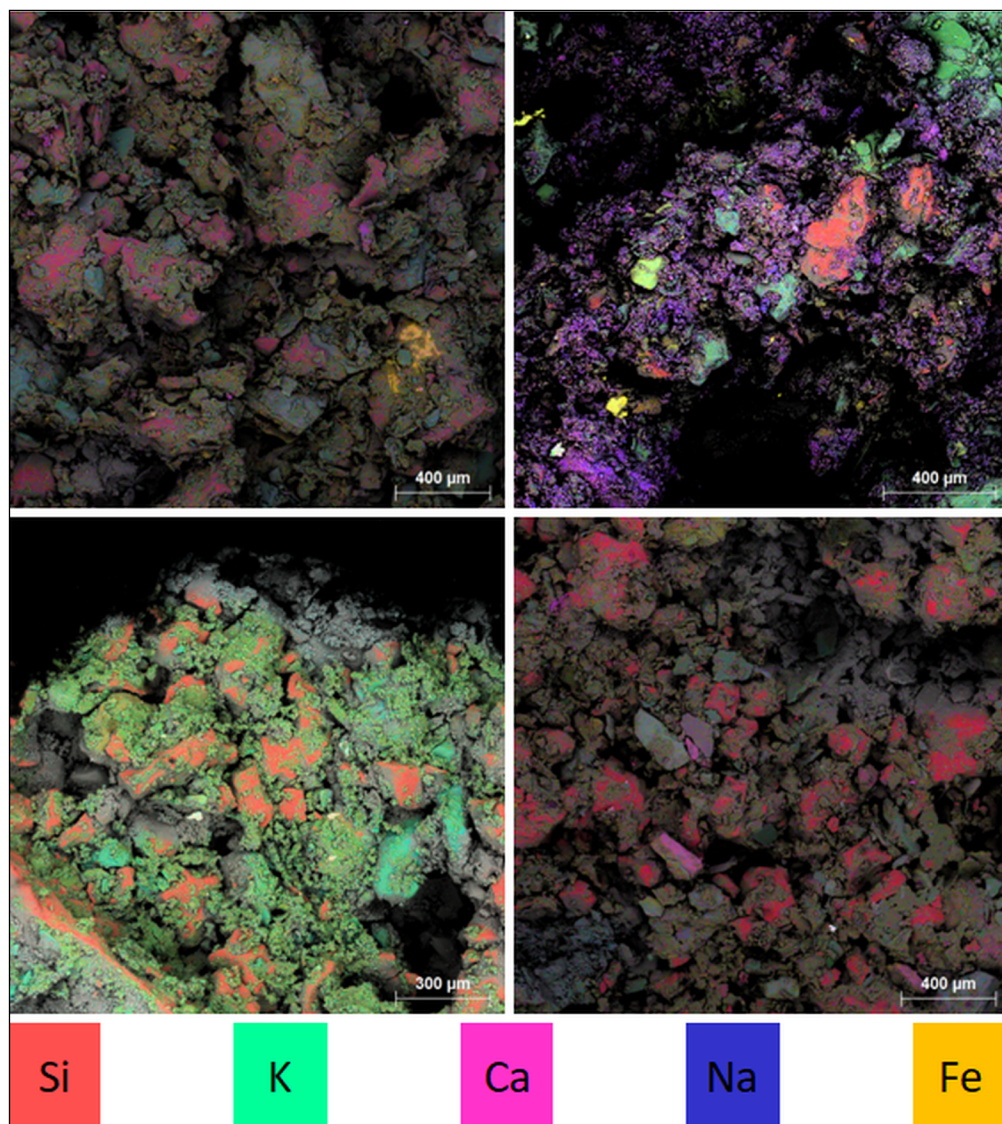
Figure 11 – SEM-EDS images of the following mortar samples: no. 25 (upper-left), 12 (upper-right), 34 (bottom left) and 00 (bottom-right).
