# EFFECTS OF HYDROELECTRIC DAM CONSTRUCTION ON LAND USE LAND COVER CHANGES IN BUI NATIONAL PARK, GHANA

**Bempah, Godfred; Boama, Prince**

Mercator - Revista de Geografia da UFC, vol. 20, núm. 2, 2021

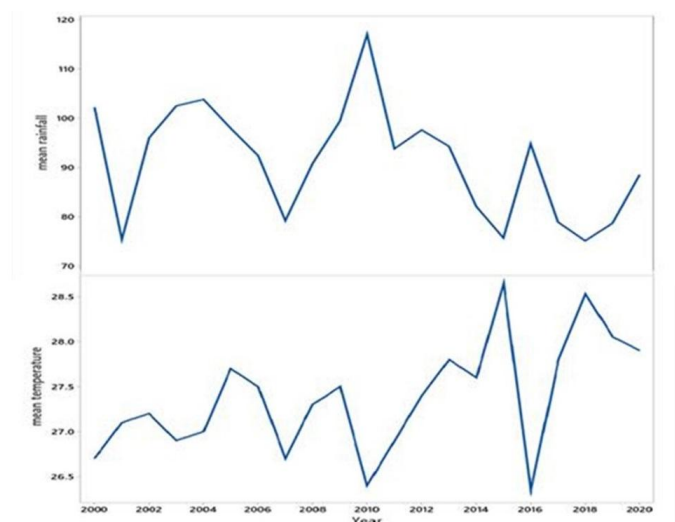
FIGURE 2

Trends of changes of mean rainfall (mm) and mean temperature (°C) from 2000 – 2020 at BNP

There was a negative correlation ( $r = -0.609$ , Figure 2), and estimated value from the series' cross correlation function (CCF) was significant ( $p = 0.003$ ) between the mean rainfall time series and the mean temperature time series for the study period.

The highest decade mean temperature ( $27.69 \pm 0.219$  °C) was recorded for 2011–2020 compared to the decade 2000–2010 with  $27.16 \pm 0.108$  °C. The highest decade mean rainfall ( $93.96 \pm 3.094$  mm) was recorded for 2000–2010 compared to 2011–2020 with  $85.954 \pm 2.77$  mm. Results of Mann Whitney U

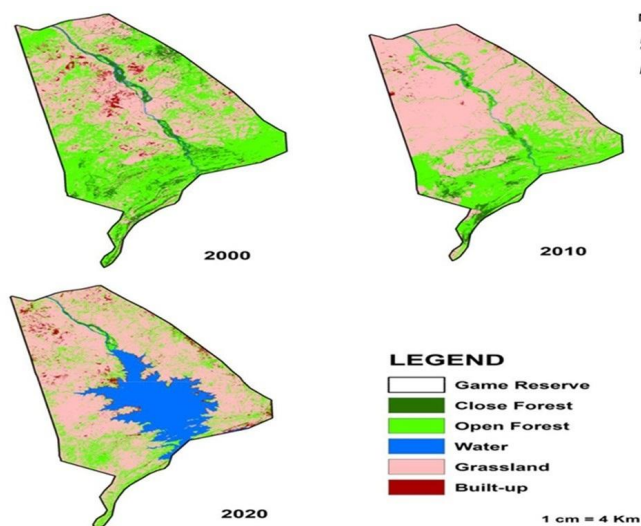
FIGURE 3

In all, five land cover types were identified, namely; built-up, close forest, grassland, open forest, and water body. A set of three different land cover maps covering the study area for the years 2000, 2010 and 2020 is shown in Figure 3.

Land cover maps of the Bui National Park for the years 2000, 2010 and 2020.

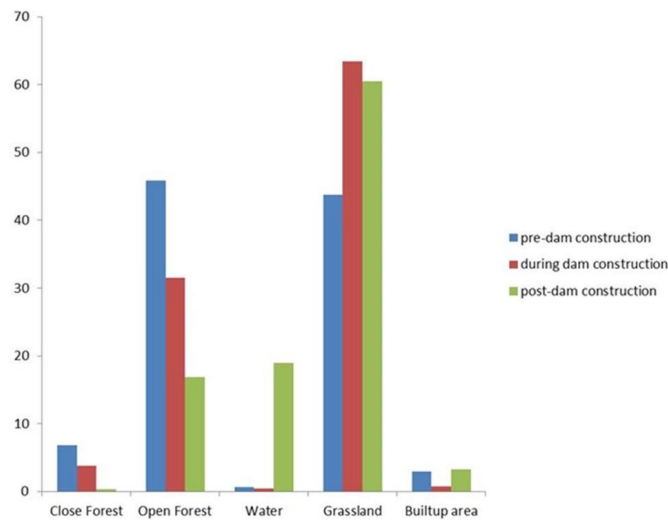
FIGURE 4

land cover classes. Before the dam construction, open forest occupied the largest portion of the total land area with 45.87 % (Figure 4). However, this changed during the post-dam construction, with grassland (60.54 %) occupying the largest percentage cover, followed by water body with 19.01 %.

Percentage of area covered by each Land cover types; pre, during and post dam construction.

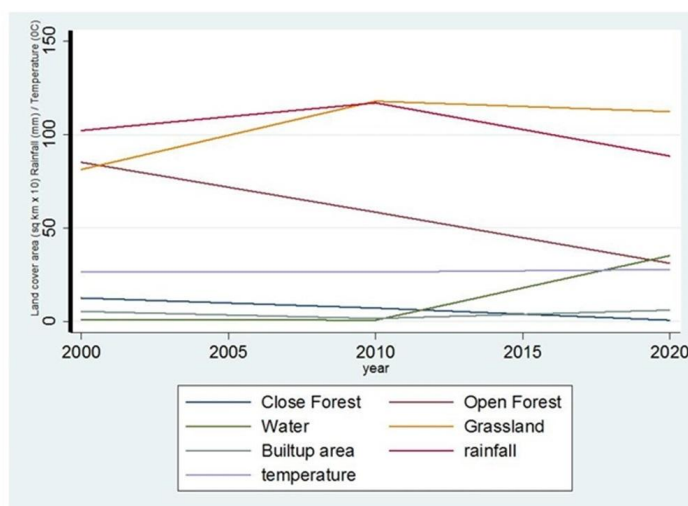
FIGURE 5

Land cover changes and climatic variables seem to follow a similar trend over the period after the dam construction (Figure 5). For example, a decrease in the amount of rainfall corresponded with a decrease in close forest and open forest. During the same period, water body, grassland and builtup area increased with marginal increase in temperature. Increase in water body results from the reservoir created by the dam and grassland and builtup area is caused by forest degradation corresponding with temperature increase.

Land cover, rainfall and temperature changes with the construction of the dam
