## Mechanical Deterioration by Weathering of the Adobe from the Tausa Chapel (Colombia)

Tecnológicas, vol. 26, núm. 58, e2733, 2023

Deterioro mecánico por intemperismo del adobe de la capilla de Tausa (Colombia)

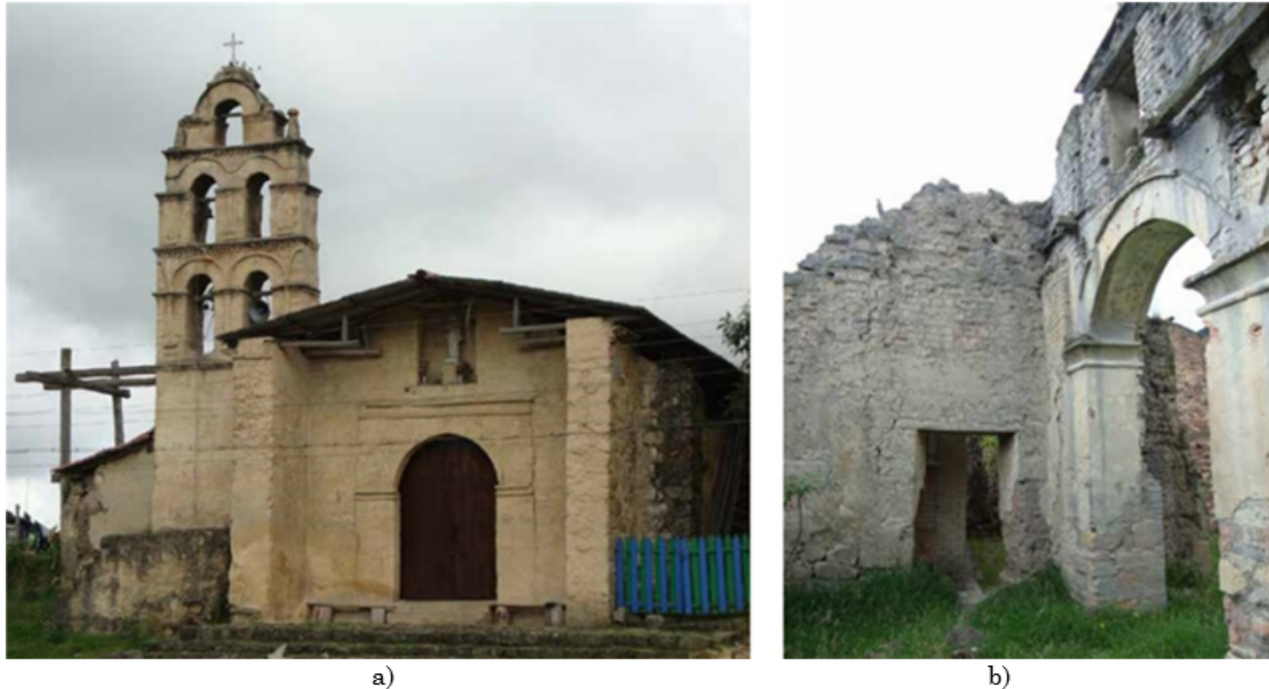
**Figure 1**  
Doctrinal chapel in Tausa: a) frontal sector; b) rear sector  
Source: Created by the authors.

chapel of colonial style, which was built more than 300 years ago. The chapel retains its original adobe structure of single nave with access framed in a semi-circular arch and a lateral belfry. Its atrium is built in stone, forming four staircases that lead to the street. According to the current structural preservation state, the building can be divided into two parts. The frontal sector presented in Figure 1a) is currently in use and is composed of the nave built in masonry, adobe, rammed earth, and collar roof. The rear sector in abandoned conditions as can be seen in Figure 1b) corresponds to the ruined walls of the presbytery and two lateral areas, of which it is unknown its use. A description of the architectonic distribution, constructive technique and physical, mechanical, and chemical characteristics of the materials can be found in [31].

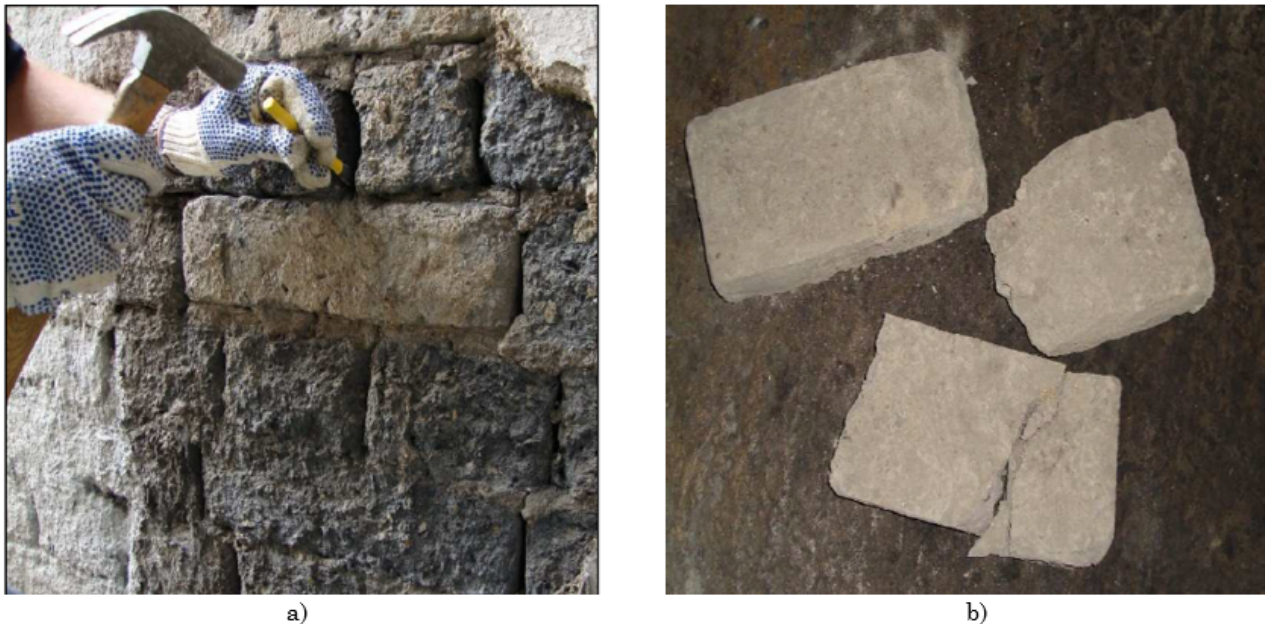
**Figure 2.**  
Samples of old adobe: a) recuperation of an adobe unit; b) recovered samples  
Source: Created by the authors

The experimental program was carried out on two groups of materials. The first one corresponds to adobe samples recovered from the rear sector of the chapel (old adobe). 15 complete adobe units and 24 fragments (Figure 2) composed old adobe samples. The second group was obtained from a soil deposit located in the area close to the chapel (new adobe). Three soil deposits in the locality were preliminarily studied by performing soil classification tests and the most similar soil to the old adobe was the chosen one. Only results from the selected soil deposit are presented in this paper. With the new adobe, 60 samples were prepared by compaction in cylindrical molds under controlled water content. Then, they were extruded from the mold and left to air-drying with no action of direct sunlight for 45 days (Figure 3). Compaction of samples was carried out to simulate the methods employed by ancient construction workers in the production of adobe walls. For this reason, modern procedures such as Proctor compaction were avoided to preserve the authenticity of the compaction process. The moisture conditions for compaction were those necessary for better workability, mirroring the practices of traditional construction [32]. This procedure aimed to obtain samples with similar characteristics of adobe units made with this conventional technique. A comparison of the physical characteristics of old adobe and new adobe samples are presented in Table 1. Results from old adobe are like results previously obtained on samples of the same chapel by [32]. However, plasticity limits are slightly lower than the results found in the present work.

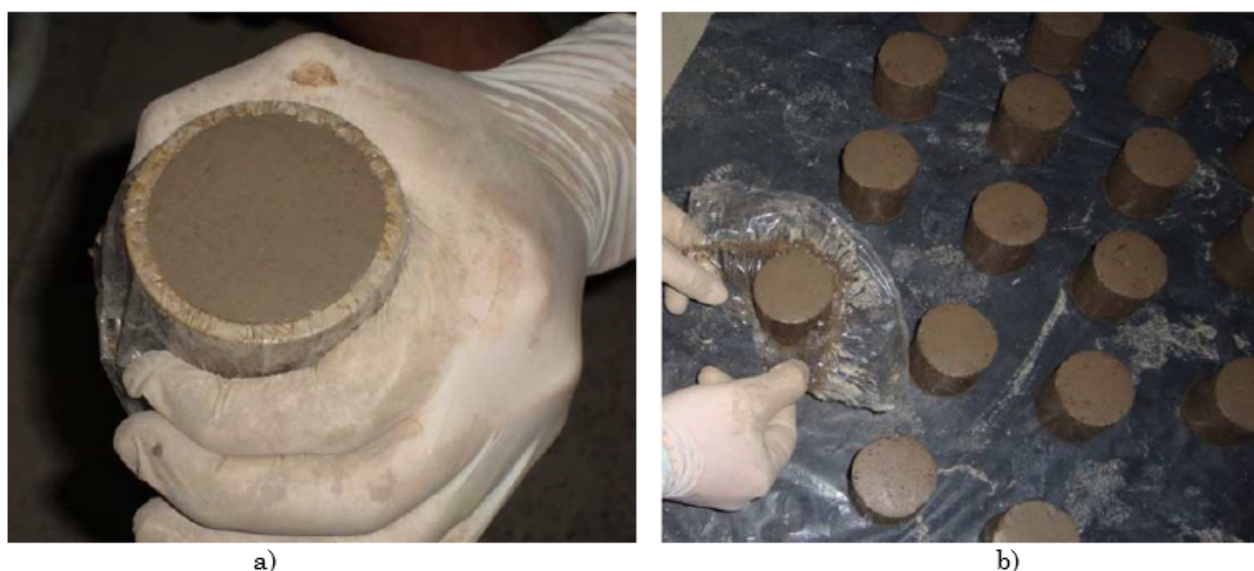
**Figure 3**

Samples of new adobe: a) preparation of the sample; b) air drying process

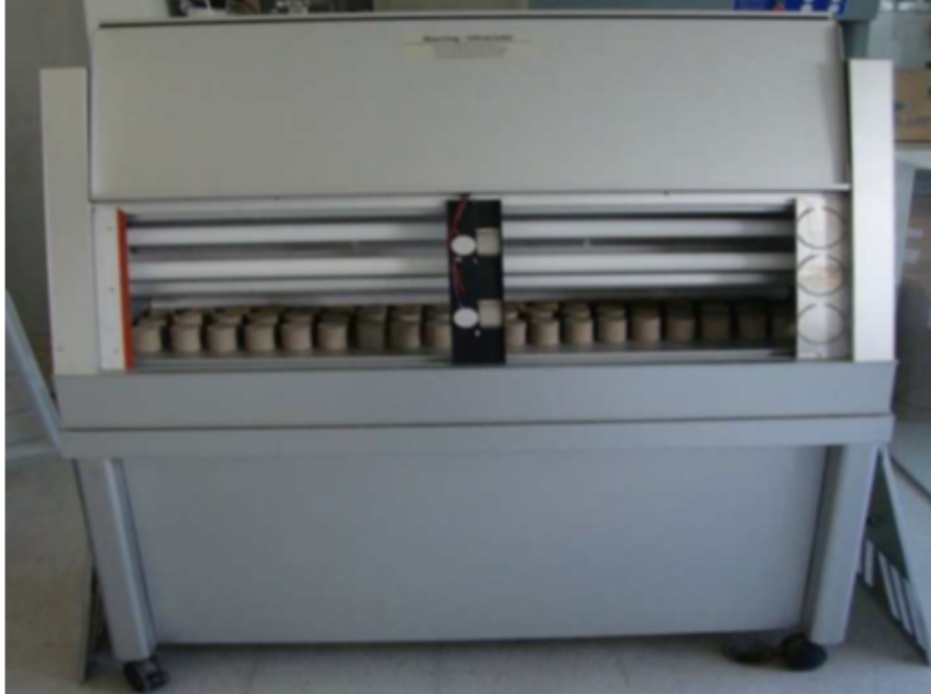
**Figure 4**  
Accelerated weathering tester QUV-SE  
Source: Created by the authors.

Cylindrical samples from old adobe were obtained from adobe samples by using a core extractor. An accelerated weathering tester QUV-SE [33] simulates the effect of ambient exposition. Figure 4 illustrates the equipment with a group of samples ready to be exposed to weathering. The equipment is capable of controlling irradiance by a closed-loop control and uses eight UVA-340 lamps simulating the sunlight from 365nm down to the solar cut-off of 295 nm. In addition, the apparatus has a condensation mechanism to simulate outdoor moisture attack by heating a water reservoir to produce a vapor that maintains a 100 % relative humidity. Radiation and condensation alternate cyclically in programmable periods. Exposition of materials to this artificial regime produces degradation in a similar way that natural ambient conditions. Proportionally time factor between natural and artificial exposition is not constant since it depends on several variables that are not fully controlled (e.g., tested material, variation in natural conditions, variables capable of controlling in the equipment). The standard ASTM G154-16 [34] covers

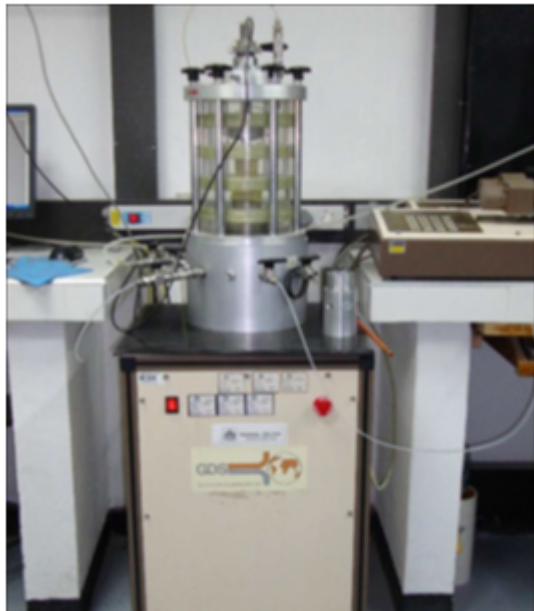
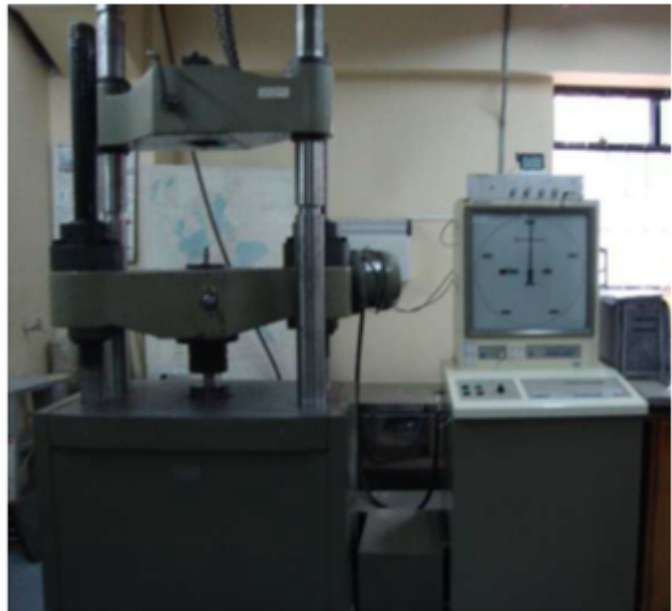
**Figure 5**  
Mechanic devices: a) triaxial testing apparatus; b) compression tester machine  
Source: Created by the authors

Mechanical tests on the samples were done by using the GDS triaxial testing apparatus shown in Figure 5a [35]. The system allows controlling confinement pressure and vertical stress. A universal compression tester machine was used for unconfined compression tests on cylindrical samples (Figure 5b). Additional equipment and accessories include scale, oven, sieves, soil classification instruments and compaction molds.

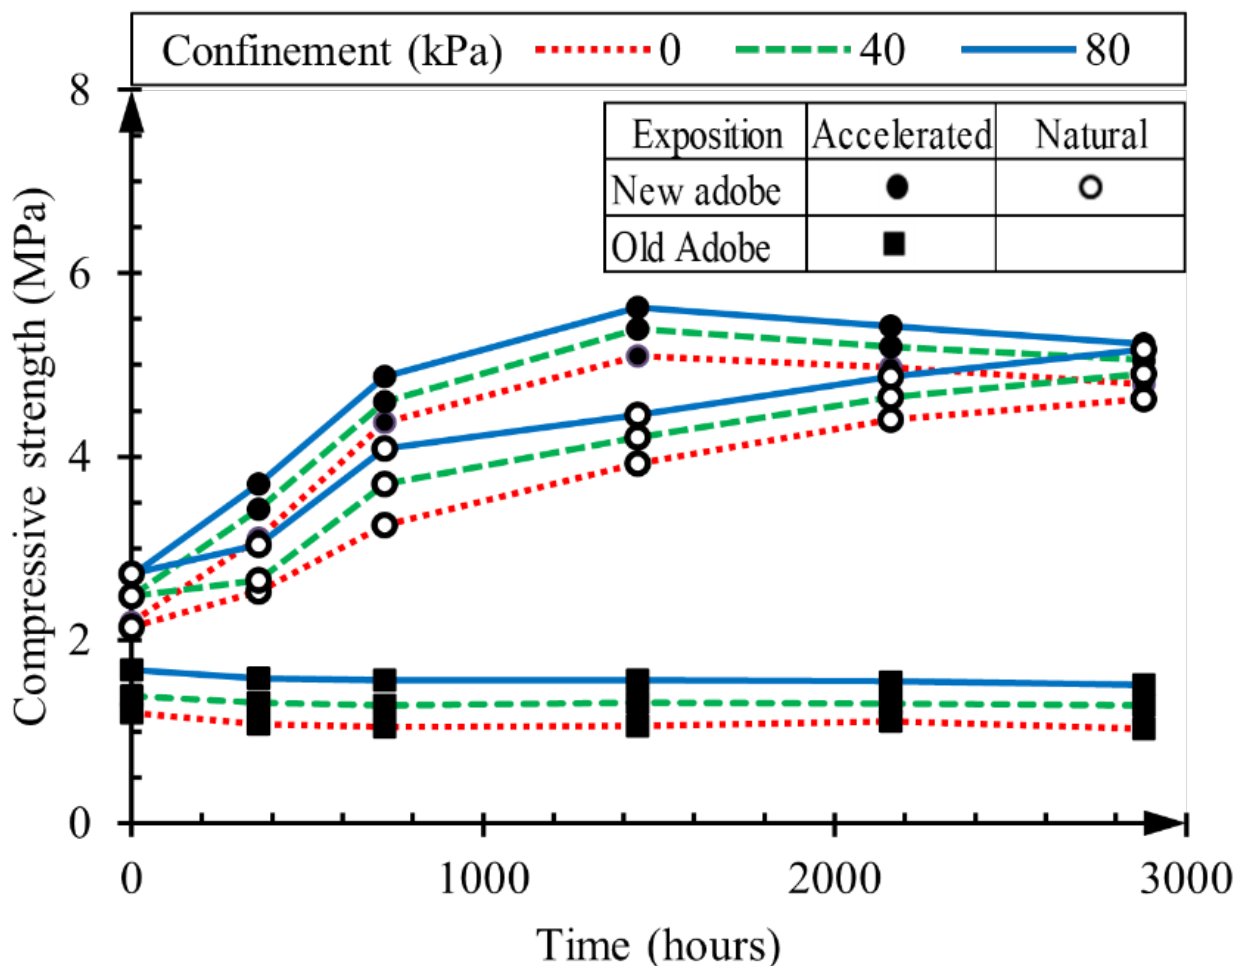
Figure 6  
Unconfined and confined compressive strength of adobe samples.  
Source: Created by the authors

Results of compressive strength from unconfined and confined compression tests appear synthesized in Figure 6. The first characteristic is the difference between the compressive strength at null exposition time: for all the test points, new adobe samples exhibit higher strength than old adobe samples. For instance, the unconfined compressive strength of new adobe was almost twice than the same property for old adobe. The substantial difference between old and new adobe could be a result of long years of direct weathering and absence of maintenance that finally resulted in the ruined conditions in which the rear sector of the chapel was found. The second evident characteristic in Figure 6 is the almost constant behavior of the strength of old adobe along the exposition time. In other words, no further deterioration is observed by additional hours of accelerated ageing for a material that was already exposed to a prolonged time under neglecting conditions. Results of unconfined compressive strength of new adobe found in literature varies

The natural-exposed new adobe gradually increases its strength, since during the period studied, the unconfined compressive strength raised from 2.2MPa up to 4.4 MPa with a rate of strengthening decreasing with time. On the other hand, artificially exposed new adobe showed an initial rapid increase in the strength, followed by a slight reduction of this property. By comparing natural and accelerated exposition curves from new adobe, naturally exposed curves could represent the first stages of accelerated curves, that is, 2880 hours under natural exposition could be reproduced by approximately 720 hours under artificial conditions. This ageing factor of four is approximated and only should be representative of the conditions in which the samples of this new adobe were subjected to ambient conditions. The effect of the confinement is reflected in the three set of samples: the higher the confinement stress, the greater the compressive strength is. Additional compressive strength caused by the applied confinement is practically constant irrespective of the adobe, weathering regime and exposition time.

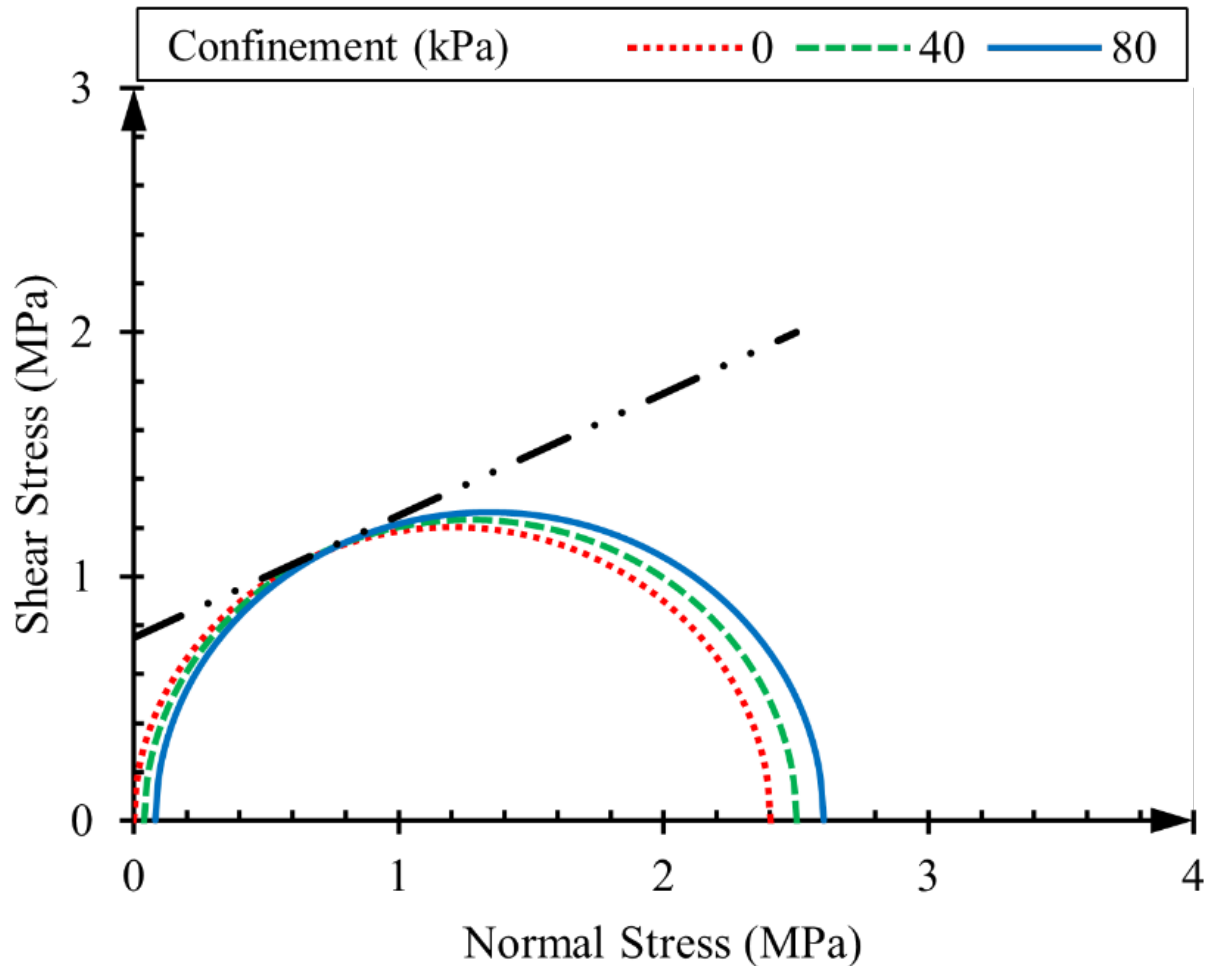
Figure 7

Mohr's circles and failure envelope of new adobe and no exposition to weathering.

Stress states at failure from compression tests were represented by Mohr's circles as can be shown in Figure 7, which includes the failure envelope according to the Mohr-Coulomb failure criterion given by (1). In this criterion,  $\tau_f$  is the shear stress at failure,  $c$  is cohesion,  $\sigma$  is the normal stress to the failure plane, and  $\phi$  is the shear strength angle.

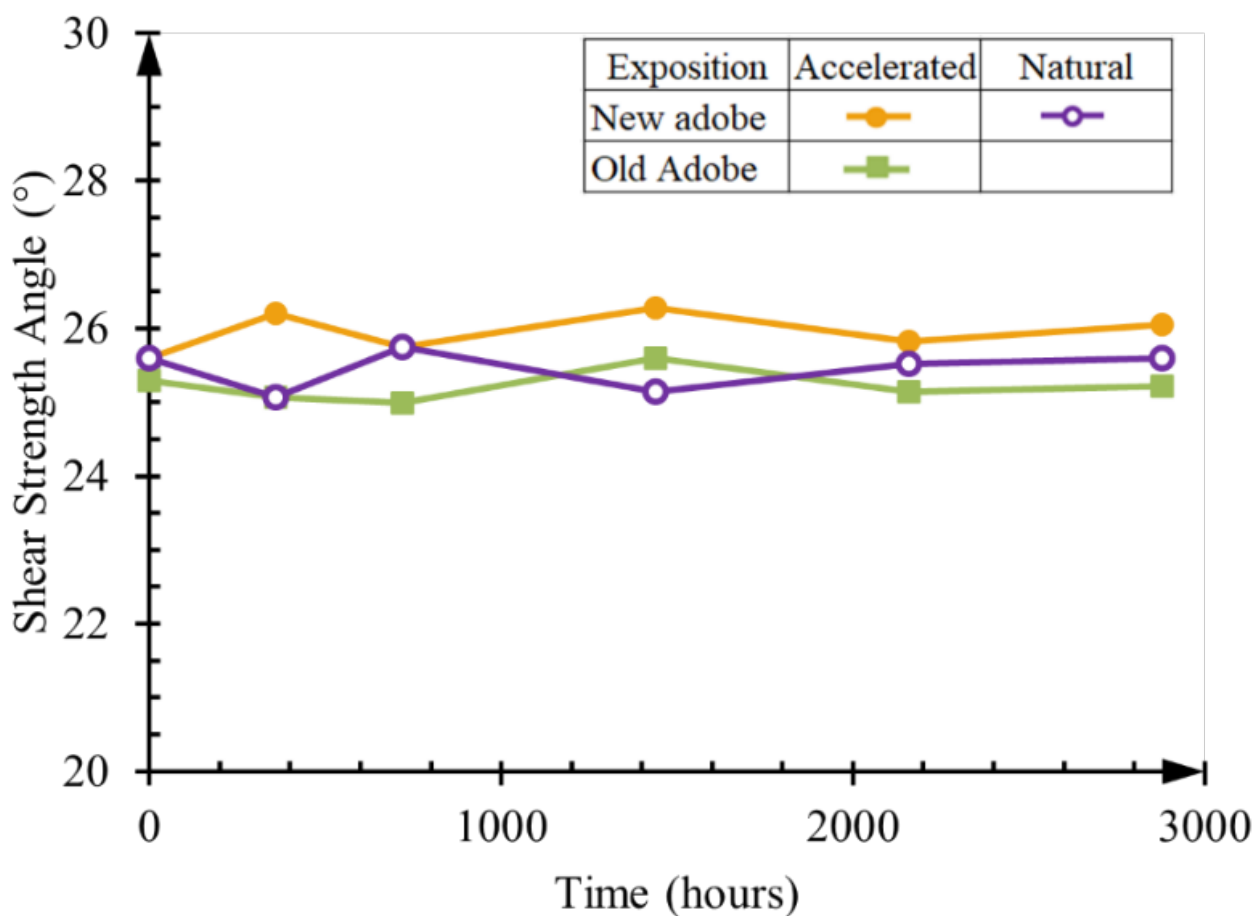
**Figure 8**  
Shear strength angle of adobe samples. Source  
Created by the authors.

Similar graphics for different adobes, exposition period and type of weathering were plotted and estimated the corresponding shear strength parameters,  $\phi$  and  $c$ . Figure 8 presents the comparison of the different shear strength angles. It is evident that this parameter was not affected by the duration of the exposition, neither by natural nor by artificial regime. As a result of the acceleration in the weathering process, new adobe exposed to artificial conditions had a very little increment in the shear strength angle compared with the same adobe but naturally exposed. It is important to realize that old adobe retained the same shear strength angle despite the long and unfavorable conditions of natural weathering. From a practical point of view, the shear strength angle is  $25^\circ$  for old and new adobe, regardless the exposition conditions.

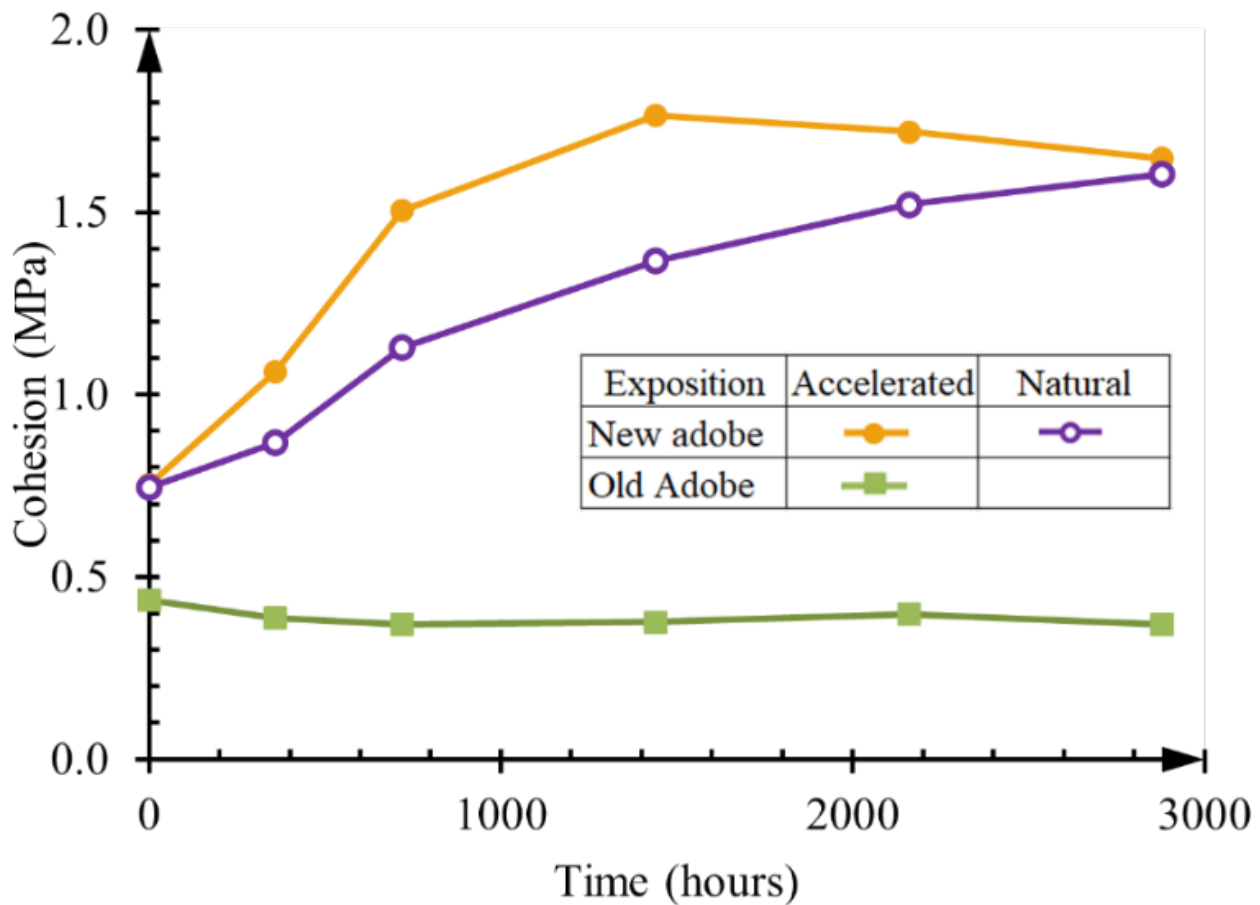
Figure 9.

Cohesion of adobe samples

The patterns observed in the compressive strength analyzed in the preceding section, are reflected in the cohesion parameter (Figure 9). This observation indicates that the growth in the strength is primarily governed by an increase in the cementation of the clay minerals by cause of exposition to natural or artificial ageing. Old adobe is nearly insensitive to accelerated exposition because after approximately 300 years of natural exposition to weathering, almost 3000 hours of additional accelerated exposition are insignificant. Nevertheless, prolonged exposition to ambient conditions without preventive or reconstructive interventions seriously diminished the cohesion of adobe units. Reduction in cohesion values after 1500 hours of accelerated exposition evidenced in new adobe samples could be due to the same mechanism that occasioned the gradual reduction of cohesion in old adobe after many years from its construction until the present.

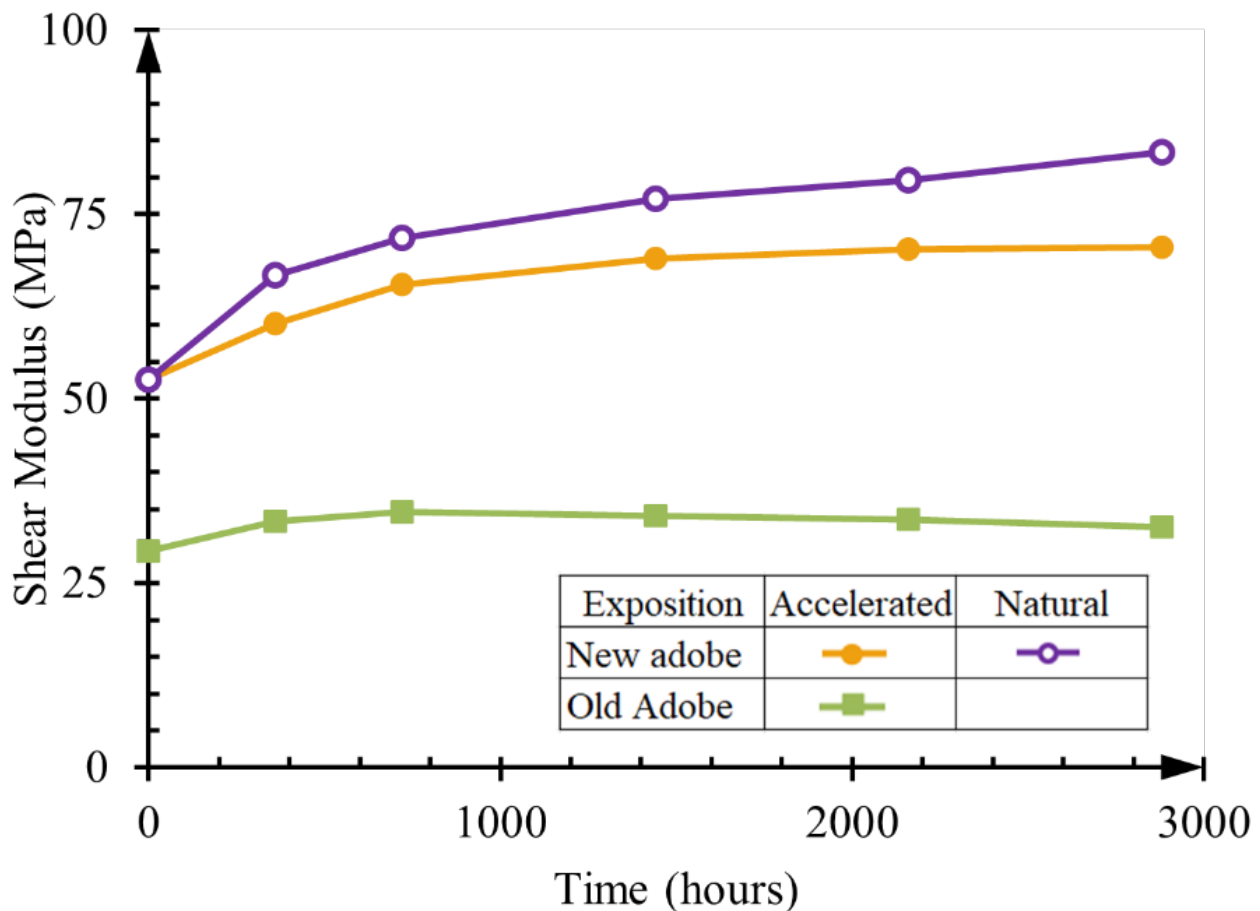
**Figure 10**  
Shear modulus of adobe samples.  
Source: Created by the authors.

The initial slope of the curve shear stress against shear strain is suitable to estimate the shear modulus. Despite the deficiency in the resolution of the sensors regarding the small strain range in which the material is elastic, results presented in this section are useful for comparative purposes. Figure 10 compares the evolution of the shear moduli for the samples studied. As other results presented in previous sections, shear moduli from old adobe are not significantly affected by additional weathering.

Regarding new adobe, naturally exposed samples were stiffer than artificially exposed samples for all the periods of exposure to weathering. This fact could be due to the condensation cycles that allow more flexibility to the material as a consequence of the gain in moisture. New-adobe samples artificially exposed reached a kind of stabilization at the end of the weathering period imposed by the accelerated tester.

Comparing shear moduli of new adobe against old adobe, it is clear the significant difference along the entire period studied. Moreover, the ratio between new-adobe modulus and old-adobe modulus from samples artificially weathered is around two for all the exposition periods. The substantial reduction of the modulus observed in old-adobe samples could be caused by the careless conditions of the structure throughout the last century during which the walls were non-protected with a roof.
