Polymeric fiber reinforced concrete exposed to fire

Dias, D. M.; Calmon, J. L.; Vieira, G. L.

Revista de la Asociación Latinoamericana de Control de Calidad, Patología y Recuperación de la Construcción,
vol. 10, no. 1, 2020

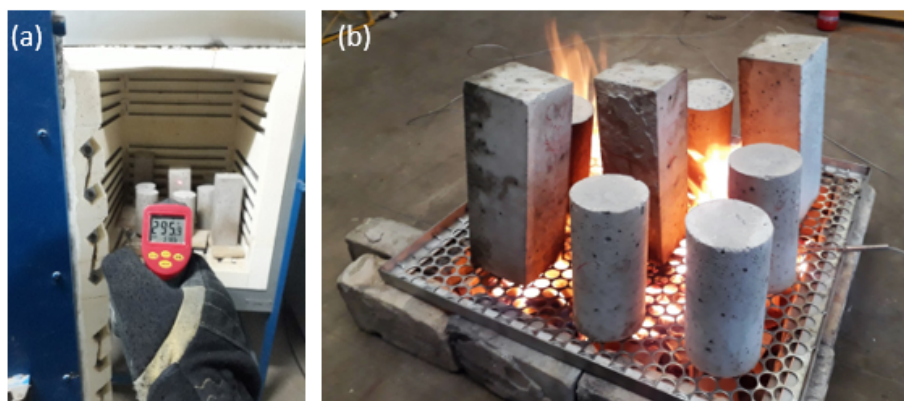
FIG. 1.
Temperature rise through furnace (a) and grill fire test (b).

In order to obtain results that could be compared with furnace heating, direct fire tests were also performed according to ISO 834-R (ISO, 2015). To perform the test, the specimens were placed vertically on a steel grill of dimensions of (500x500) mm in a height of 100mm of the combustible material, leaving space between them to have direct contact with the fire. In the tests with real fire, as found in (Shihada, 2011), the fuel material used was wood. The amount of wood used in each test was calculated based on a standard low-risk fire load of 300 MJ/m² commonly found in apartments in Brazil (CBMES, 2009; São Paulo, 2011; ABNT, 2000), considering the caloric potential of 19 MJ/kg of wood in each burn. To start the burning, alcohol was used. Two K-type thermocouple sensors were placed in the device to gauge the temperature evolution. The Espírito Santo Fire Department – Brazil (CBMES) supported with knowledge and protective equipment in the realization of the real fire test. This test lasted 80 min, which practically coincided with the end of the combustible material, and the cooling was ambient. The furnace test and the fire test can be seen in Fig. 1

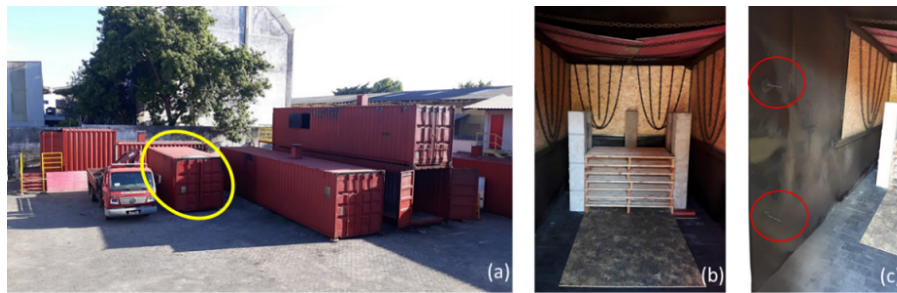
FIG. 2.
Chosen simulator (a), device assembly (b) and sensor arrangement (c).

Aiming to complement the analysis, especially of the spalling, tests were carried out with real fire in the short columns through one of the CBMES's live fire simulators. The chosen module provides extreme fire behavior within the first few minutes of fire. Ventilation was controlled through the front doors. The fire load stipulated was also low risk using plywood and pallets. The arrangement of the fire load and the columns in the simulator can be seen in Fig. 2. The mounting followed firing patterns of the fire brigades and aimed to provide reality in the evolution of fire and uniformity of firing. Type k thermocouple sensors were inserted at 0.8m and 1.6m high in the container to gauge the internal temperature and a sensor was monitoring the external temperature. A firefighter with all the necessary personal protective equipment started this simulation. See Fig. 3 for a sequence of photos of the test run.

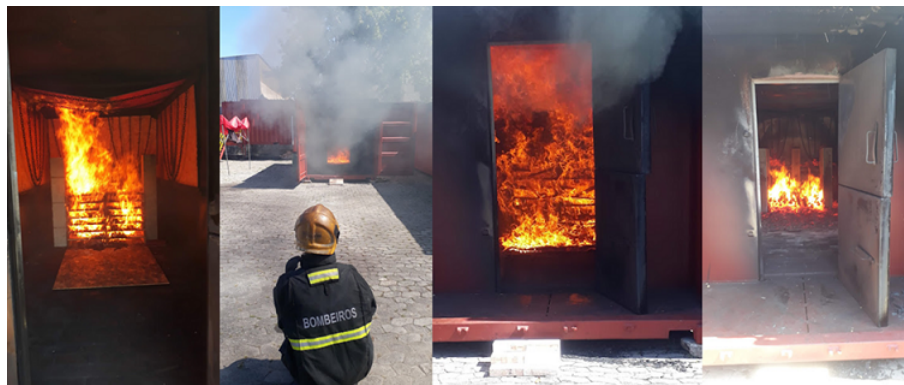
FIG. 3.
Real fire simulation in columns

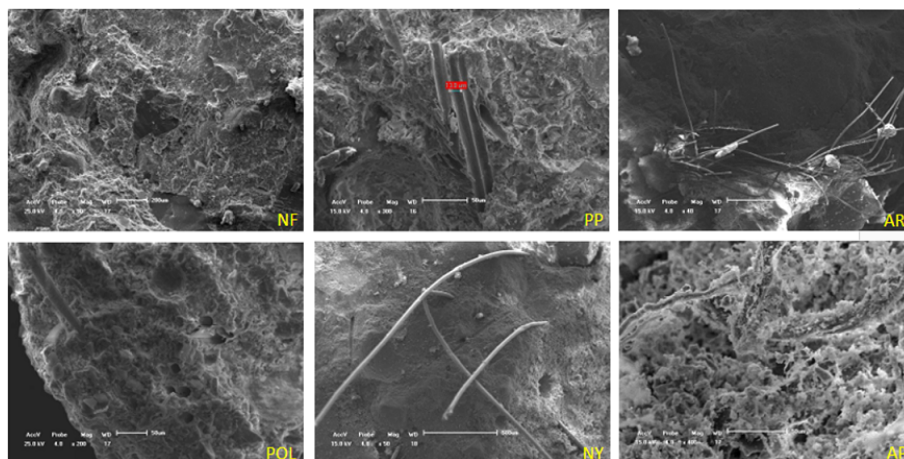
FIG. 4.
SEM of concretes after being subjected to a temperature of 500°C

The Fig. 4 shows the concretes after being subjected to a temperature of 500°C in furnace.

It is observed that PP and POL did not contain more fibers after 500°C, that the AR and AP did not lose the fibers in their totality and in the NY there was the partial fusion of the fibers. The temperature applied was 500°C, but it is worth remembering that the heat in the concrete goes through conduction and that is the reason why some fibers of the inner part of the NY remained and others not, that is, at the analyzed point the internal temperature of the concrete was close to 260°C. The arrows in Fig. 4 show this information.

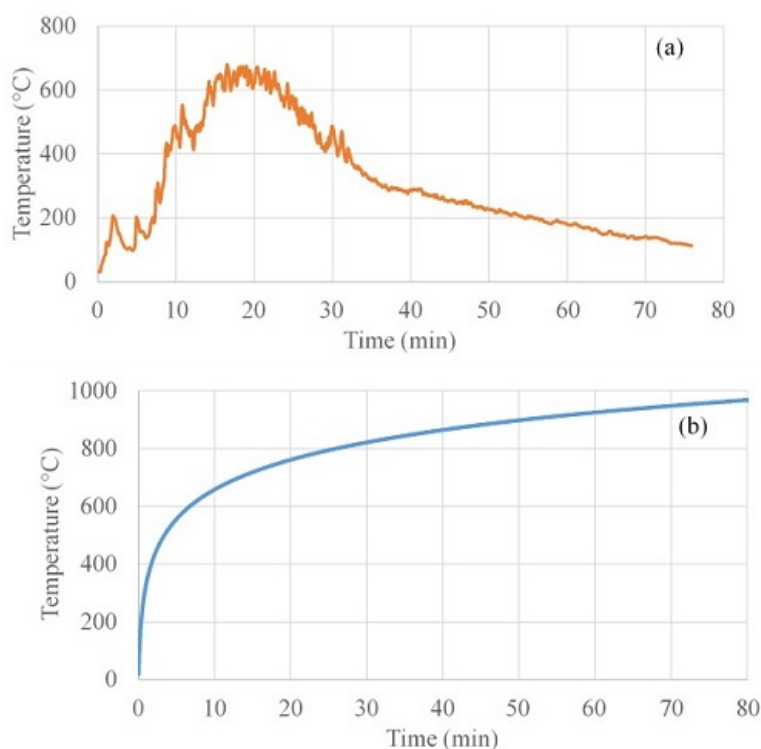
FIG. 5.
Temperature x time in the grill fire test (a) and ISO 834 (b) curve

The type K thermocouple sensors gauged the behavior of real temperature evolution over time in the grill fire test and live fire simulator test. It is observed that the behavior is quite different from the standard ISO 834 curve of an electric furnace. Such a difference can be seen in Fig. 5.

As shown in the graph, in the grill fire test there were the phases of the compartment burning, in other words, the tests showed the ignition point, growth phase, with or without generalized burning, apex and decay due to lack of material fuel. A behavior different from that found in furnace assays. Another divergent point is the heating pattern of the specimen. Heat is passed by conduction to the specimen. In a fire, the fire front most of the time has a pattern. In furnace burning all sides transfer energy equally to the test specimen. In Fig. 6 it is observed in thermograph images how the heat is passed in the two types of tests performed.

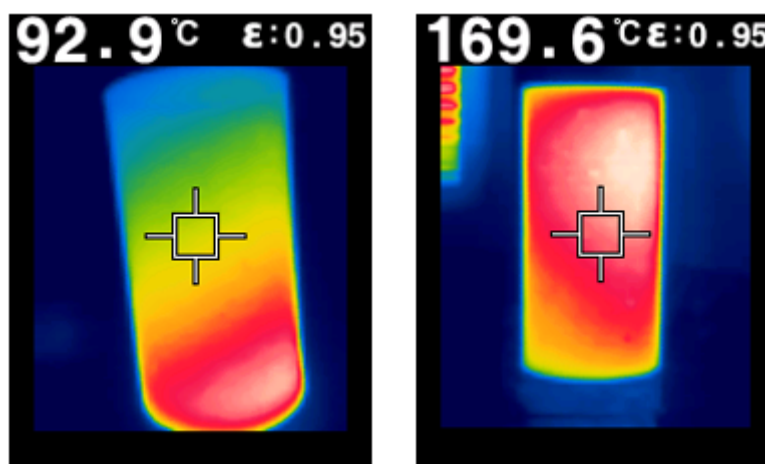
FIG. 6.

Thermographic images of the specimens in cooling phase, immediately after burning on grill fire test (a) and immediately after being subjected to 500°C in furnace (b)

The Fig. 6(a) shows a well-defined temperature gradient, showing hotspots in the lower part of the specimen, where the fire load was concentrated. Already Fig. 6(b) shows that the heating of the specimen is almost uniform, which was expected, the furnace heat on all sides. Most real fires have a definite fire front, i.e. grill fire test was most effective in this aspect.

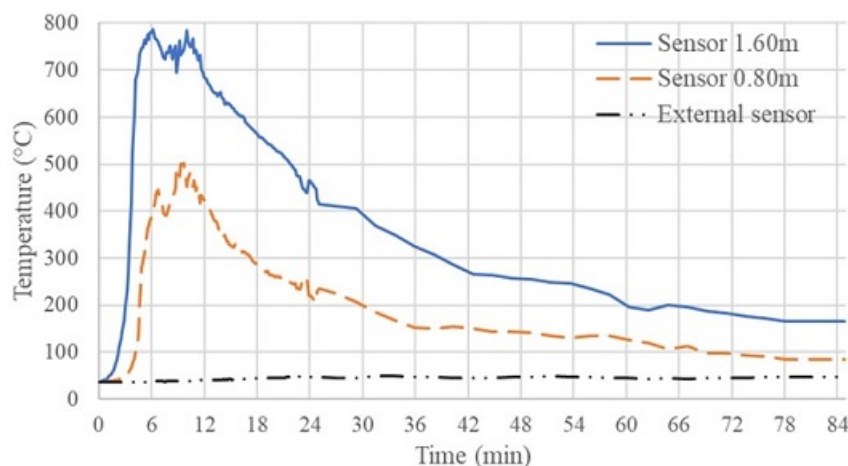
FIG. 9.

Temperature vs time in the live fire simulator for the three sensors.

In the Fig.9 are shown the temperature indices as a function of time of each of the sensors that monitored the fire in the live fire simulator.

The mean temperature in the sensor outside the container was 42°C. It was observed that, in fact, the fire had an extreme behavior in the simulator, since in just 6 minutes after the fire began the temperature in the container reached its maximum range of 786°C in the sensor located at 1.60m.

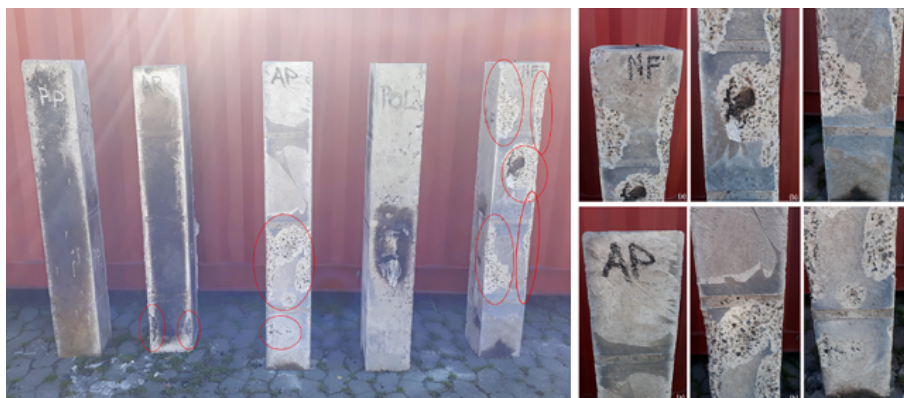
FIG. 10.

Columns after being subjected to the fire and focus in NF and AP post fire, showing the top (a), center (b) and base (c).

After the test and the total cooling of the site, the visual analysis of each column was performed in the following day. Fig. 10 shows the columns side by side. The signs made in the columns show the displacements that happened in some of the concretes.

It was observed that NF exhibited the highest spalling, followed by AP. AR also showed a small spalling at the base. The pillars of PP and POL did not present spalling, that is, the damages were not observed in the visual analysis. These concretes only showed a burning mark from the wood. At least one phase of each pillar showed this soot mark, a very common feature found in fires due to incomplete burning of combustible materials.

Fig. 10 also shows the detail of the most affected pillars. Both surface and edge spalling were observed in NF and AP too. As the main influences, besides the presence of the fiber in the case of PA, can mention the concrete permeability, thermal expansion of the aggregate, presence of steel and heating rate.
