Image analysis on disintegrated concrete at the post-heating stage

Akca, A. H.; Özyurt, N.

Revista de la Asociación Latinoamericana de Control de Calidad, Patología y Recuperación de la Construcción,
vol. 10, no. 2, 2020

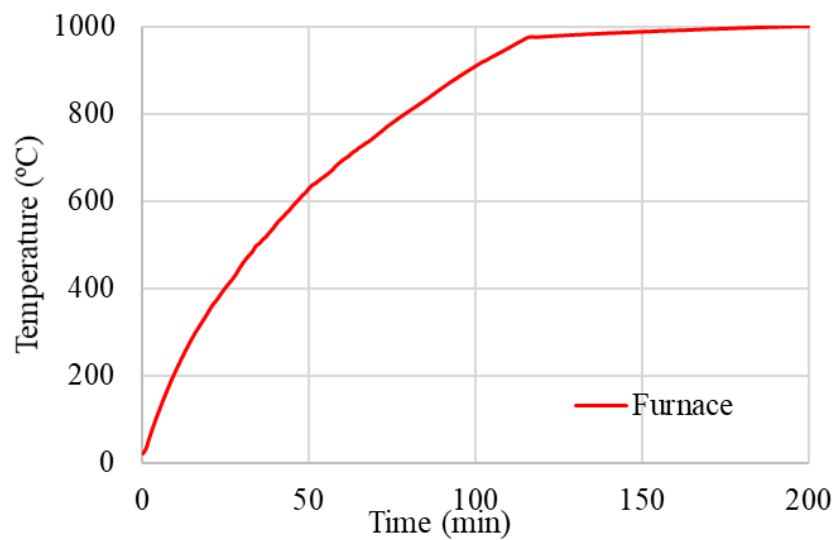
FIGURE 1
Heating procedure.

An electrical furnace which has a 1250 °C maximum operation temperature was used in this study. Two stages of heating were determined and during the first stage, specimens were heated to 1000 °C and during the second stage specimens were kept at this temperature until the end of the total heating time (200 minutes). Figure 1 represents the heating procedure. Electrical furnace was operated at full power and temperature inside the furnace reached 1000 °C in approximately 120 minutes. Since furnace heating capacity was limited, heating rate was 20°C/min at the beginning but the rate decreased to 5 °C/min at the end of the first stage of heating. After the second stage completed, hot concrete specimens were not taken out until the furnace cooled down to 100 °C.

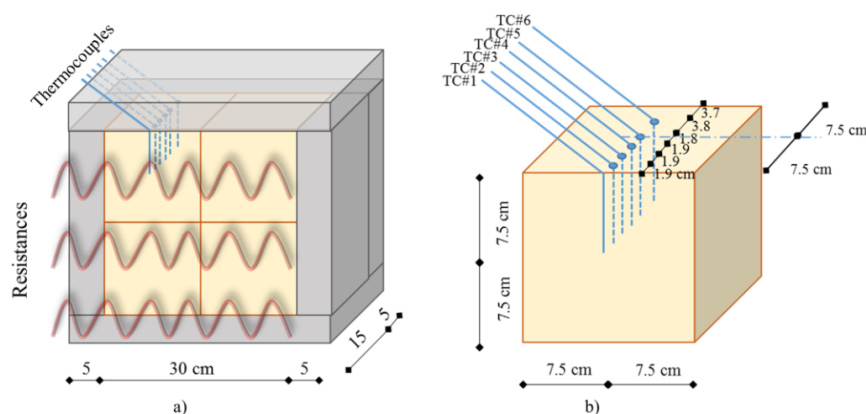
FIGURE 2.
a) Heat insulation of concrete specimens in electrical furnace, b) positions of the K-type thermocouples used to monitor temperature change.

Four concrete cubes were placed together in the electrical furnace and in order to simulate one face heating conditions they were insulated with aerated concrete blocks as shown in Figure 2. For temperature monitoring K-Type thermocouples were placed inside a concrete specimen during heating.

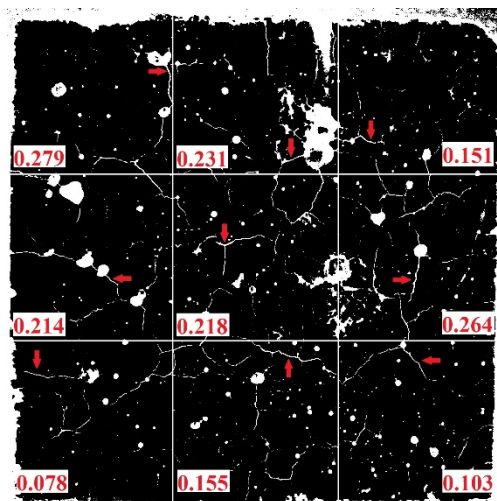
FIGURE 3

Crack width measurements on a C00X specimen (surface just after cooling).

Visual changes on heated or fire exposed concrete give information about maximum temperature experienced and amount of deterioration of concrete (Yüzer et al. 2004; Ingham, 2009). Therefore, photograph of the heated face of a survived specimen from each concrete group was taken by using a DSLR camera. These pictures were analyzed via software called Image J as can be seen in Figure 3. During an analysis the whole picture area was divided into 9 subareas and maximum crack widths of each subarea were measured and then mean crack widths were obtained.

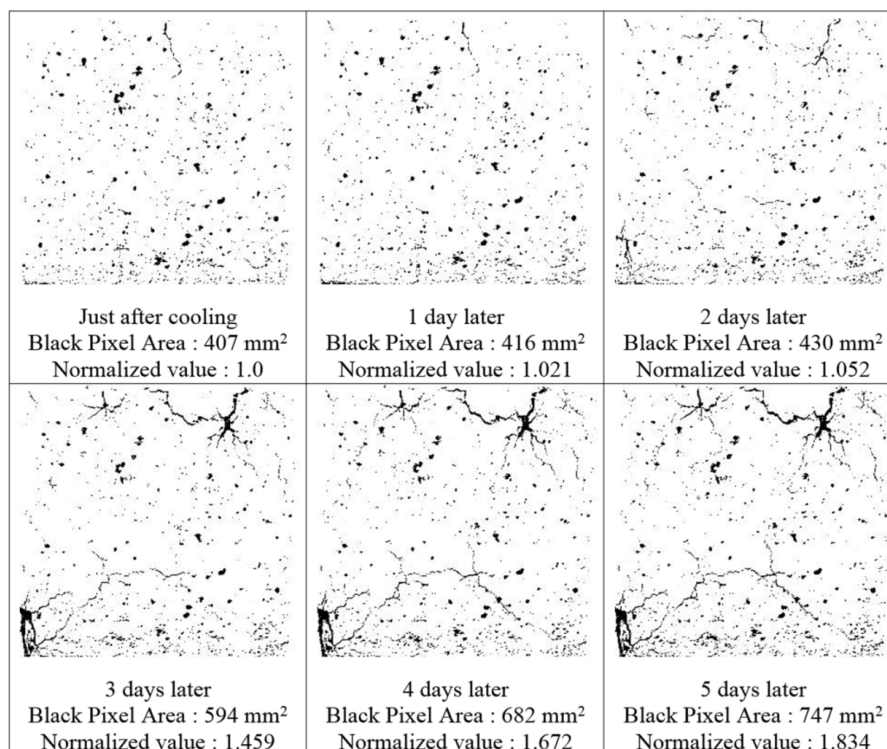
FIGURE 4

Crack growth monitoring on black and white images captured from C0PZ specimen during air re-curing.

Development of cracks during air re-curing was monitored by taking photos of heated surfaces at every hour for a week. A high resolution DSLR camera and a 100 mm macro lens were used in order to obtain detailed images. As can be seen in Figure 4, these images were converted to 8-bit black and white images by using Image J and black pixel analyses (BPA) were conducted on them.

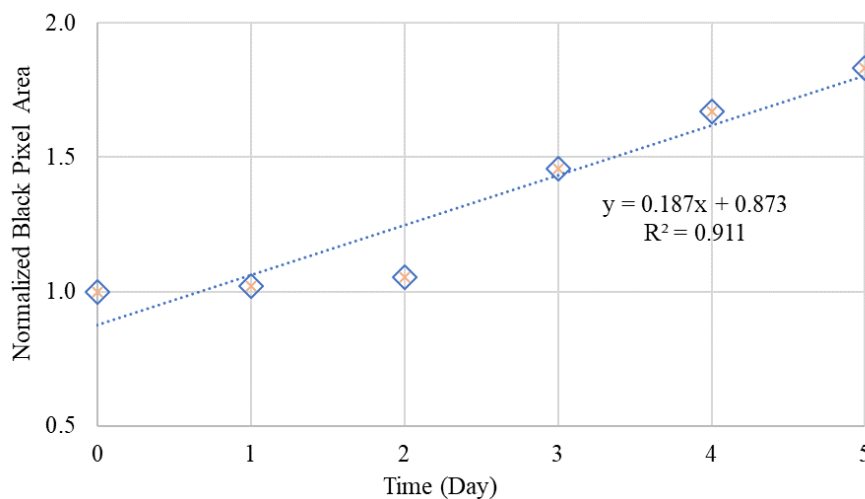
FIGURE 5

Black pixel analysis value of C0PZ specimen.

Black pixels represent cracks, air voids, surface delamination and shadow (due to positions of spotlights) on the heated surfaces of specimens. Total areas of black pixels were calculated for all images separately. Then these calculated values were divided to black pixel area of first image in order to obtain normalized area values. Finally, normalized area-time graphs were drawn for all concrete groups except the groups experienced spalling during heating and trend lines were fitted on the graphs as shown in Figure 5. These curves were used to monitor deterioration of concrete for a week. The slopes of fitted trend lines were called BPA rates and they were compared to compressive strength reduction ratios of air re-cured concrete groups.

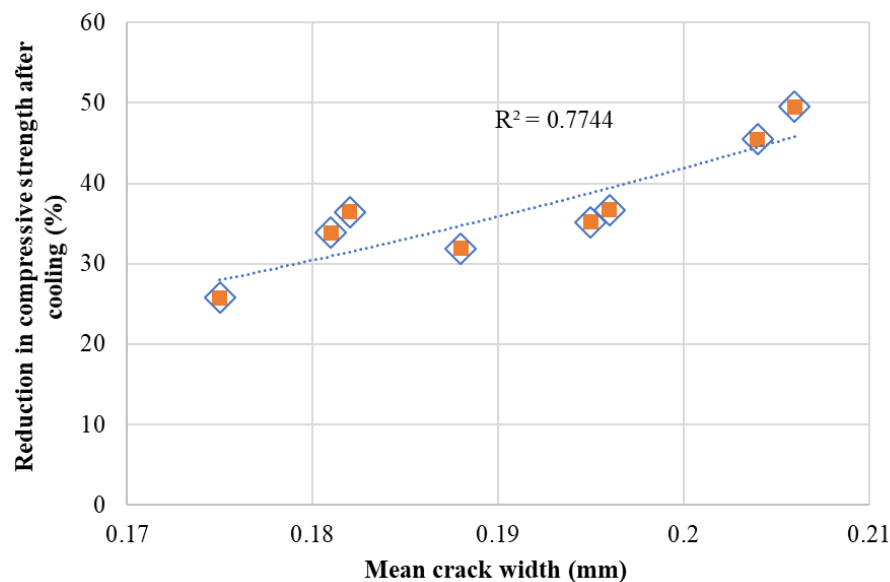
FIGURE 6

Relation between reduction in compressive strength and mean crack width after cooling.

Calculated average crack widths were compared to reduction in compressive strength of specimens after cooling as can be seen in Figure 6. Results showed that increase in average crack width of specimens caused increase in reduction in compressive strength. This relation can be used to predict the extent of the deterioration in residual mechanical properties of concrete elements without applying destructive tests on them after an event of a fire.

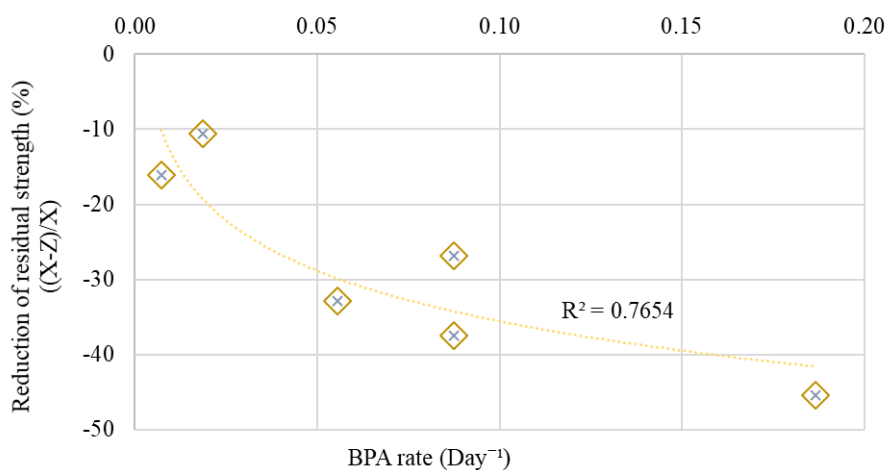
FIGURE 7
Black pixel analyses results.

After comparison a scatter gram was obtained as shown in Figure 7 and it showed that there was a logarithmic relation between changes in compressive strength and BPA rates. Calculated R² value for all set of data was 0.77. This rate can be increased by using advanced photographing techniques, by analyzing in specific software, by increasing sample size etc. For example, air voids on the surface of the specimens influence the total amount of black pixels. If the effect of air voids is somehow eliminated more accurate BPA rates can be obtained.
