Recommendations for rehabilitation and corrosion protection of a 100-year-old steel bridge (Durgadee) across heavily polluted river near Mumbai, India

Revista de la Asociación Latinoamericana de Control de Calidad, Patología y Recuperación de la Construcción, vol. 10, no. 2, 2020

PRESENT SCENARIO OF DURGADEE BRIDGE

DISTRESSES NOTICED IN DURGADEE BRIDGE

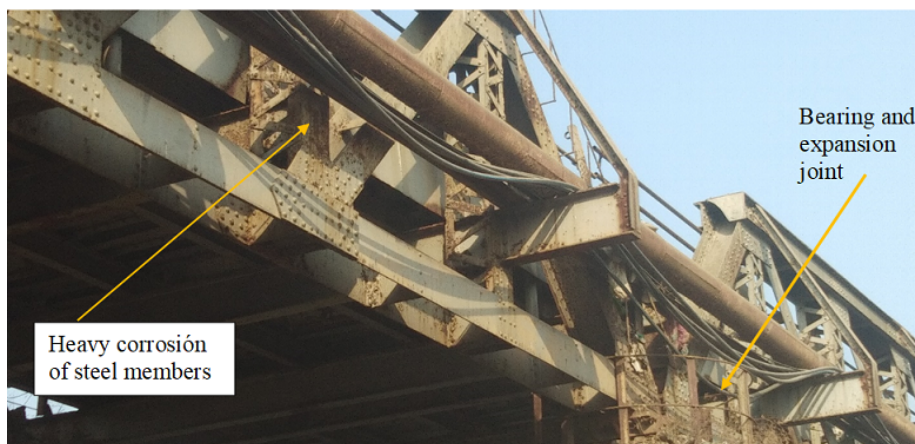
FIGURE 2

Photo of bridge showing bearing and expansion joint location

Suspended or hanging platform will be needed for working below the soffit. Detailed drawings will be prepared for above cases considering site situation and methodology of repair. Ideally floating pontoon with small boat along with winch machine will be very useful for speedy execution of work. Figure 2 is a photo of bridge showing bearing and expansion joint location.

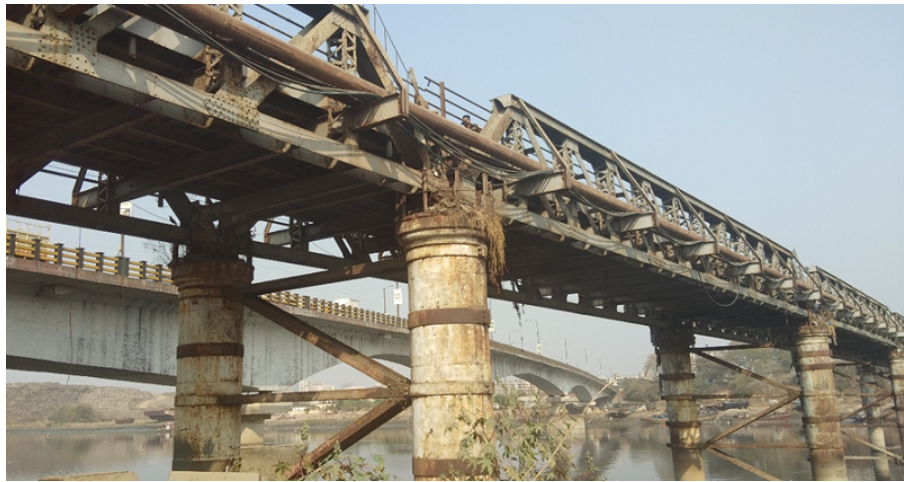
FIGURE 3

Figure 3 is a photo of the bridge showing the warren truss type structure. The work of repairing built-up steel girders by restoring or replacing damaged or deteriorated elements include, but is not limited to, providing temporary supports for jacking; modifying girders to accept jacking loads; temporarily supporting or reducing loads carried by girders; disconnecting or removing elements from girders by removing bolts or rivets; drilling and reaming holes; grinding to provide required finish or tolerances on steel surfaces; making minor repairs to decks within the work area; erecting repaired or replaced elements and incidental items by welding or high tensile strength bolting; and preparing surfaces damaged or left bare by the work and applying a prime coat of paint.

Photo of bridge showing warren truss type structure.
