## Control of reinforcement concrete in pile caps over steel piles – Case study

**Boni, R.; Helene, P.**

Revista de la Asociación Latinoamericana de Control de Calidad, Patología y Recuperación de la Construcción,  
vol. 10, no. 3, 2020

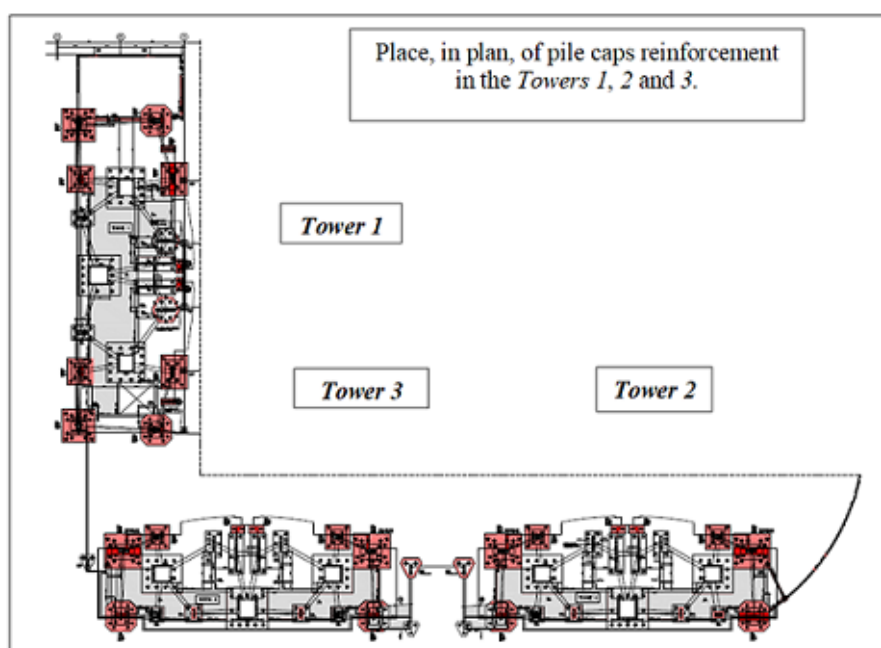
FIGURE 1

Location detail, in plan, of pile caps structural reinforcement in the residential towers.

The structural reinforcement project for the residential tower pile caps was prepared according the recommendations of standard ABNT NBR 6118:2014. This project includes the reinforcement of 20 structural elements, as highlighted in Figures 1 and 2, which presents the structural reinforcements executed in floor plan and in perspective (highlighted in red), respectively.

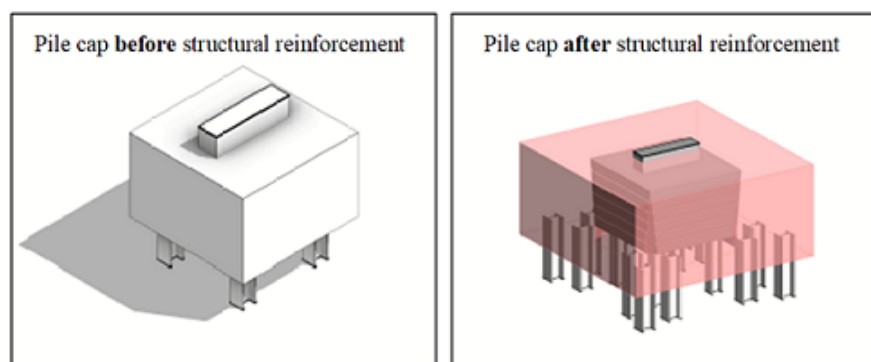
FIGURE 2

Generic detail in perspective from the pile caps structural reinforcement (before and after).

In Figure 2, it is noted that additional steel piles were driven into the periphery of existing piles caps. In total, 152 piles shape W200x86 and W250x115 were spiked, with a workload of 194tf and 258tf, respectively. Execution lengths ranged from 20 to 22 meters deep. The foundation reinforcement project was developed based on the requirements of standard ABNT NBR 6122:2010.

The services started with the driving of steel piles in the regions located around the pile caps to be reinforced, as shown in the perspective of Figure 2. These piles have depths ranging from 20 to 22 m and were spiked by adapted piles, positioned between slabs, as shown in Figure 7.

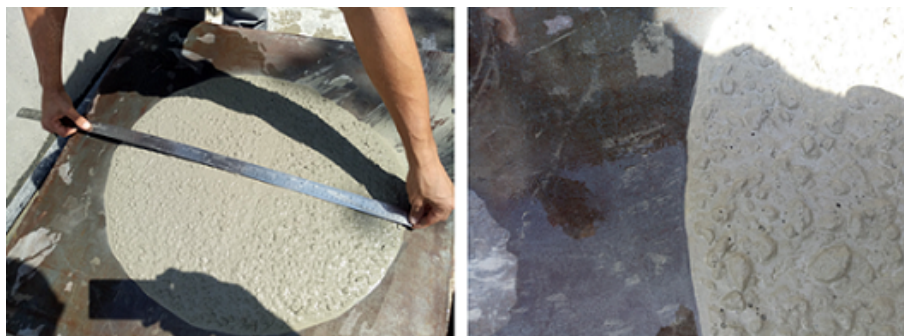
FIGURE 3

Detail of spreading test performed in the laboratory during the dosage study.

The visual aspect of concrete in question can be seen in Figures 3, 4 and 5, which show the spreading tests, passing skill in J ring and passing skill in box L, performed in accordance with standards ABNT NBR 15823-2:2017, ABNT NBR 15823-3:2017 and ABNT NBR 15823-4:2017, respectively. Still, in Figure 3,

it is also possible to observe the visual stability index (IEV) of concrete that was developed especially for the structural reinforcement of pile cap on this project.

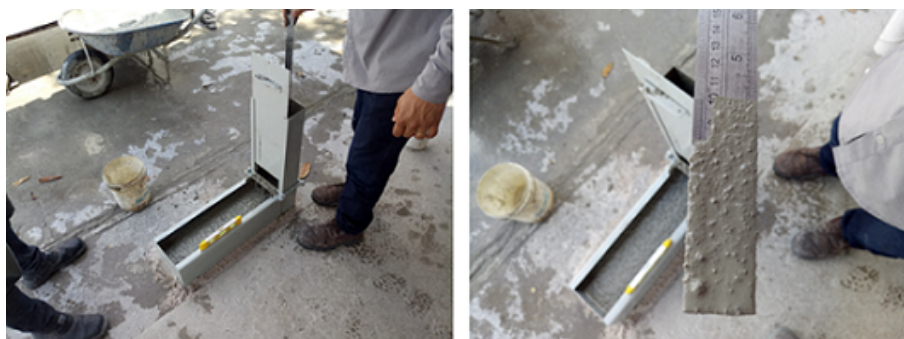
FIGURE 4

Detail of passing skill test through box L, performed in the laboratory during the dosage study.

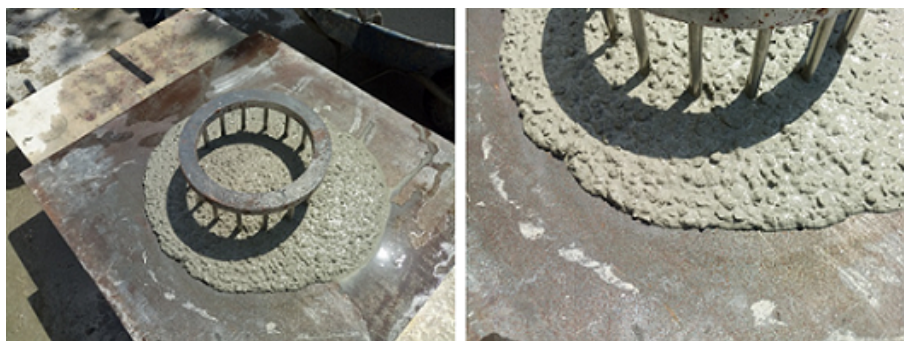
FIGURE 5

Detail of passing skill test through the J ring, performed in the laboratory during the dosage study.

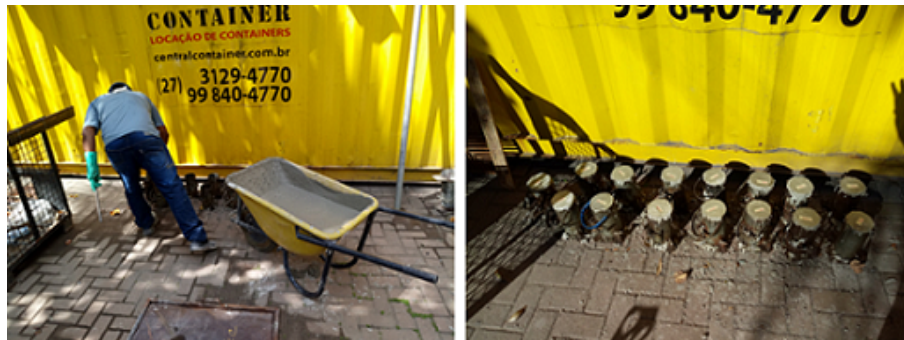
FIGURE 6

At the opportunity of prototype concreting event, cylindrical specimens were also molded for compression strength tests at 3, 7, 14, 28 and 45 days of age and elasticity modulus at 28 days, as shown in Figure 6.

Detail of the molding of cylindrical specimens in the prototype concreting event for tests of resistance to compression and modulus of elasticity.

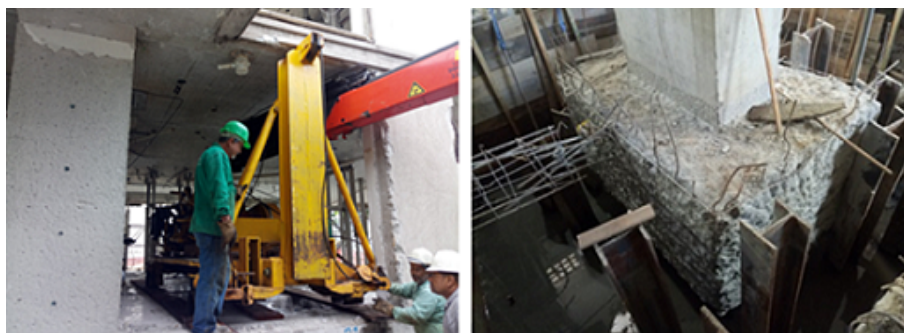
FIGURE 8

In this way the metal segments piles were spiked and immediately welded to the subsequent segments, as the services progressed. Figure 8 illustrates the execution of services and the piles spiked in the periphery of one of pile caps. In the latter case, for better visualization, the image registration made after excavating the pile cap surroundings.

Detail of execution of spiking services (on the left) and of steel piles spiked around the pile cap to be reinforced (on the right).

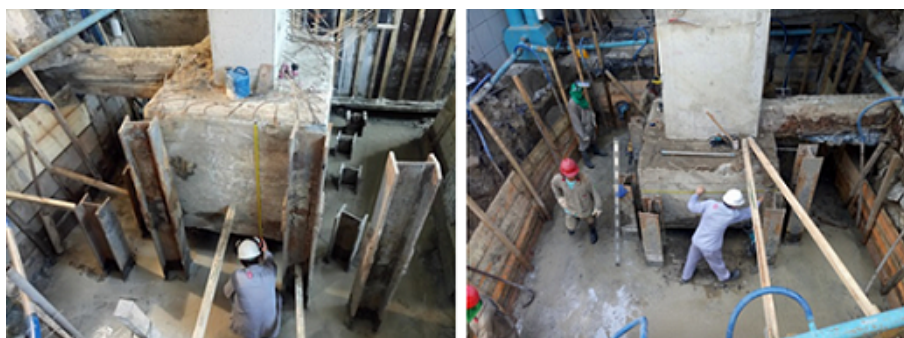
FIGURE 9

In the sequence, the thin concrete coverage with 5 cm thickness was executed, as well measure of dimensions of existing piles caps, through the topography, possible eccentricities of existing piles (under load), as shown in Figure 9.

Detail of measurement dimensions of existing pile cap and of the steel piles, after excavation and execution of thin concrete.

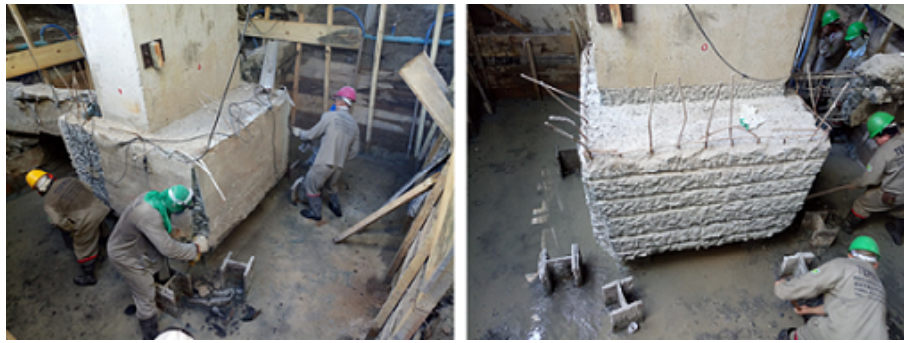
FIGURE 10

After this stage, the services of cutting the piles began, whose top should be 35 cm above the lower level of reinforcement pile cap, and preparation of lateral surfaces of pile cap, as shown in Figure 10. In this stage, chamfers and ridges were made in the edges and lateral surfaces of pile caps, in addition to chipping of all faces, except the lower one, according to structural design requirements.

Detail of execution of chamfers and ridges in the edges and lateral surfaces of pile cap.

The execution of chamfers and ridges on the sides of existing blocks were essential and very important, since they aimed to guarantee the quality of concreting joint in the old concrete/new concrete interface (to be launched) and to collaborate in the transmission of efforts. The execution of chamfers on the lateral edges provided a cone-like geometry (or stopper) that dispensed the verification of adherence between the existing block and structural reinforcement.

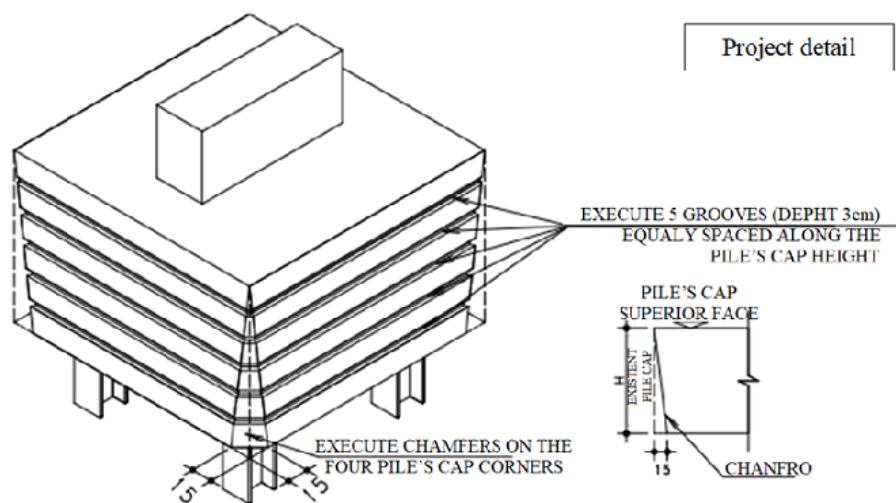
FIGURE 11

It is recorded that the ridges were made 3 cm deep along all the lateral surfaces and the chamfers of lateral edges with dimensions varying from 0 cm (on the upper face) to 15 cm (on the lower face of pile cap), as evidenced in Figure 11.

Detail of project indicating positioning of ridges and chamfers.

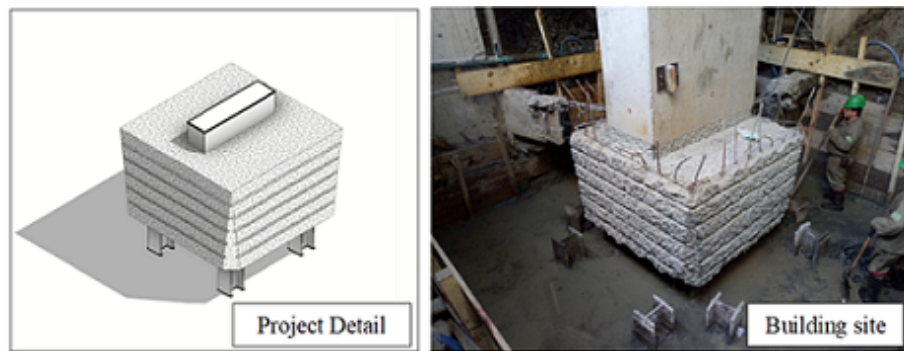
FIGURE 12

The Figure 12 shows the pile cap after the completion of concrete surface treatment services.

Detail of the surface treatment of pile cap. Detail of the project (left) and the situation “building site” (right).

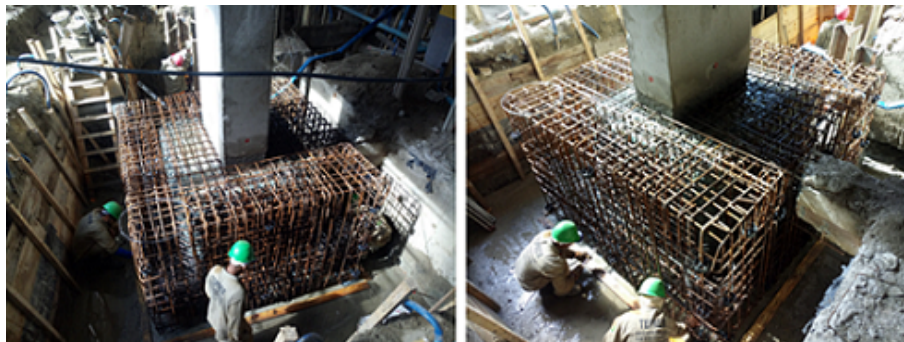
FIGURE 13

It is recorded that that the steel bars used in the structural reinforcement of pile caps (gauges 25 mm, 20 mm, 16 mm and 12,5 mm) were delivered to the work cut/folded and properly identified. Figure 13 shows the execution of reinforcement frame services for the pile caps.

Detail of execution of reinforcement frame services of pile caps.

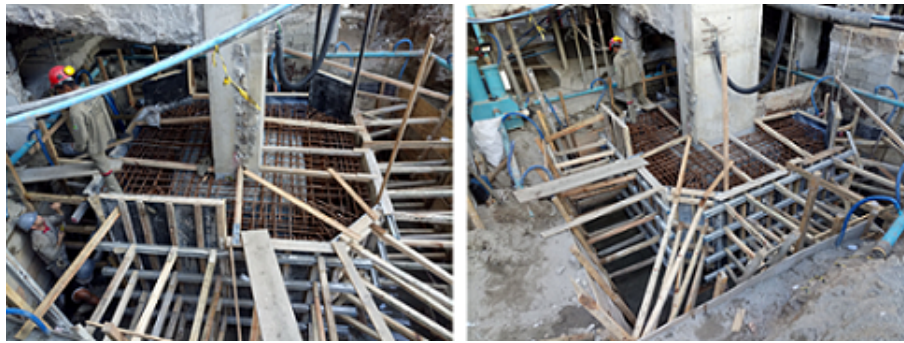
FIGURE 14

Upon verification of frame and release by the engineering staff, initiated the assembling the wooden forms and shoring, as shown in Figure 14. All of these services were also monitored and checked for flatness, plumbs, dimensions, locking system and water tightness.

Detail of the formwork of structural reinforcement pile caps.

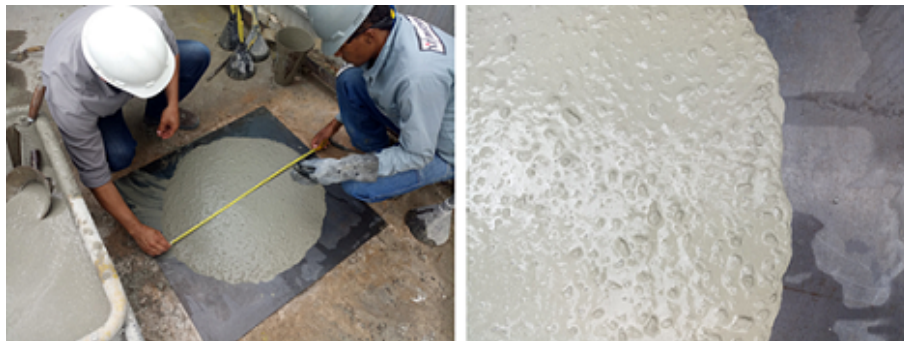
FIGURE 15

Finishing the structural reinforcement services, the concreting of reinforcement structural element was carried out, through the use of self-compacting, pumped concrete, as detailed in item 2 “*Basic Data of Reinforcement and Concrete Design*” of this paper. Figure 15 shows the visual aspect of concrete observed in the field.

Visual aspect of self-compacting concrete used to reinforce structural pile caps.

At this stage, it was indispensable that the concrete was cast at a low speed to avoid trapping air on the lower surface of pile cap, thus avoiding possible hidden concrete failures. In order to avoid non-conformities of this nature, the concrete from the lower portion of pile cap was launched slowly, on only one side of pile cap, and moderately vibrated with immersion vibrators with a diameter needle of 40 mm.

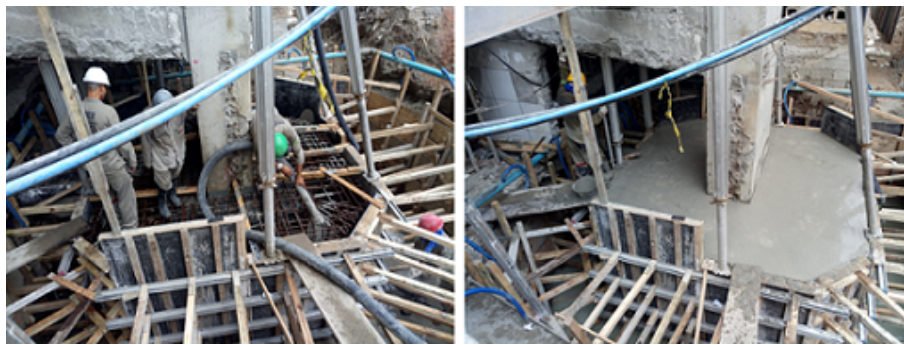
FIGURE 16

The Figure 16 shows the concreting event of reinforcement of one pile cap, performed with self-compacting concrete, respecting the premises mentioned in the previous paragraph.

Detail of the concreting of reinforcement of pile cap, made with self-compacting concrete.

It is important to note that the treated surface of existing pile cap, the region of interface with the new concrete, was previously cleaned with a pressurized water jet, in order to remove all dust, powdery material or any other type of contaminant. The self-compacting concrete was cast on a clean surface in a dry saturated condition.

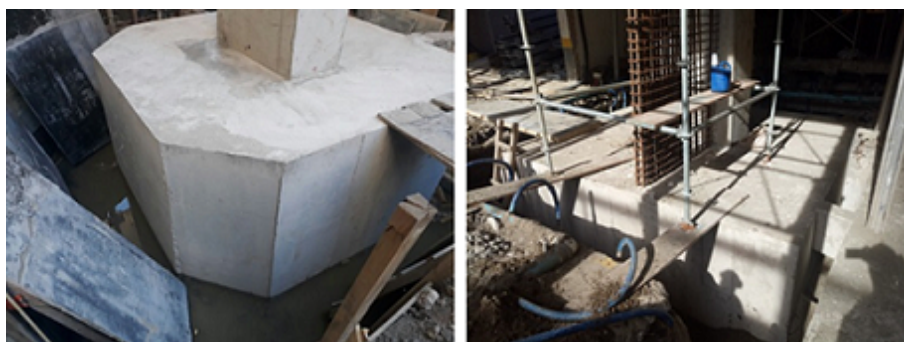
FIGURE 17

Figure 17 shows the visual aspect and the surface finish of concrete in the hardened state applied in the reinforcement of pile caps.

Detail of the visual aspect and the surface finish of concrete of reinforced pile caps.

Subsequently, after removing the formwork, thorough inspections were carried out on all surfaces of reinforcement performed and in the regions of new concrete/old concrete interface. It is registered that no type of non-conformity was found related to concreting failure, fissures etc.

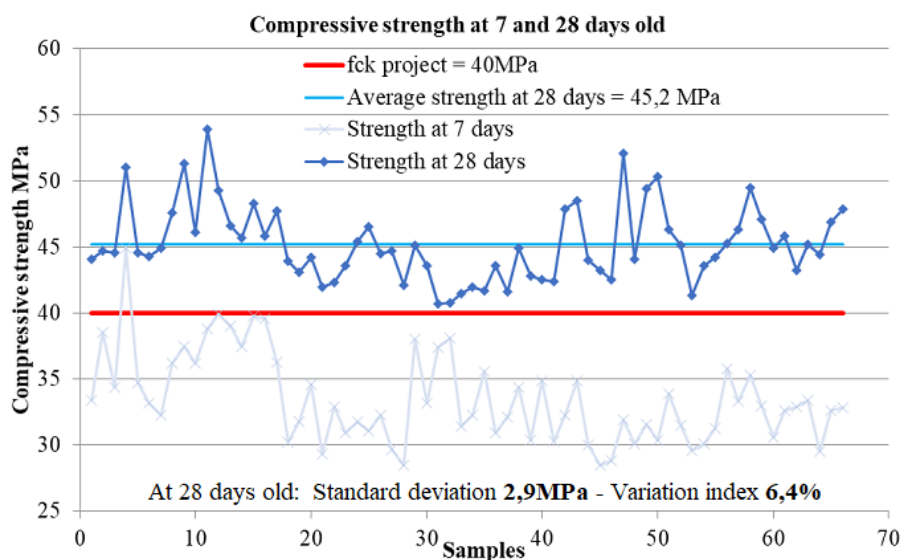
Regarding the technological control of concrete applied in the structural reinforcement of pile caps on residential towers, Figure 18 graphically presents the results of concrete compressive strength at 7 and 28 days of age of 66 concrete mixer trucks (100% sampling), in the form of chart

As can be seen, the average resistance obtained was 45,2MPa, standard deviation of 2,9 MPa, coefficient of variation equal to 6,4% and with extreme values ranging from 40,7 MPa (minimum) to 53,9 MPa (maximum). Considering the resistance specified in the project, it is registered that all results are in compliance.

FIGURE 18  
Concrete individual chart of values fck 40MPa, self-compacting used in the structural reinforcement of pile caps.
