## Critical beaches due to coastal erosion in the Caribbean south of Costa Rica, during the period 2005-2016

Revista Geográfica de América Central, vol. 1, no. 64, 2020

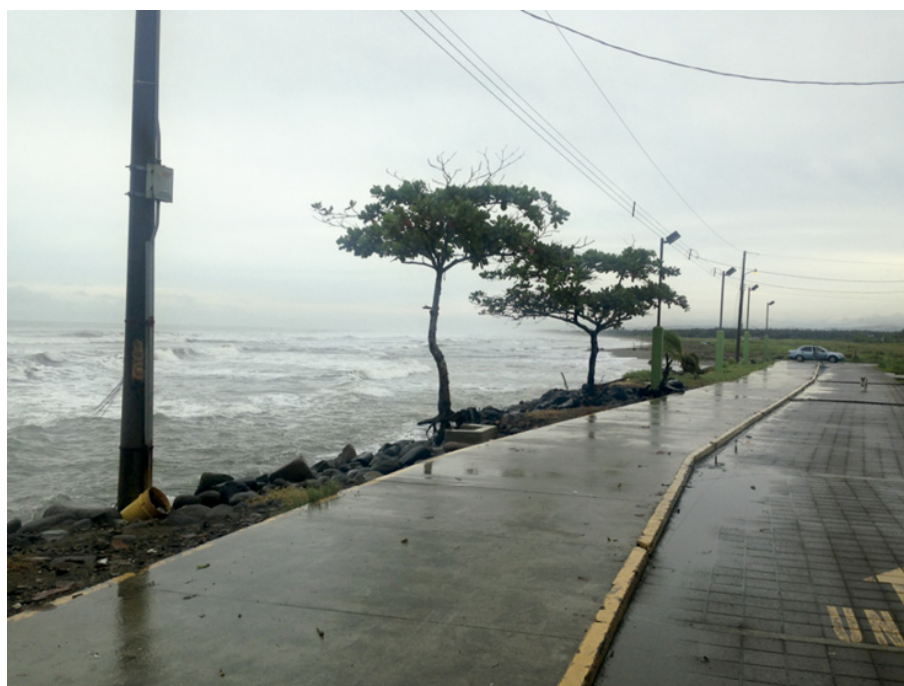
Figure 4. Placement of rocks for public infrastructure protection in Cieneguita Beach.

FIGURE 4.  
Placement of rocks for public infrastructure protection in Cieneguita Beach.  
Source: Photograph by G. Barrantes, 2017.

The sector between the jetty and the airport runway is considered an erosion hotspot registering a retreat rate of 1,430 m<sup>2</sup>/year for the 2005-2010 period and 3,936 m<sup>2</sup>/year for 2010-2016. According to these data, the retreat rate almost tripled in the second period (Figure 3.a). The above points to an apparent erosion process indeed confirmed by field inspection, during which it was also evidenced the resulting deterioration of public infrastructure and the ongoing maintenance works to contain further downgrade by placement of stones and wire meshing (Figures 4 and 5).

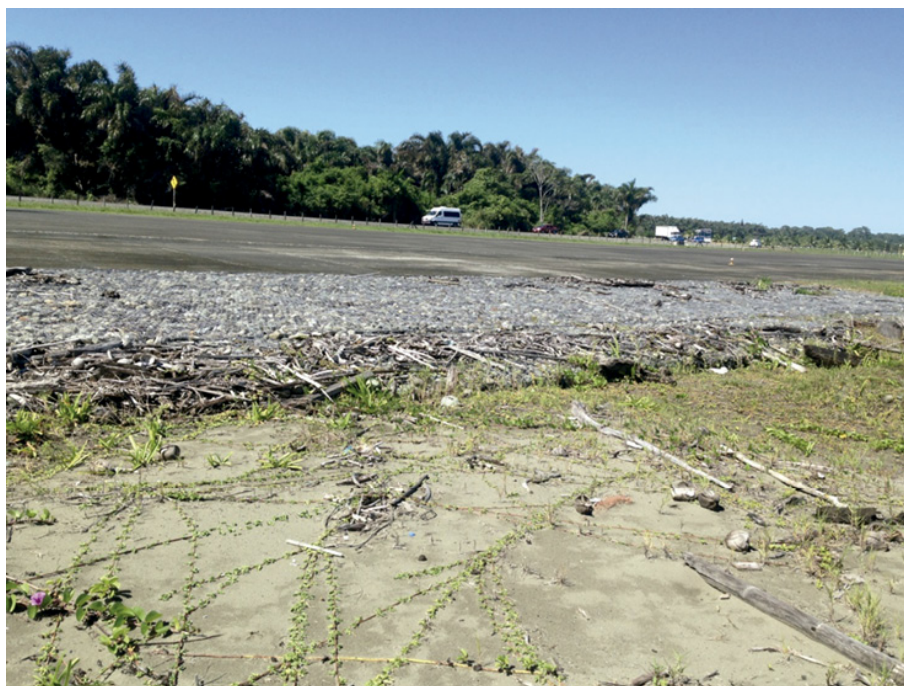
Another erosion hotspot is near the airport (Figure 3.b). For the period 2005-2010, the erosion rate of this sector was 8,801 m<sup>2</sup>/year and, for the period 2010-2016, it decreased to 1,599 m<sup>2</sup>/year. To the south of the airport there is a wetland characterized by the presence of small elongated lakes interconnected by channels that drain before reaching the town of Westfalia, thus suggesting an alteration of part of the Cieneguita wetland. The erosion of the beach has affected the asphalt layer of the runway; for its protection, rock and wire mesh covering has been installed (Figure 6).

FIGURE 6  
Stone and wire mesh covering on one side of the airport  
runway where erosion has made necessary such repair works

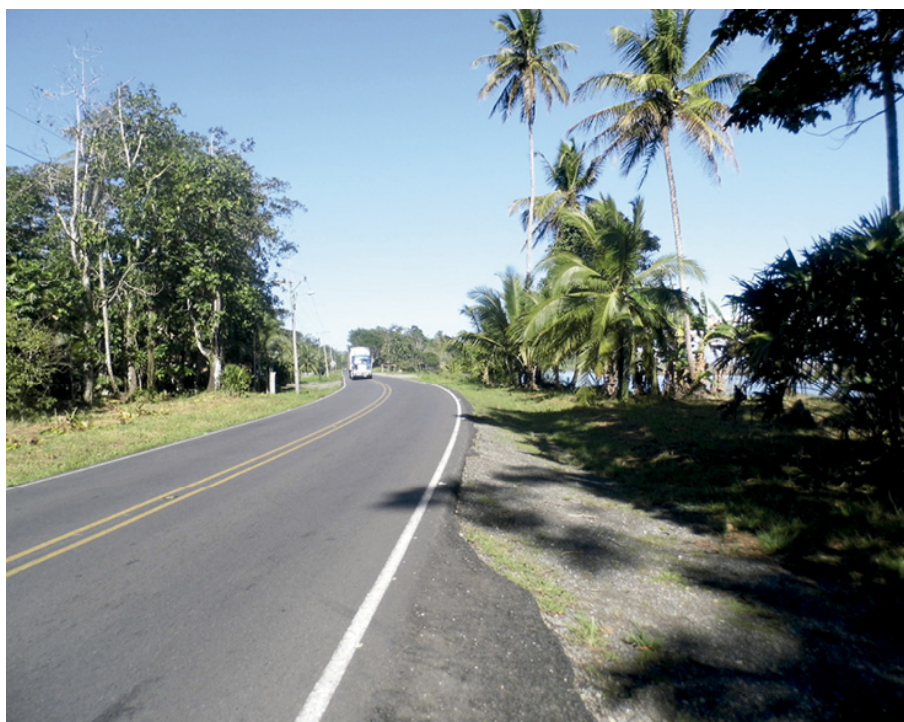
Another critical point of erosion was located at the mouth of the Bananito River (Figure 7.a) where, as in the previous cases, it is related to the migration of the river course. In this case, the proximity of the shoreline with the road threatens the integrity of the main road that gives access to the rest of the region (figure 9). The

erosion rate at this point is 2,817 m<sup>2</sup>/year in the period 2005-2010 and 2,793 m<sup>2</sup>/year between 2010-2016, which indicates that the rate remains similar between the two periods.

FIGURA 9  
Proximity of the road with the beach erosion zone  
Source: Photograph by G. Barrantes, 2017.
