Duarte-Poveda, Gloria I; Valera-Rosales, Martin M;
Manrique-Rojas, Miguel; Mateus-Barragán, Miguel
EVALUATION AND IMPLEMENTATION OF HIGH DENSITY POLYETHYLENE LINER:
ALTERNATIVE OF SOLUTION TO CORROSION-WEAR PROBLEMS IN FLOWLINES

CT&F - Ciencia, Tecnología y Futuro, vol. 9, no. 1, 2019, pp. 65-72
Instituto Colombiano del Petróleo (ICP) - ECOPETROL S.A.

EVALUATION AND IMPLEMENTATION OF HIGH DENSITY POLYETHYLENE LINER: ALTERNATIVE OF SOLUTION TO CORROSION-WEAR PROBLEMS IN FLOWLINES

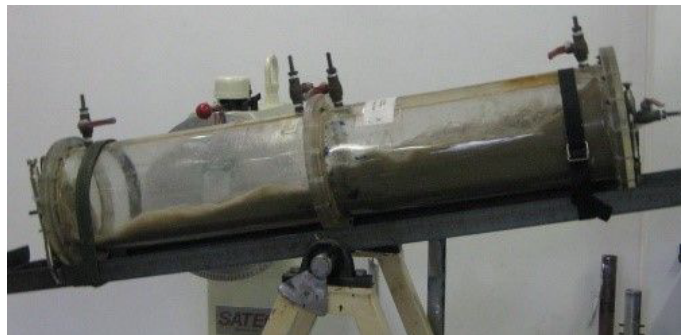
Figure 1. Experimental set-up to validate wear effect and flow pattern in abrasive wear test

Preliminary tests were performed out in acrylic pipeline section taking as reference the Darmstadt test [10], as shown in the experimental set-up in **Figure 1**, to validate the flow pattern evidenced in the production lines type slug, the abrasive wear effect on the inner surface of the pipelines due to contact forces of the sand particles, and to adjust the sand content required for the abrasion tests according to geometrical dimensions of the HDPE and carbon steel sections.

The simulated behavior of abrasion preliminary tests in acrylic pipeline enabled the adjustment of the pattern flow and the differences in geometrical dimensions between the HDPE and carbon steel pipe sections, modifying the content of sand in abrasive slurry. Thus, the sand content in the HDPE and carbon steel sections amounted to 1.4 and 1.6 kg, respectively.

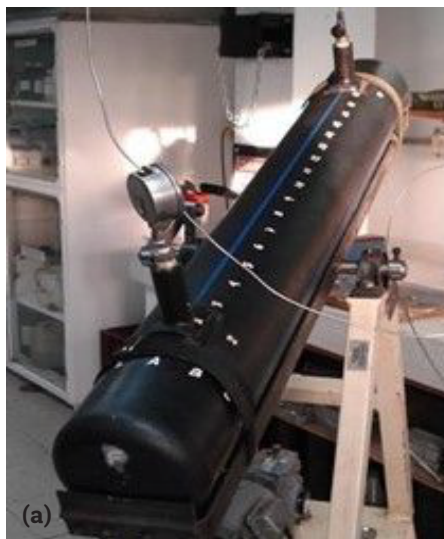
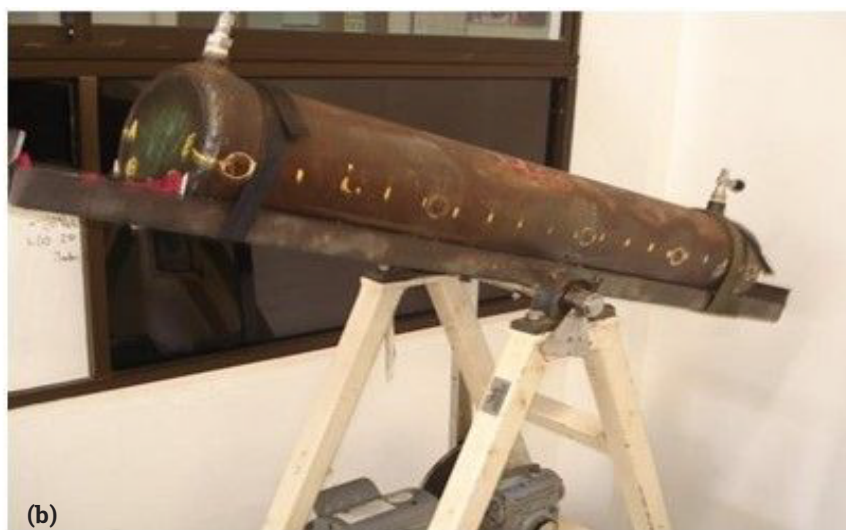
Figure 2. Experimental set-up to abrasive wear and corrosion tests (a) HDPE pipeline section (b) carbon steel pipeline section

For abrasion and corrosion tests, pipeline sections (HDPE and carbon steel) are filled with the abrasive slurry and saturated with CO₂ (g) to 0.55 MPa (80 psi), a pressure value higher than pressure in Casabe's collector lines of 0.41 MPa (60 psi), to evaluate the gas permeation and the pressure drop during the test time. For simulation of the abrasive wear effect on the pipeline sections of HDPE and carbon steel sealed at the ends, these materials were exposed to an alternating movement in longitudinal direction with a calculated angle of 22.5° during 900.000 cycles, a frequency of thirty cycles per minute, and flow rate of 1 m/s. The experimental set-up of abrasion and corrosion tests is shown in **Figure 2**.

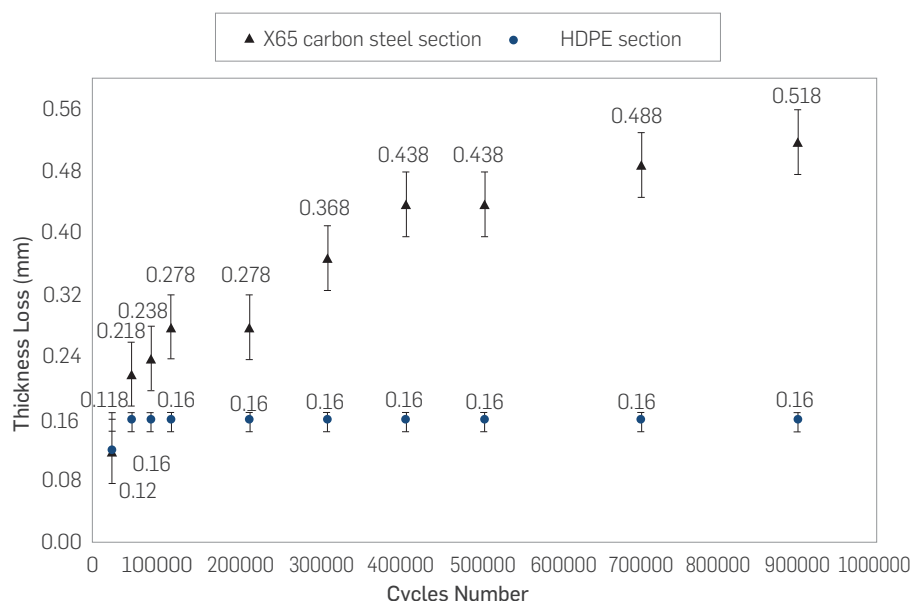
Figure 3. Abrasion-corrosion resistance in function of thickness loss in HDPE and carbon steel pipeline sections

The wear rates due to abrasion-corrosion phenomena using a characteristic simulated fluid of the Casabe field, measured in terms of loss of wall thickness after 900.000 cycles in X65 carbon steel and HDPE pipe line sections at environmental temperature, are shown in **Figure 3**.

As seen in **Figure 3**, in test conditions, the minimal wall thickness loss in HDPE pipeline section remains constant during the 900.000 cycles, with a value of 0.16 (-0.02) mm, in contrast to that observed in the carbon steel pipe section, which presents a thickness loss with an increasing trend of up to 0.52 ± 0.05 mm using the same number of cycles. These results suggest a wall thickness loss 3.2 times greater in the carbon steel and a higher abrasive wear resistance in the HDPE pipeline section as compared with the carbon steel pipeline. Therefore, the abrasive wear increases in the carbon steel during the exposure time, while it remains constant in the HDPE.

Thickness loss under the evaluated conditions demonstrates the abrasive and corrosive effect of the test fluid on the internal surface of the carbon steel section. As it is also observed in **Figure 3**, the thickness loss is 0.44 mm in a 10-day period, assuming a linear behavior. It is possible to estimate in the carbon steel a total thickness loss at 6-o'clock position over a 6-month period. This result is in agreement with the performance evidenced in the collector lines of Casabe's field, where in a period ranging between 6 and 9 months, the carbon steel pipeline presents failure and fluid leakage at 6-o'clock position, **Figure 4b**, as a result of the combination of abrasive wear and corrosion. It is a fact that these failure mechanism significantly reduces the lifetime due to the higher rate of material loss [20].

On the other hand, the resistance of HDPE section to combined damage mechanisms of abrasion and CO₂ corrosion is evident, with a very slight thickness loss at the beginning test, which continued constant until complete total number of cycles. The slight abrasive wear would be caused, among other factors, by effect of shear stress of biphasic fluid (brine + sand production) and internal pressure in pipeline section.

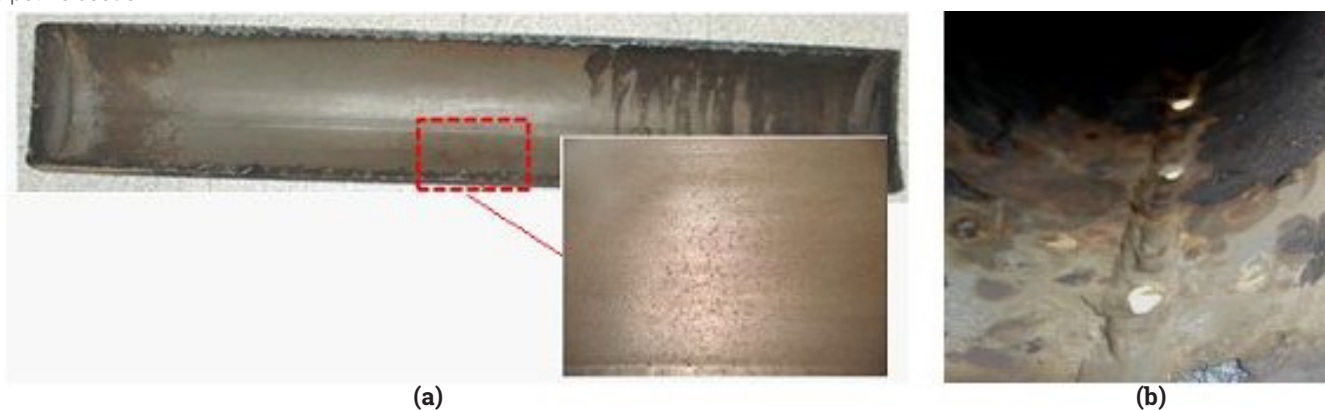
Figure 4. Visual inspection of internal surface (6 o'clock position) at X65 steel (a) after abrasion-corrosion test (b) failure in the Casabe's field collector line

A small pressure drop of approximately 0.07 MPa (10 psi) was measured in the HDPE section during the 900.000 cycles. This was possibly due to CO₂ permeation through polymeric material, in contrast to that observed with the carbon steel section, where no loss of pressure was evidenced. The loss of wall thickness after 900.000 cycles in the X65 carbon steel section is in accordance with the wear observed on the internal surface at 6-o'clock position, as can be seen in **Figure 4a**.

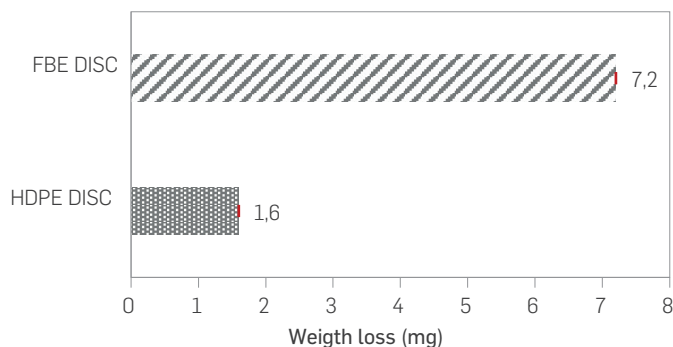
Figure 5. Comparison of abrasion resistance between HDPE and FBE coating

In **Figure 5**, abrasion resistance obtained on flat discs of HDPE and FBE organic coating is shown in terms of weight loss (mg) before and after applying a load of 1000 g during 1000 cycles of exposure.

The wear of abrasive wheels grade CS-17 is higher on FBE coating surface with a weight loss of 7.2 ± 0.005 mg as compared with surface wear of HDPE, which is 1.6 ± 0.001 mg. It is worth pointing out that even though the FBE coating present in comparison with other coatings systems shows best behavior in abrasive solids flows or production sand with mass loss, in Taber test of 7 mg as reported by Lauer et al. [18], the HDPE presents an abrasive wear resistance 4.5 times higher than FBE coating. These results could indicate that in abrasive conditions or fluids with sand, the FBE coating would not be the best option; in these cases, the HDPE liner has better behavior, added to its resistance in corrosive environments.

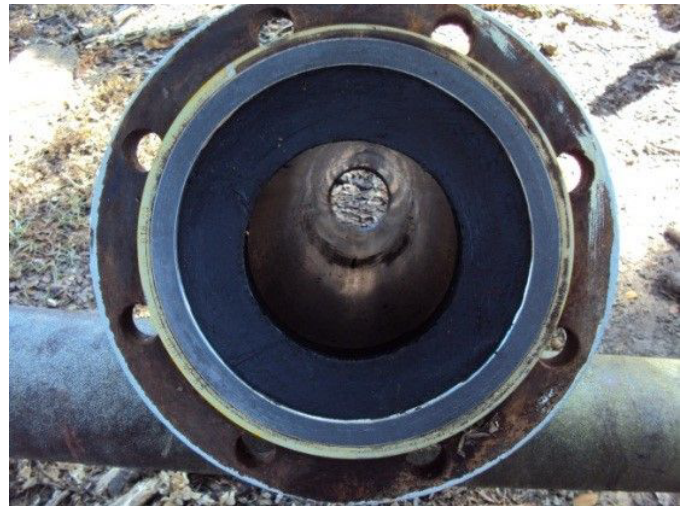
Figure 6. Test spool inspected without defects after 12 months in service

The results of the hydrostatic test in the HDPE liner system performed at 1.5 times operating pressure for 4 h showed absence of leaks in HDPE joints. Monitoring of the HDPE liner system installed in collector line of station 3 of the Casabe field was carried out after 12 months in service, removing the inspection sections mounted. The monitoring comprises activities of cleaning and visual inspection of HDPE lining in connections or flanges and pipeline. During the visual inspection, anomalies and defects in the HDPE liner, such as leaks, blistering, signs of collapse, discoloration and accumulation of solids were not evidenced, as can be seen in **Figure 6**, which verifies the resistance to abrasive wear of HDPE in exposure conditions.

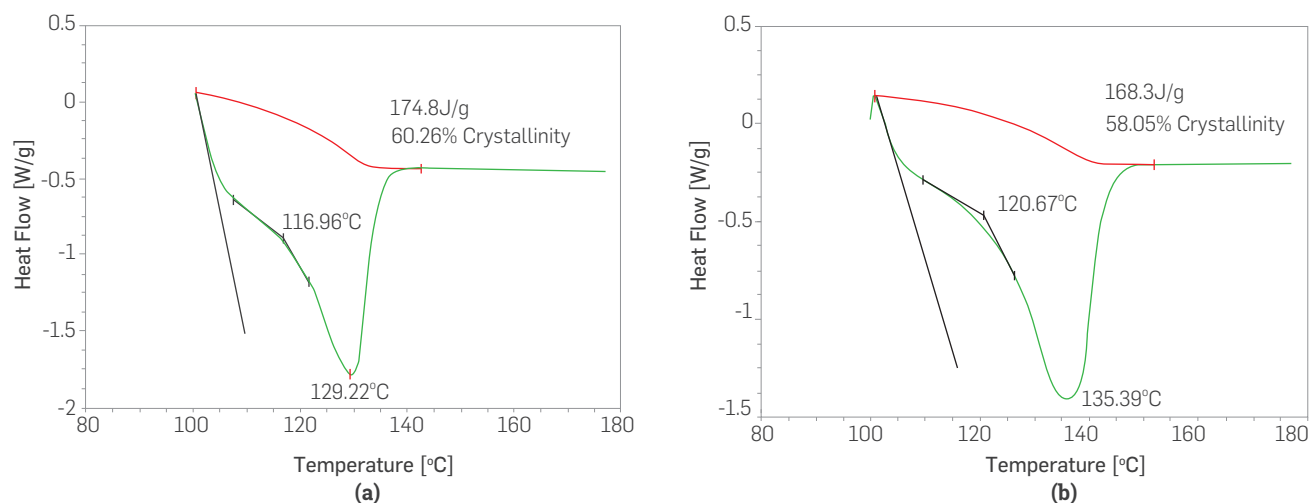
**Figure 7.** DSC of samples of HDPE (a) new (b) after exposure to fluid

Added to the results of visual inspection, the melting temperature and crystallinity of HDPE samples, new and after exposure, to fluid as observed in **Table 2** and **Figure 7**, determined by DSC tests, did not reveal significant structural variation caused by hydrocarbon absorption.

The HDPE evaluated remained thermally stable with enthalpy of fusion of 168 J/g before and after exposure, respectively. The crystallinity calculated from enthalpy shows an unchanged polymeric structure. The variation between melting temperatures before and after exposure are within the range established by standard ISO 23936-1 for thermoplastic liners [26].
