Fiber interfacial transition zone concept for steel fiber-reinforced concrete by SEM observation

Journal of applied research and technology, vol. 19, no. 4, 2021, pp. 294-307

## Fiber interfacial transition zone concept for steel fiber-reinforced concrete by SEM observation

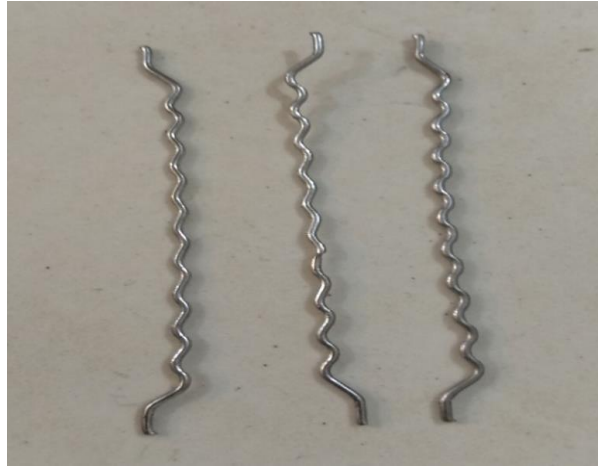
Figure 6. Twisted steel fibers.

To study cracks in the FITZ around steel fibers, 15-cm concrete cube specimens containing steel fibers were made, and their cracking patterns were studied by SEM. To compare cracks in the ITZ with those in the FITZ, concrete specimens with and without steel fibers were made. Hooked and twisted steel fibers (Figs. 5 and 6, respectively) of 1, 3, and 5% by weight (for both cases) and a tensile strength of 1050 MPa were used in the concrete mix. Table 1 shows the specifications of the steel fibers, and Tables 2, 3 show the concrete mix design and cement analysis respectively.

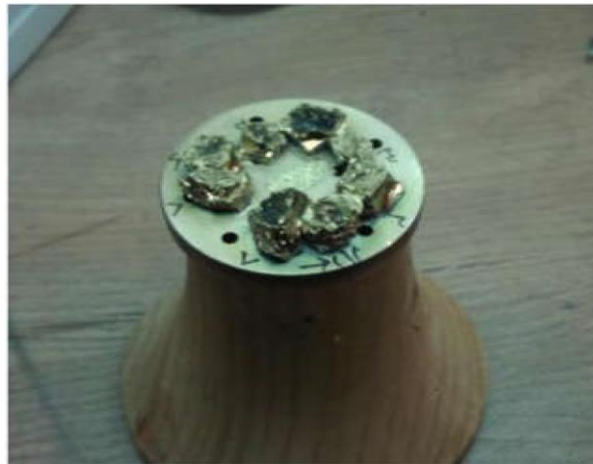
Figure 7. Gold cover on specimens.

SEM has been used to study cracks and microcracks in conventional and fiber-reinforced concrete. This microscope, also used by some researchers to study the microstructure of concrete and its constituent materials (Delannoy et al., 2018; Faleschini et al., 2015; Feiteira et al., 2017; Huiskes et al., 2016; Khankhaje et al., 2016; Santamaría et al., 2017), does not use an optical method to observe cracks; it rather radiates an electron beam on the surface of the concrete specimen and scans it. The sample were taken from the right side of concrete specimens, because for imaging by SEM at least one side of sample should be flat and then they were covered with gold in this research to ensure that the surface is scanned well (Fig. 7).

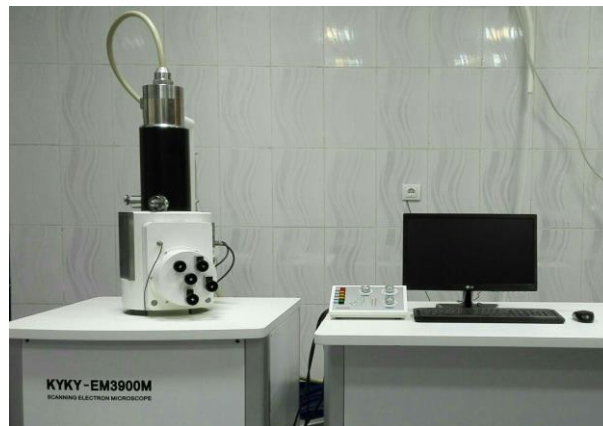
Figure 8. SEM device.

that SEM imaging depends strongly on its operator; only an skilled operator can take proper images of the specimen surface. The SEM device used in this study (Fig. 8) belongs to the University of Sistan and Baluchestan (Zahedan, Islamic Republic of Iran). Although some researchers have investigated the crack forms in FRC (Berrocal et al., 2016; Hemmati et al., 2016; 2015; 2014; Pyo et al., 2016), observation of micro cracks in this kind of concrete is probably carried out for first time in this work. This research first located the steel fibers in the specimen and then captured images of the FITZ cracks.

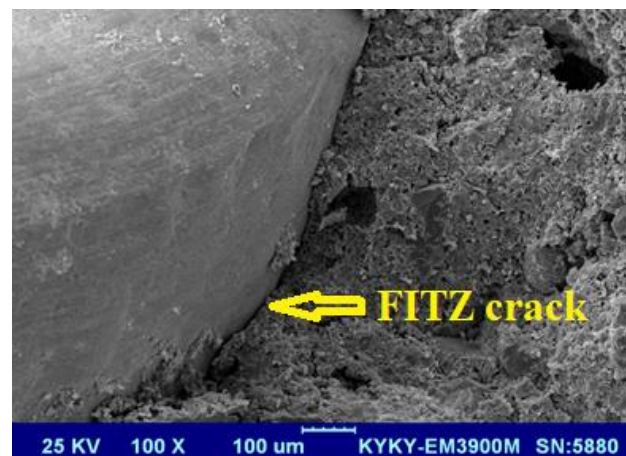
Figure 13 Twisted steel fiber in concrete.

When twisted steel fibers are used in concrete, the attachment of the two is stronger and lengthy cracks are not formed along fibers; rather, finer, less risky cracks are formed around the fibers in the FITZ because of the fibers' spiral shape. A microcrack in the FITZ of a twisted fiber is shown in Fig. 13, with the same magnification of Fig. 7, showing a crack in the FITZ; even the fiber curvature is visible in the figure. As shown, the concrete-fiber connection is better than that in Fig. 9. In the latter, the crack formed along the fiber is longitudinal, but in Fig. 13, it has a curved path looped around the fiber and is clearly smaller in size. Fig. 14 also shows the lower part of the same crack from a closer view, because it is larger and more critical. Compared to Fig. 10 (with the same magnification), it is obvious that the concrete-fiber bond is grater and the crack is thinner; Fig. 10 shows complete fiber-concrete detachment whereas the crack in Fig. 14 is bonded with the concrete in many places.

Fig. 15 shows the same crack in Fig. 13 with the magnification of Fig. 11 (almost 600 times); as shown, the FITZ has a crack smaller than that in Fig. 11. Here, the full detachment of Fig. 11 is not seen in the FITZ and twisted fibers are still attached to the concrete in many places. At points where there are cracks and concrete-fiber detachment, the crack diameter is small. Again, an important point is the oblique crack growth around fibers and not longitudinal detachment along them (as in Fig. 11).
