Topaloglu, Elif; Ustaomer, Derya; Ozturk, Murat; Pesman, Emrah
Changes in wood properties of chestnut wood structural elements with natural aging
Maderas. Ciencia y tecnología, vol. 23, 20, 2021
Universidad del Bío-Bío

CHANGES IN WOOD PROPERTIES OF CHESTNUT WOOD STRUCTURAL ELEMENTS WITH NATURAL AGING

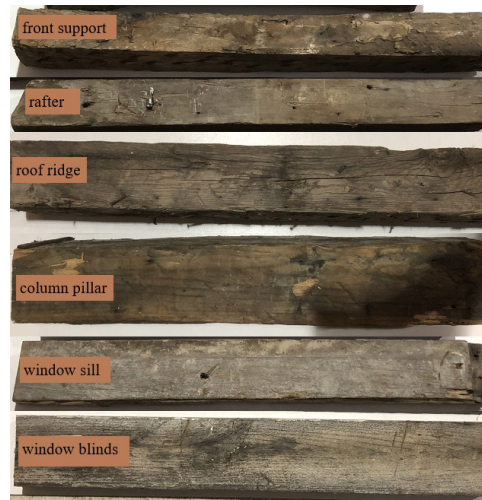
Figure 1: Macroscopic appearance of old wood materials from Zeytinlik houses.

Traditional Zeytinlik houses are located in Zeytinlik District of Giresun (40°55' north latitude - 38°23' east longitude), Turkey. A total of six old wood materials were extracted from three randomly selected houses from traditional Zeytinlik houses. The approximate ages of the houses where the old wood materials were extracted can be stated as follows: 120 years for the front support, rafter and roof ridge, 113 years for the window sill and window blinds, and 88 years for the column pillar. The front support, window sill and window blinds are the structural elements that act as facade elements, the rafter and roof ridge are the roof elements, and column pillar is the carrier elements. In addition, the front support, rafter, roof ridge and column pillar are the elements that serve as load carriers in the structure. Figure 1 shows the macroscopic appearance of old wood materials used in this study. It was found macroscopically that all the old wood materials extracted from the houses were produced from the heartwood part of the tree and the sapwood part was not very common. In addition, as a result of visual inspection, there are nails on the front support, rafter and roof ridge elements; window sill and window blinds elements were exposed to UV degradation and color change was observed on their surfaces.
