Paz-Triviño, Franklin; Buitrago-Sierra, Robison; Santa-Marín, Juan Felipe Wear resistance and hardness of nanostructured hardfacing coatings DYNA, vol. 87, no. 214, 2020, July-September, pp. 146-154 Universidad Nacional de Colombia

# Wear resistance and hardness of nanostructured hardfacing coatings

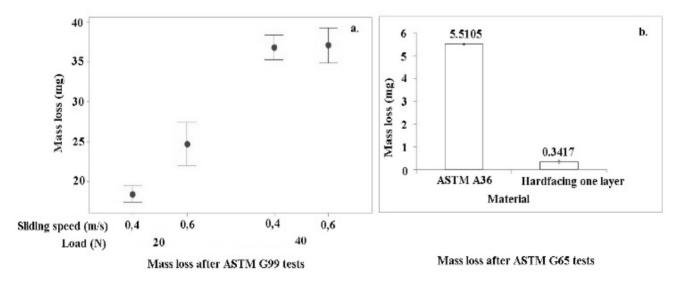
Fig. 8 presents the mass losses of the coating after two different tests: ASTM G99 and ASTM G65. Fig. 8a details the values obtained after pin-on-disc tests. The base metal lost 1700 mg after the wear tests with high loads and a sliding distance of 204 m. The coating lost 37 mg at the same load and after running the tests for 2716 m. The wear rates of both materials were calculated; values of 8.3 mg/m in the base metal were obtained, in contrast with 0.013 mg/m in the nanostructured hardfacing coating. These values confirm a reduction of 638 times in terms of mass loss in the hardfacing coating compared to the base metal in the pin-on-disc test. An analysis of variance allowed us to conclude that the load effect is statistically significant at a p-value of 0.05 with a 95.22% confidence level. In addition, the interaction effect and sliding speed appear to be not significant when p-values higher than 0.05 are used.

Figure 8. a) Mass losses after conducting ASTM G99 tests. b) Mass losses after conducting ASTM G65 tests. Source: The Authors.

A different behavior was found with low loads, and mass losses increased when the sliding speed was higher. This result probably indicates that a transition from a wear mechanism was found for the velocities under study. One plausible explanation found in the literature is that mass losses are higher since friction heating is expected to increase along with sliding speed [33]. However, a comprehensive understanding of this result is beyond the scope of this article.

Fig. 8b presents the mass losses after the dry-sand rubber wheel procedure (ASTM G65). The mass loss of the hardfacing was found to be 14 times lower than those obtained in the base metal. The difference between the results in the pin-on-disk tests and the dry-sand rubber tests can be explained by the fact that, in the first one, the pin passes over the same track repeatedly. Hence, lower mass losses are expected in pin-on-disk tests since the abrasive particles are detached from the cloth.
