Amariles-López, Cristhian Camilo; Osorio-Gómez, Cristian Camilo
Weighted Average Bridge Inspection Methodology (WABIM)
DYNA, vol. 90, no. 225, 2023, January-March, pp. 55-63
Universidad Nacional de Colombia

Weighted Average Bridge Inspection Methodology (WABIM)

Cristhian Camilo Amariles-López & Cristian Camilo Osorio-Gómez

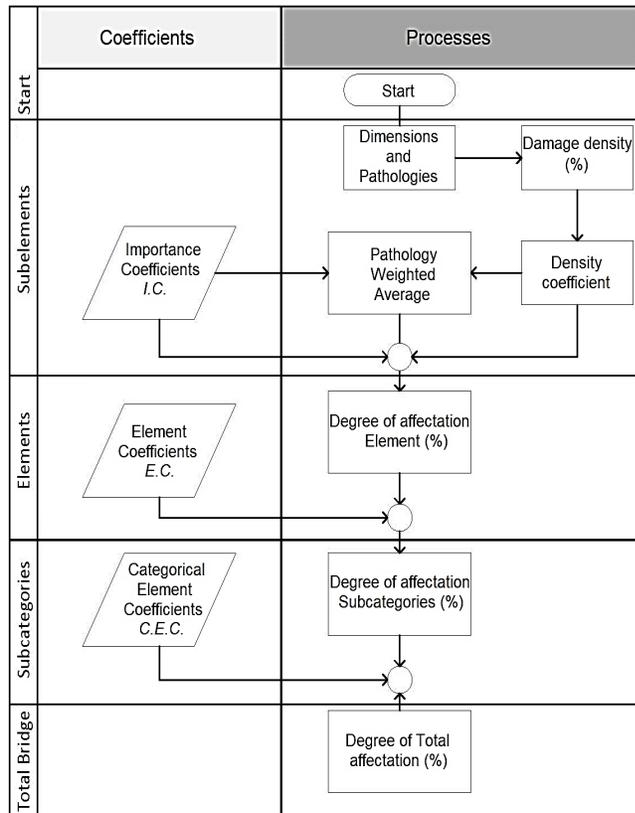
Figure 1. Calculation process for WABIM. Source: Authors, 2022.

The methodological process is shown in Fig. 1; it consists of four general stages: sub-elements, elements, subcategories, and total bridge. First, it is necessary to measure the Sub-elements of the bridge and the deterioration pathologies evidenced in them, allowing to determine the density of damage that represents the severity of each pathology in a coefficient. Next, the weighted average is calculated for each pathology based on the determined density coefficients and Importance Coefficients (I.C.) defined for each Sub-element.

Second, the degree of affectation of each element of the bridge is determined, and obtained from the integration of the weighted averages calculated previously.

Third, the degree of affectation of each Sub-category is calculated based on previous stages, besides the effect caused by categorizing the importance of the elements through the Element Coefficient (E.C.).

In the fourth stage, the degree of total affectation of the bridge is determined as a result of quantification of the contribution of each deterioration determined in the previous stages for each Sub-category affected by the Categorical Element Coefficients (C.E.C.).

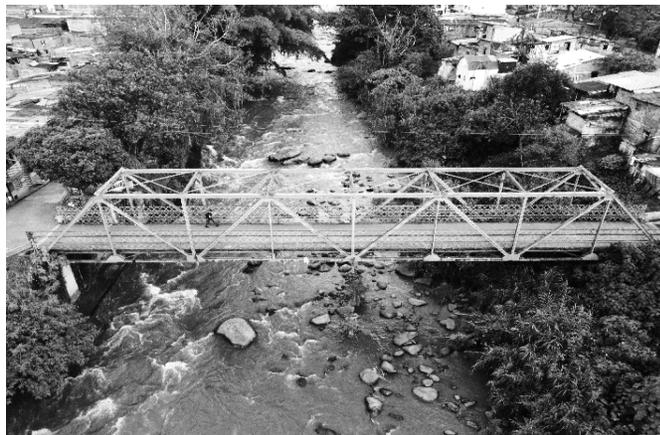
Figure 2. Longitudinal structure.
 Source: Authors, 2022.

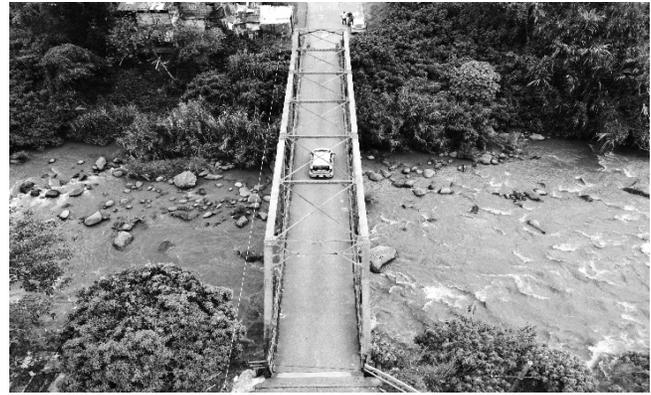
Figure 3. Transverse structure.
 Source: Authors, 2022.

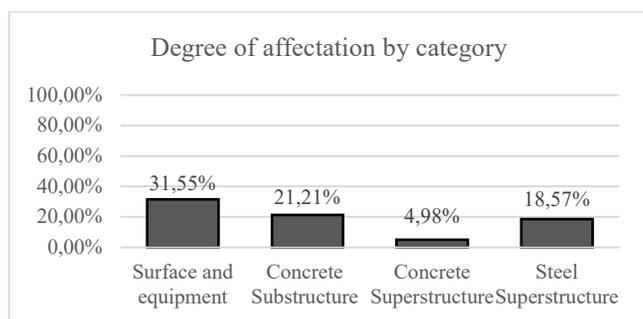
Figure 4. Transverse structure.

Starting from the qualitative methodology contained in the Manual of visual inspection of bridges and pontoons of Inviás, the WABIM methodology was applied to the La Esneda bridge structure, allowing the generation of objective analysis and recommendations based on the deterioration measurement results of all the elements of the bridge presented in Fig. 4.

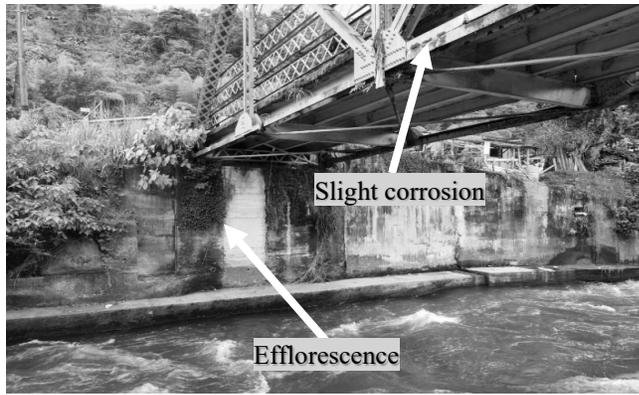
Figure 5. Transverse structure.
Source: Authors, 2022.

The substructure has 21.21% efflorescence due to the vegetation that the concrete abutments present, as shown in Fig. 5, which can cause significant damage in the future at the integral level of the structural reinforcing steel and the physicochemical composition of the concrete. Nevertheless, the integrity of the abutments has not been severely affected.

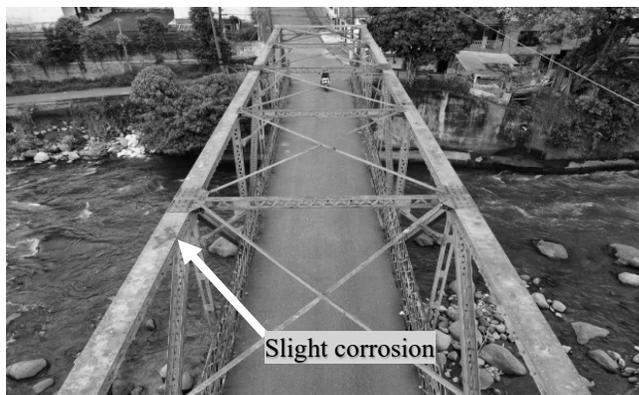
Figure 6. Transverse structure.
Source: Authors, 2022.

The concrete superstructure has a 4.98% impact on the slab due to some contaminated areas efflorescence on the sides. This agent is due to the high humidity in the area and lack of maintenance on the bridge. The steel superstructure has 18.57% damage, and the lower chords and the diagonals have slight corrosion, as shown in Fig. 6.
