Al-Fares, W.; Asfahani, J.  
Evaluation of the leakage origin in Abu Baara earthen dam  
using electrical resistivity tomography, northwestern Syria  
Geofísica internacional, vol. 57, no. 4, 2018, October-December, pp. 223-237  
Instituto de Geofísica, UNAM

## Evaluation of the leakage origin in Abu Baara earthen dam using electrical resistivity tomography, northwestern Syria

W. Al-Fares and J. Asfahani\*

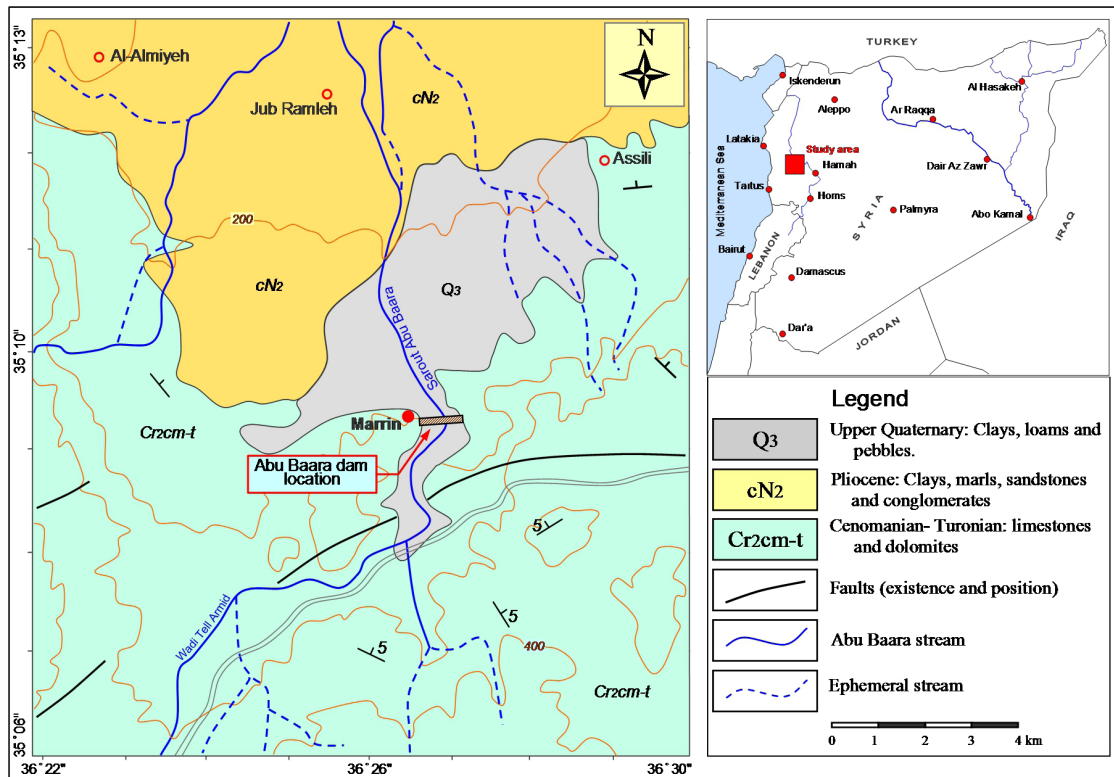
**Figure 1.** Simplified geological map of the study area showing the location of AbuBaara earth dam (modified after Ponikarov, 1963).

Abu Baara dam is situated at the southern margins of Al-Ghab plain depression, 30 km west of Hama city (Figure 1). The depression of Al-Ghab is developed by the effect of the tectonic evolution along the northern parts of the Dead Sea Fault System (DSFS) in the northwestern part of Syria. This depression forms a plain region suitable for agriculture due to the suitable climate conditions, fertile lands and reasonable average rainfall (700 mm/y). The flanks of the depression are clearly limited by faults with series of blocks and scarps (Devyatkin *et al.*, 1997; Brew, 2001; Gomez *et al.*, 2006; Hamade and Tabet, 2013).

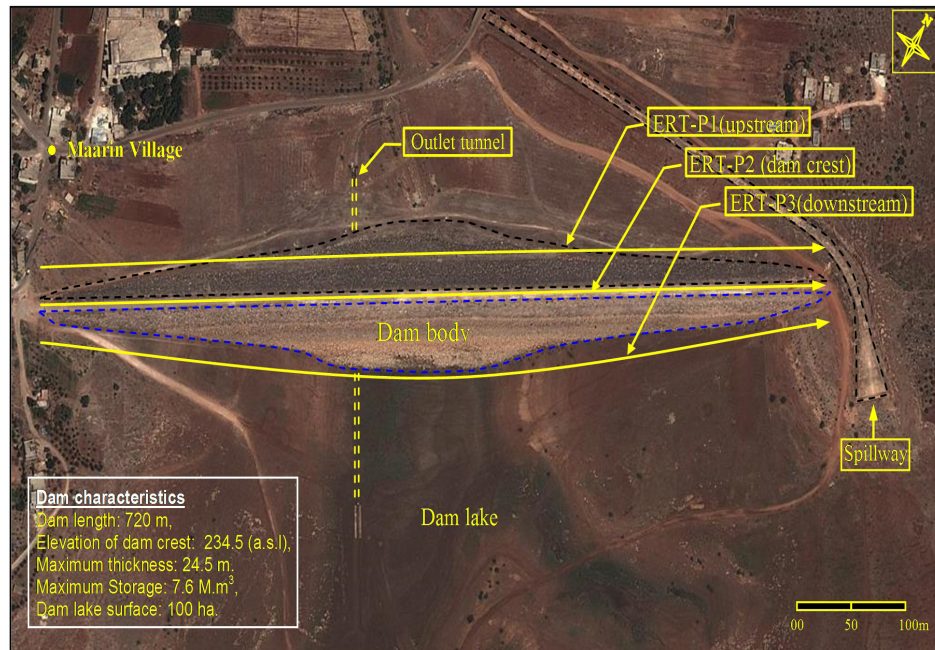
**Figure 2.** Locations of the ERT profiles carried out in Abu Baara earthen dam (Google Earth).

Three ERT profiles of 715m length for each one were executed in Abu Baara dam site (Figure 2): the first one was in upstream side (behind the dam body), the second at the top of the dam's crest and the third in downstream side. These profiles are straight and parallel to the dam body. It is worth mentioning that the field measurements of the ERT profiles were carried out through the summer season where the dam's lake was dry and completely empty of water. Additionally, a topographical survey was also carried out for each profile using a GPS device with UTM projection.

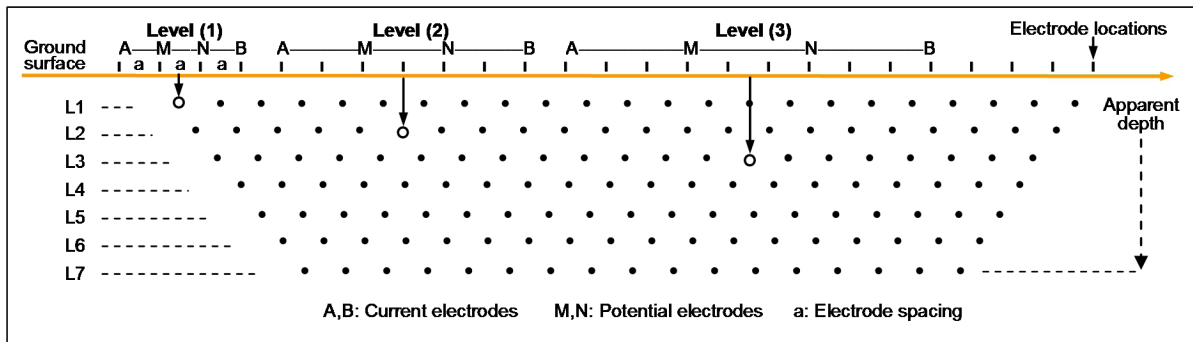
**Figure 3.** Electrical resistivity tomography configuration. Increasing the distances between current electrodes implies a deep penetration depth.

of potential electrodes M and N, as shown in Figure 3. on the ground surface with a current applied through a pair of current electrodes A and B. The apparent resistivity  $\rho_a$  in Ohm.m ( $\Omega.m$ ) is then computed from Ohm's law:

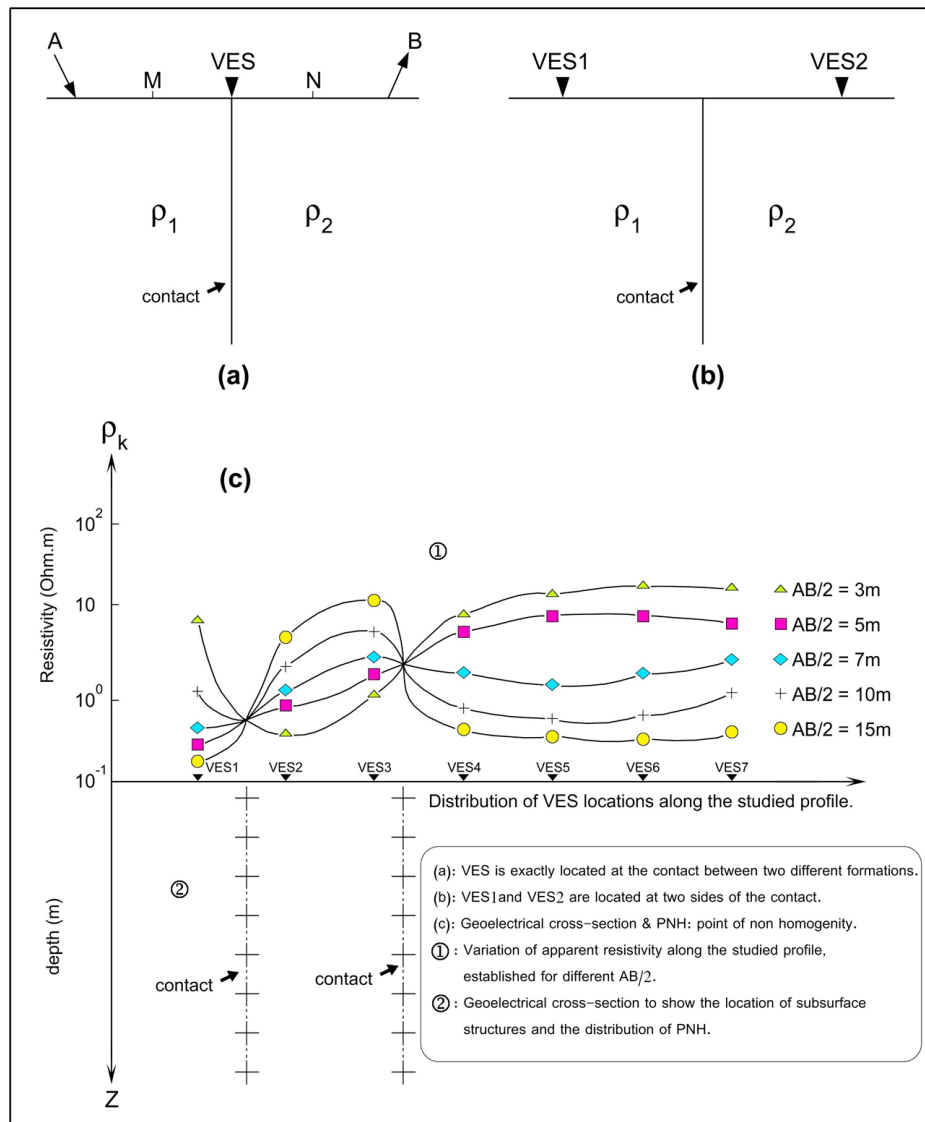
**Figure 4.** Principal of Pichgin and Habibullaev technique (modified after Asfahani, 2011).

The theory behind the Pichgin–Habibullaev technique can be summarized as follows: Suppose two vertical electrical soundings, VES1 and VES2 are performed on either side of a vertical contact. For every given current electrode half-spacing ( $AB/2$ ), all the resistivity profile curves will be intersected at a point located directly over this vertical contact. The locations of the vertical electrical soundings carried out on a given profile are therefore plotted on the abscissa, and the corresponding measured apparent resistivities for each given  $AB/2$  are plotted on the ordinate, as shown in Figure 4.

Points (NHP), are plotted on a 2-D (x,z) geological section. The depth (z) of each NHP can be determined from the following equation:

$$z = [(AB/2)_i + (AB/2)_j] / 2$$

where  $(AB/2)_i$  and  $(AB/2)_j$  are the half-spacings between the electrodes A and B, at which two horizontal resistivity curves are intersected. The sub fractured zones are determined according to the distribution and interpretation of NHP along the studied profile.

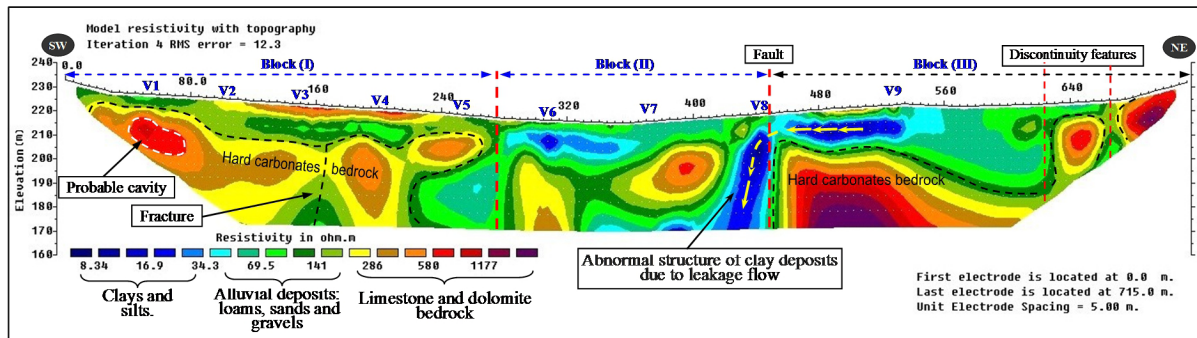
**Figure 5.** Inverted geoelectrical section of the ERT-P1 profile carried out behind the dambody (upstream site), V: locations of VES.

The ERT-P1 profile was carried out in upstream side at a distance of 10m from the dam body (Figure 2). The profile starts from the western edge of the embankment to end up at the eastern edge traversing a distance of 715m. Figure 5. shows the inverted ERT-P1 geoelectrical section, which can be divided into three principal distinguished blocks:

The first block runs from the beginning of the ERT-P1 section to the distance of 280m. This block includes a subsurface layer, of 10m thickness in average, which corresponds to the Quaternary alluvial deposits ( $Q_3$ ), composed of loams, sands and gravels. The electrical resistivity values of these formations are ranging between 50 and 200  $\Omega$ m. The alluvial deposits overlay a layer of hard limestone and dolomite Cenomanian-Turonian ( $Cr_2$ cm-t) rocks. Those rocks are characterized by an irregular feature due to fractures and cracks, which makes them heterogeneous chromatically in the geoelectrical section. The limestone and dolomite rocks have resistivity values of more than 1100  $\Omega$ m. These rocks constitute the main hard bedrocks of the dam lake. Otherwise, a distinctive resistive anomaly was noticed between the distance interval 60 and 80m of the ERT-P1 section (Figure 5). This anomaly is distinguished by a high electrical resistivity value (up 1200  $\Omega$ m), which most likely could be associated with probable karstic cavity developed within the limestones bedrock. Evidently, the presence of a possible cavity constitutes a suitable potential pathway for water leakage occurrence, especially when the water storage reaches high levels in the lake.

section. This zone seems well matched with the course of the main valley behind the dam body. The alluvial deposits are prevailing in this part of profile and filling the valley with exception the existence of two big scattered masses of limestones. The right boundary of this block (at the point 440m) is determined by a vertical hard rocks edge. This almost could be related to the occurrence of a tectonic event such as a fault struck the main valley. Moreover, a distinct anomaly of clay was identified adjacent to the mentioned vertical edge; this abnormal structure may be due to a vertical groundwater flow towards the deeper formations. This finding may indicate to the existence of hydraulic connection between the shallow and the deep geologic formation. It is obvious that significant leakage most likely occurs through this sector along the tectonic contact zone between the alluvium and the limestone rocks.

The third block extends from the point of 440m to the end of the geoelectrical section (Figure 5). The alluvial deposits thickness ranges between 10 to 20m, with resistivity values reach 150Ωm. Those deposits overlay the resistive hard limestone bedrock (more than 1100Ωm). A discontinuity features were observed in two locations at the end of the profile (at 630 and 670m), these features are corresponding to fractures in the limestones and dolomite rocks. These discontinuities in the bedrock form additional possible pathways for water leakage from the dam's lake.

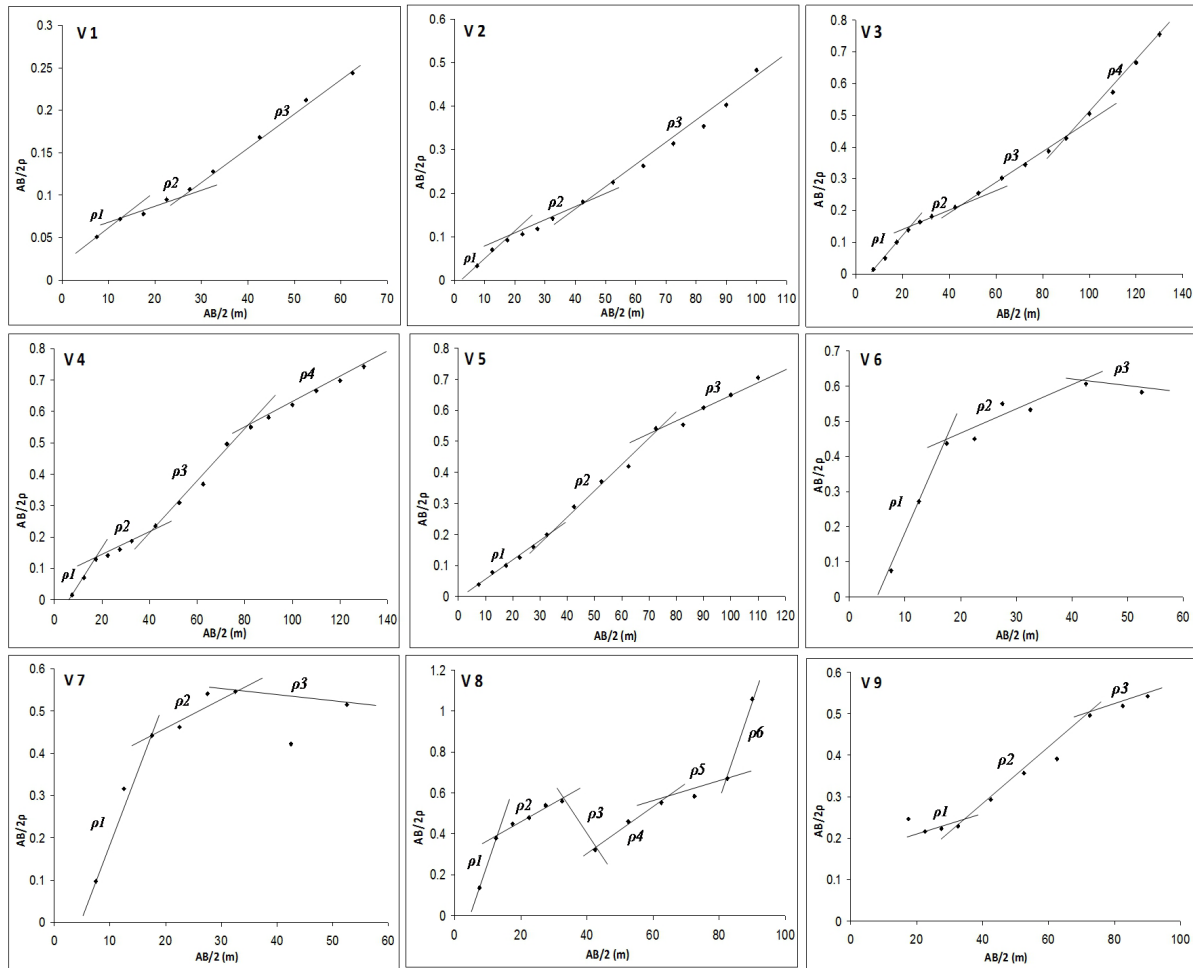
**Figure 6.** Quantitative 1D interpretation results of nine VES measurements carried out along ERT-P1 profile obtained by *ISM*.

Inverse slope method *ISM* with adapting 1D assumption has been applied in this research for interpreting the nine Schlumberger VES distributed along P1 as shown in Figure 6. True thicknesses and resistivities for the corresponding layers under the study profile P1 have been obtained as shown in Table 1.

The most important remark observed while interpreting those nine VES is the presence of negative slopes, indicating high resistivity values in the studied P1 section. Those high values clearly reflect the hard limestone and dolomite rocks existed in the study region (Ponikarov, 1963). The advantages of applying *ISM* is that it easily distinguishes between the different layers under the study VES. The low resistivity values are attributed to the Quaternary alluvial deposits, while the high ones are attributed to the Cretaceous hard limestone and dolomitic rocks. The *ISM* results obtained confirm well those obtained by the ERT measurements and discussed above, particularly the low and high resistivity distributions.

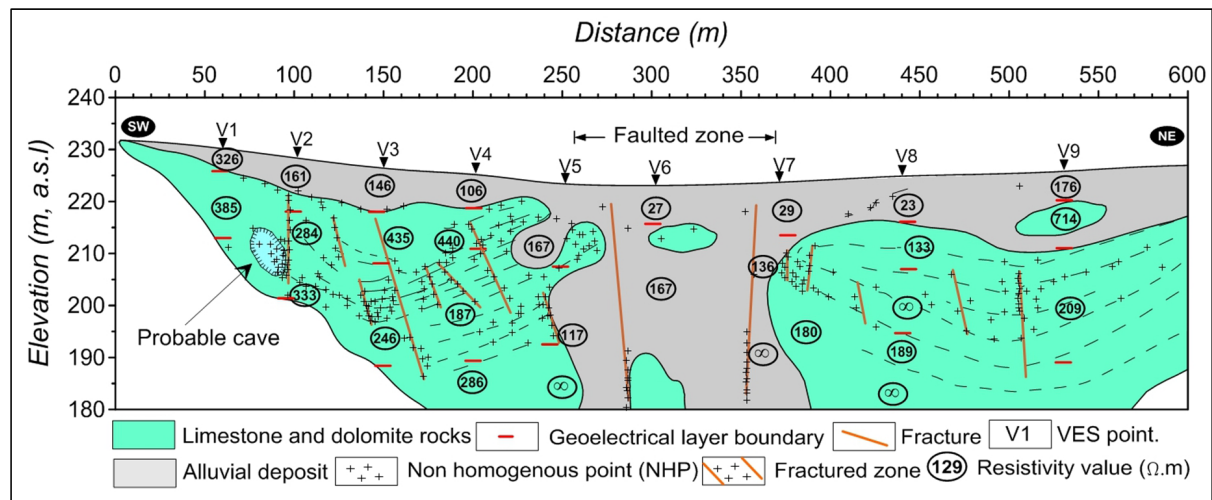
**Figure 7.** Quantitative interpretation of VES data carried out along ERT-P1 profile by using Pichgin and Habibullaev technique.

The same nine VES distributed along profile P1 have been interpreted by Pichgin and Habibullaev technique explained above. The geometry distribution of the Non Homogeneous Points (NHP) in the 2D (X-Z) section shown in Figure 7 clearly indicates the presence of three main blocks. The central one of more than 150 m wide could be related to a faulted zone, representing the main alluvial valley. The two other right and left blocks are related to the Cenomanian-Turonian limestone and dolomitic rocks. At a detailed level, the NHP clearly shows a basal structure, and the positions of the fractured zones in those two blocks. Their locations are the main leakage points in the study dam under profile P1. It is worth mentioning that the results obtained by interpreting VES data using Pichgin and Habibullaev technique confirm well those obtained by ERT measurements along Profile P1.

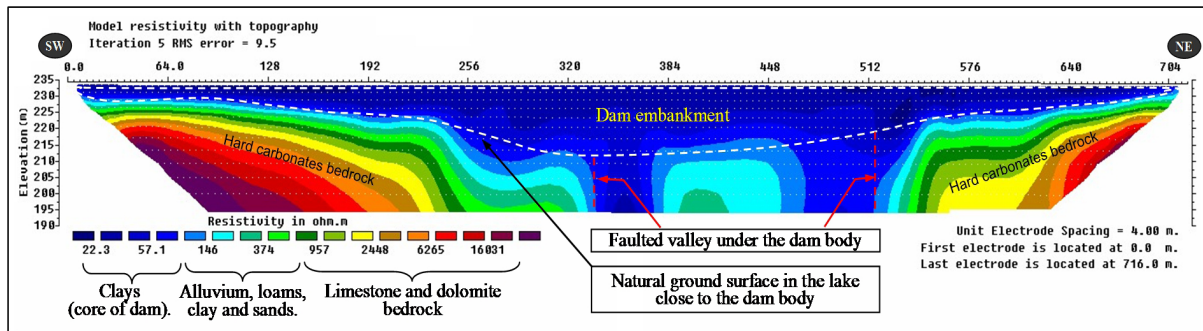
**Figure 8.** Inverted geoelectrical section of the ERT-P2 profile carried out at the top of the dam body.

profile (Figure 2). This ERT profile, located on the top of dam body, has been carried out by using an electrical driller to dig holes, 4m apart, in the hard asphaltic layer to facilitate the electrodes plantation. The planted electrodes were wetted with salty water and some clay added to ensure a good contact with the underlying soil and to reduce the noise. This profile has length of 716m and 234.5m above sea level (a.s.l.) as a constant topographic elevation. Figure 8 shows the inverted geoelectrical section of the ERT-P2 profile, where two main zones can be vertically distinguished; the first zone is directly related to the clayey core of the dam body, marked by clear blue color in Figure 4. The white dotted line represents the lower boundaries of the dam body with the original land surface of the lake. The resistivity values of this zone range between 20 and 50  $\Omega\text{m}$  and the thickness increase towards the main valley to reach 25m. The clayey core of the dam seems to be intact and structurally homogeneous and the lower boundaries are clear and distinct especially at the contact with the underlying bedrocks. The second zone of the ERT-P2 section represents the hard limestones and dolomites bedrock. The general structural of this zone is similar to the ERT-P1 structure. It is consisting of two units of massive carbonates rocks separated by the main valley: the first unit extends from the beginning of the geoelectrical section until the point 320, while the second starts from the point 512 to the end of the section. Both units are well differentiated and characterized by high resistivity values.

The central part of the second zone extends along the distance between 320 and 512m, this part corresponds to the main valley course

underneath the dam body. It is believed that the absence of hard bedrock at this part of section could be attributed to dissolution processes of the carbonates rocks by the influence of the water flowing stream, or probably related to tectonic activities such as faults leading to the formation of a subsidence faulted structure filled up later by alluvial deposits (Figure 8). The absence of the bedrock under the central part of the dam body could pose problems in future related to the safety and stability of the dam, particularly when the water reaches high levels during the rainy seasons. Many cracks covering the top of the dam were observed during the fieldwork in the asphaltic layer. This seems to be a negative indicator and must be taken into consideration through the implementation of a permanent monitoring program in order to prevent probable failure of the dam. It is consequently believed that most of the vertical leakage occur through this sector at the contact between alluvial deposits and the hard limestones rocks.

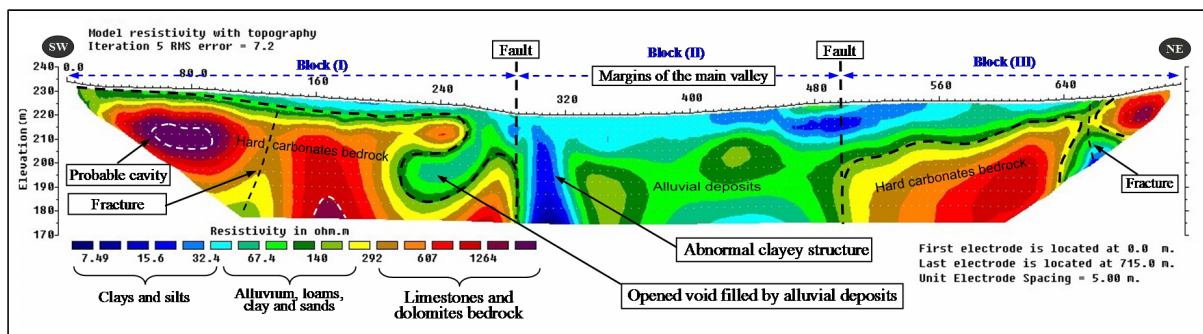
**Figure 9.** Inverted geoelectrical section of the ERT-P3 profile carried out on downstream site of the dam body.

The first and third blocks are interpreted together because they are composed of the same formations. The first block extends from the beginning of the section to a distance of 300m, while the second one starts from 500m to the end of ERT section. The two blocks include a surface layer of alluvial deposits (Q3). The thickness of these deposits ranges between 1 to 5m in the block(I), and reaches 20m at the third block, since it increases towards the main valley. The resistivity values of these deposits vary as mentioned above from 40 to 150 $\Omega$ m. The alluvial layer covers the bedrock of the hard limestones, which are characterized by high resistivity values (300-1200 $\Omega$ m), as shown in the geoelectrical section. The bedrocks are dipping about 7° (block I) and 15° (block II) towards the main valley. On the other hand, a resistive anomaly is observed between the interval 60 and 90m of the section, this anomaly has been also observed in the ERT-P1 section. It is characterized by a high electrical resistivity value (1200 $\Omega$ m), which is most likely related to a karstic cavity within the limestone bedrock. The appearance of this anomaly in the ERT-P1 and ERT-P3 sections at the same location probably indicates

the presence of a subsurface karstic conduit passing under the dam body at this sector. This subsurface conduit certainly constitutes a suitable pathway for the occurrence of intensive leakage from the lake to outside the dam, especially at the high water storage levels.

Another abnormal structure is also observed between the distances 215-280m of the ERT-P3 section. This structure seems as a void or an opened cavity filled with alluvial deposits (40-150 $\Omega$ m). This void or cavity could be resulted by the influence of a tectonic activity followed by erosion and dissolution processes of the limestone and dolomite rocks by the act of water flow effect. Moreover, the discontinuity features identified at the ERT-P1 section is also present in ERT-P3 section at the same location, this feature is almost correspond with a fracture extending perpendicular to the dam body within the subsurface carbonate bedrocks. This fracture expands with depth, and it is filled with alluvial and clay deposits of low resistivity (Figure 9). Existence of those fractures constitutes an additional causative of the water leakage from the dam lake.

The second block is stretching along the distance from 300 to 500m, and forming the central part of ERT-P3 section. The margins of this sector are in concordance with the main valley and they are delineated by two vertical rocky edges. This part of the section is completely composed of alluvial deposits, where their thicknesses reach more than 50m. Moreover, an abnormal structure of clay, located between 300-320m, is observed at the left edge of this block. This structure represents additional evidence of the presence of a vertical water leakage between the surface and the deep formation. This block is structurally considered as the most significant part of the profile, where many structural anomalies are localized and identified. The filtration and the leakage processes are mostly occurring through this sector. The table (2) globalizes the resistivity values for the different subsurface detected structures obtained from the inversed ERT sections.

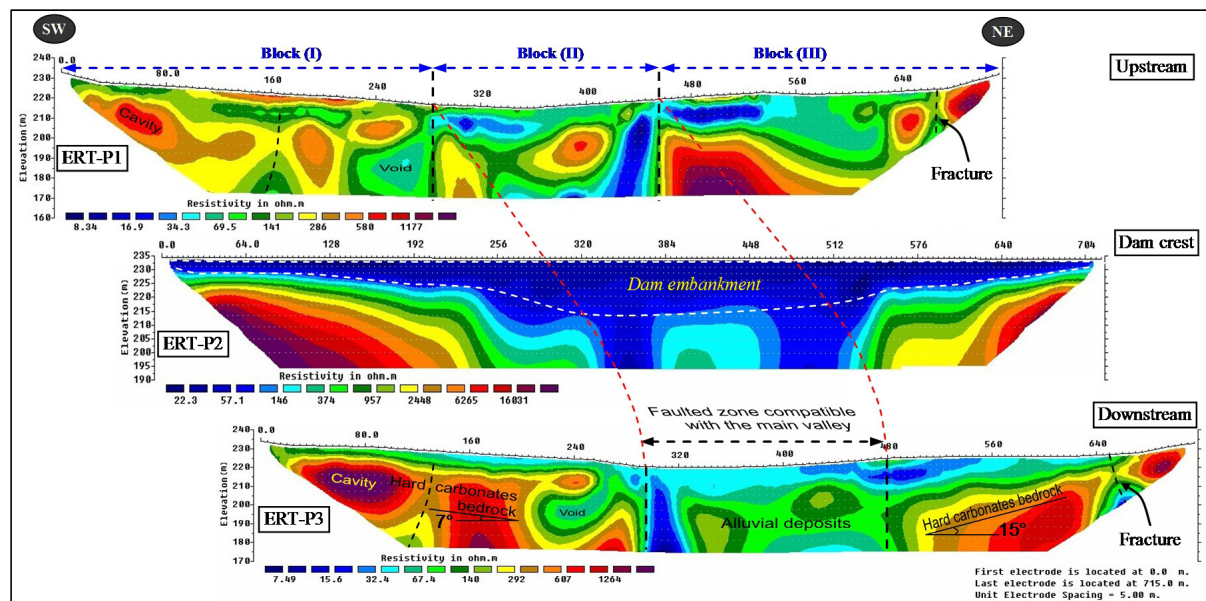
**Figure 10.** Comparison between the general structure of the inverted geoelectrical ERT profiles carried out in upstream, dam crest and downstream of Abu Baara dam body.

A global structural comparison between the geoelectrical ERT sections of the three profiles is illustrated in Figure 10. The general structure of these sections seems to be similar and they are composed of three distinct structural blocks. A remarkable faulted zone can be traced within the interval 300 to 500m of the ERT sections. This zone is compatible with the main valley. Moreover, a karstic cavity located at the beginning of the ERT sections can be observed as well as the presence of discontinuity features at the end of the sections. It is worth mentioning, that many field observations have been noted during the implementation of the field measurements, which point to the role of the tectonic activity and other karstic features in the leakage processes. Figure 11 shows some of these features, where small sinkhole of more than 50 cm of diameter and a large fracture extended for more than 200m parallel to the dam lake margin are observed in many places throughout the lake and behind the dam body.

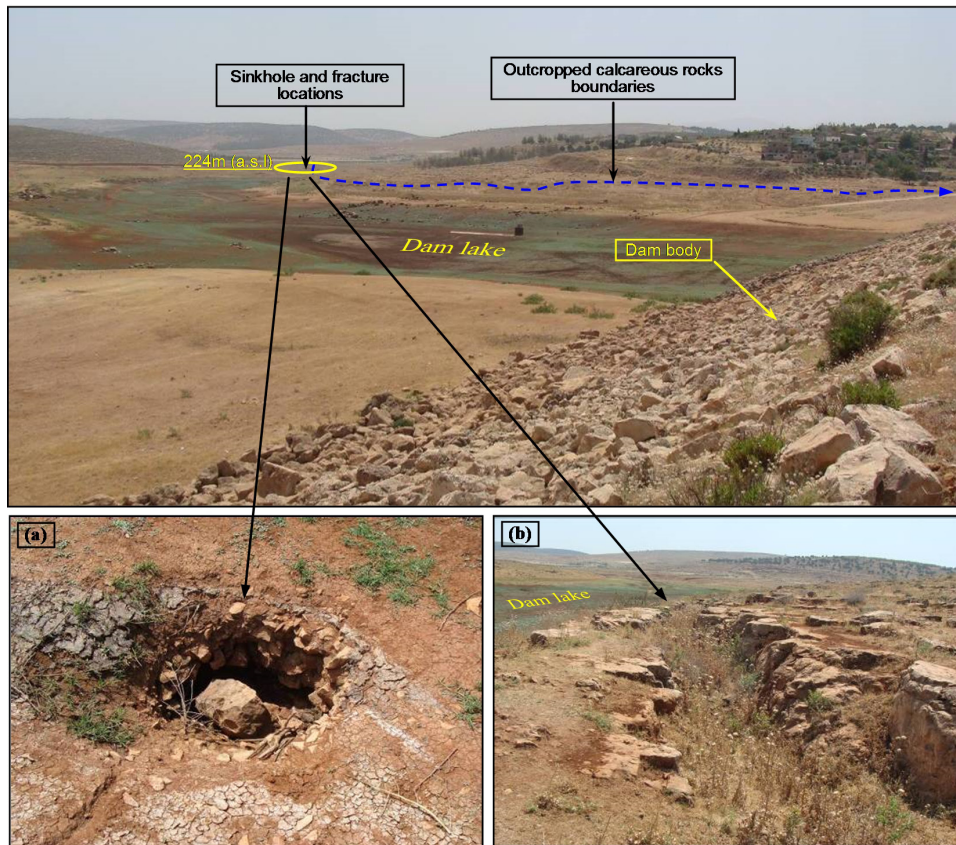
**Figure 11.** Locations of some leakage features observed at the right bank of Abu Baara dam lake, (a): one of the sinkholes which is located nearby the limestone and dolomite rocks boundary (more than 50cm of diameter), (b): a large fracture of 2-3 depth extends for more than 200m in parallel with the dam lake margin.
