Geofísica internacional, vol. 57, no. 4, 2018, October-December, pp. 275-287

Integration of electrical resistivity tomography with electromagnetic and soil radon measurements for characterizing the leakage problem in Afamia B dam, Syria

Walid Al-Fares and Mohamed Al-Hilal*

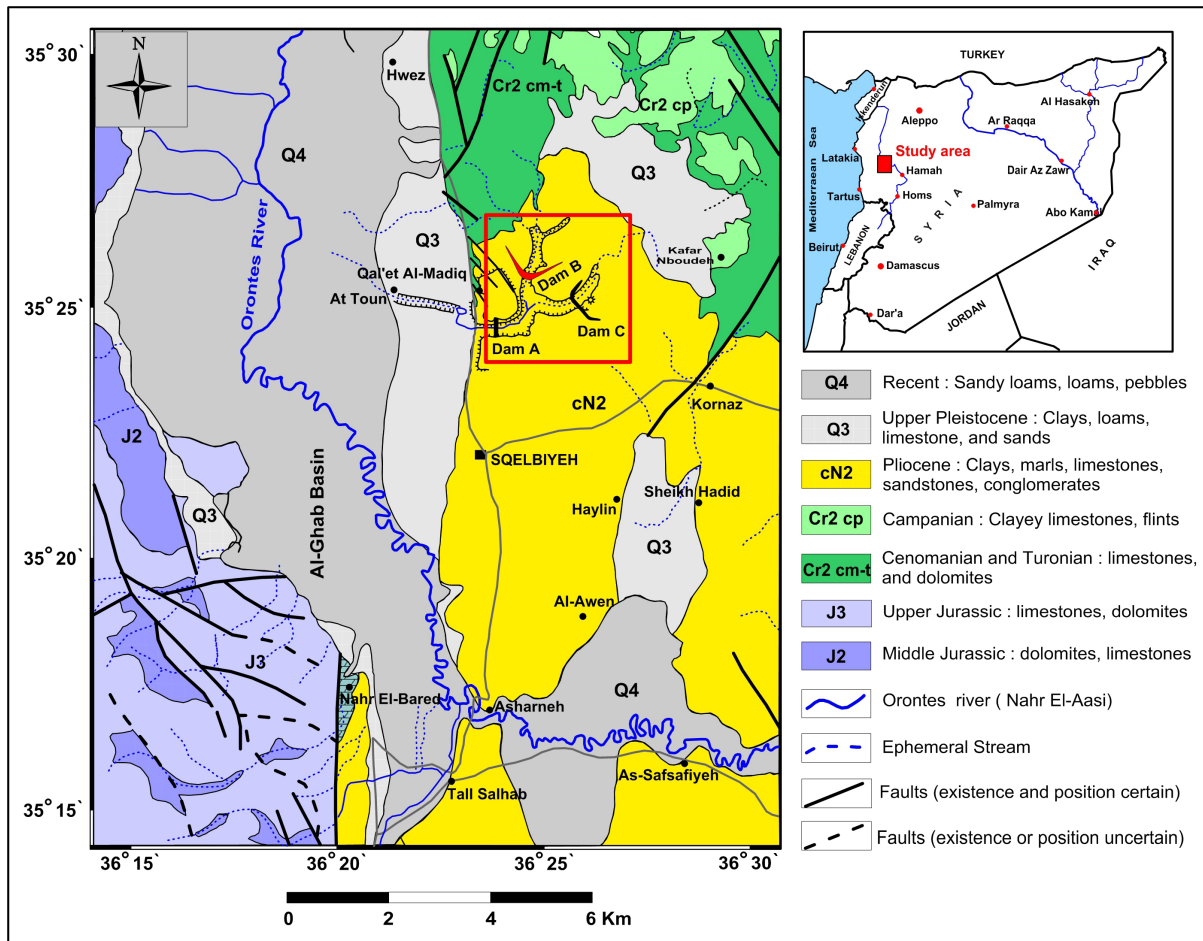
Figure 1. Simplified geological map of the study area showing the locations of Afamia dams (modified after Ponikarov, 1966).

Afamia dams are located on the eastern margin of the Ghab plain in the northwestern part of Syria, close to Qalet Al-Madiq town (Figure 1). The Ghab plain constitutes a prominent fertile terrain in western Syria that suitable for growing a wide range of agricultural activities. Hence, three adjacent earth-filled dams, (A, B and C), were constructed nearby the great ancient city of Afamia, at about 3 km eastern margin of the Ghab basin. In fact, the Afamia dams were built in this area essentially to divert some water out of the Orontes River (Nahr El-Aasi) to be stored and used afterward for irrigation and other domestic uses during drier months of late summer and autumn. The dam B, which has the maximum storage capacity of 37 millions cubic meters, is subjected to serious problems of leakage through the bedrock of its reservoir. It is worth to mention that the dam body extends along 2870m, with 55m high and it has a constant elevation of 282m above sea level (a.s.l.). In 1999, the dam was set in operation and filled up with water for the first time in order to check its validity for water storage. However, the water level in the lake has shown a clear sign of water loss ranged between 17 and 20 cm per day. Therefore, several geological and geophysical investigations, including vertical electrical soundings (VES) and electrical profiling (EP) surveys, have been carried out in dam by the Syrian General Company of Hydraulic Studies (2001). The objective of their surveys was to characterize the geological and tectonic settings of the dam site. Additionally, some foreign consulting companies performed more hydrogeological and geophysical investigations (Minasian, 2001). The results of these studies revealed various anomalies which indicate some probable scattered zones of infiltration distributed in many parts of the dam lake, but the exact pathways of leakage were not defined precisely. Further assessments of the pervious works were fulfilled by a Swiss company in attempt to identify the problem and to better understand the origin of water leakage (Joos and Bussard, 2004).

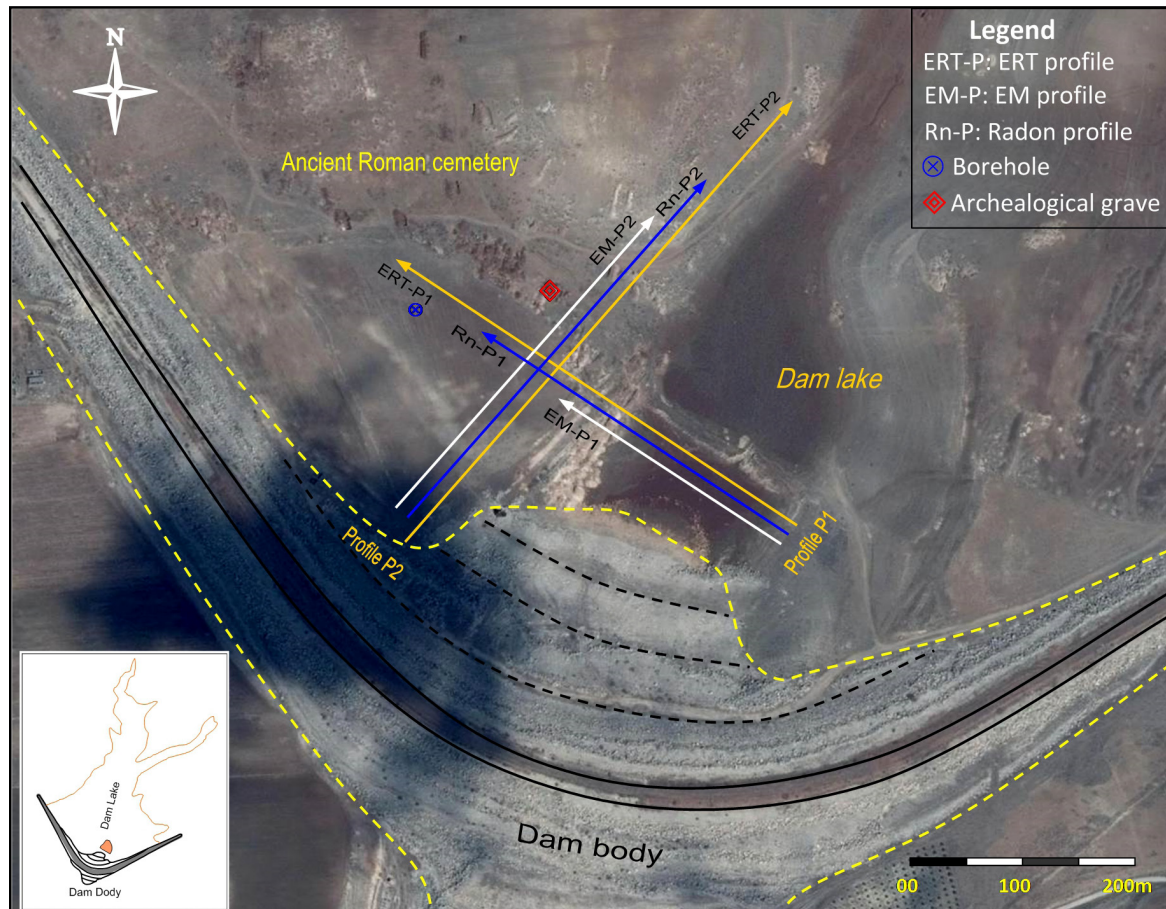
Figure 2. Locations of the ERT, EM and soil radon measurement profiles carried out in the lake of Afamia B dam.

In the framework of this study, two main profiles (ERT-P1 and ERT-P2) were chosen in the lake close to the dam body (Figure 2). The first one is extending close to the central part of the dam body and it is perpendicular to the main valley, while the second is stretching along

the included methods carried out along two intersected measuring profiles, denoted as P1 and P2, traversing the main basin of the Afamia dam lake as shown in figure (2). The following sections include detailed discussion and interpretation of the results obtained along both measuring profiles.

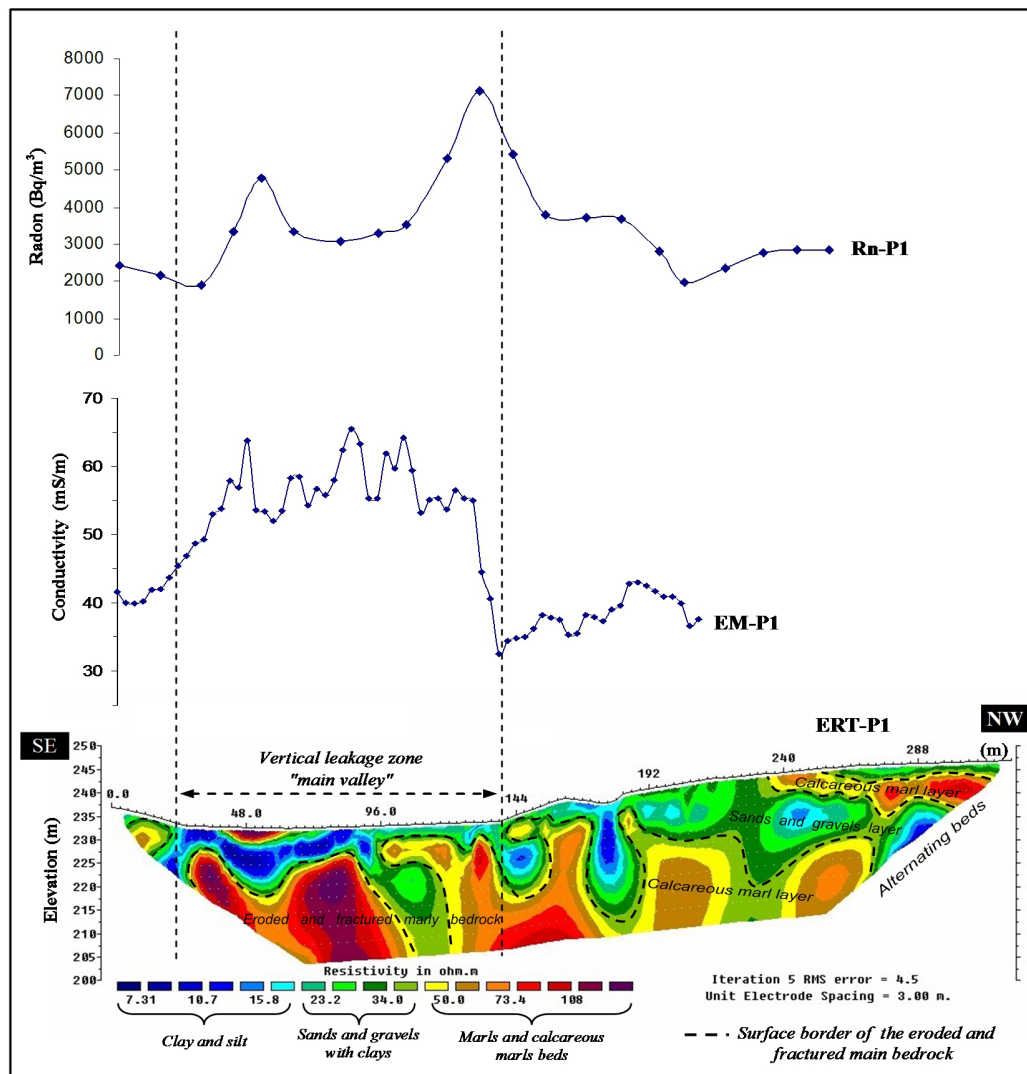
The figure (3) shows the interpretation of the P1 profile, which includes the combination of the ERT-P1, EM-P1 and Rn-P1 measurements. The geoelectrical ERT section reveals the presence of thick clay and alluvial deposits layer covering most of the main valley which extends along a distance of 144m. The thickness of these deposits reaches up and

more than 10m in some parties. In the middle of the main valley (X= 96m of the ERT section), the alluvial deposits extend downward towards the deeper formations. The extension of the alluvial deposits, in this form, could be resulted by the effect of the leakage of water laden with sediments towards the underline eroded layers (Figure 3). The resistivity values of these deposits seems to be relatively low and vary between 7-20 Ω .m. These deposits lay over eroded and fractured bedrock which is consisted essentially of marls and calcareous marls. The resistivity values of this bedrock are ranging between 50 and 120 Ω .m with a thickness could reach more than 20m depending to the applied configuration and the used electrodes spacing step (Wilkinson *et al.*, 2006; Szalai *et al.*, 2013).

Figure 3. Interpretation of the P1 profile which includes the ERT, EM and soil radon measurements that carried out in Afamia B dam.

With respect to the curve of the EM conductivity (Figure 3), it seems to be well correlated with the inverted ERT-P1 section. The high electrical conductivity values are related with the clay deposits that accumulate within the course of the main valley, where the values reach 70 mS/m ($\approx 14 \Omega \cdot \text{m}$). However, a sudden decrease of the EM curve appeared to be well corresponded with the margins of the main valley. This decrease could be due to lithological changes between clay deposits from one hand and sands and gravels from other hand, where the conductivity values decrease to reach less than 30 mS/m ($\approx 33 \Omega \cdot \text{m}$).

Concerning the radon concentration along the measuring profile (Rn-P1), two notable increases values were noticed at distances of 60m and 145m from the start point of the ERT-P1 section. The first small radon peak was found to be directly correlated with a higher permeability structure due to the presence of subsurface fractured zones close to the left edge of the main valley. The second anomalous soil radon signature was also recorded above the site of a major fracture, which

was delineated by the ERT-P1 geoelectrical section at the right margin of the main valley (Figure 3). These relatively high radon signals may reveal the existence of possible spatial relationship with the underlying permeable geologic medium that is associated with the expected fractured zones. Further, this finding may indicate the possibility of using soil gas radon technique as a useful tool for tracing unknown subsurface faults. In view of the geological environment of the studied dam, the

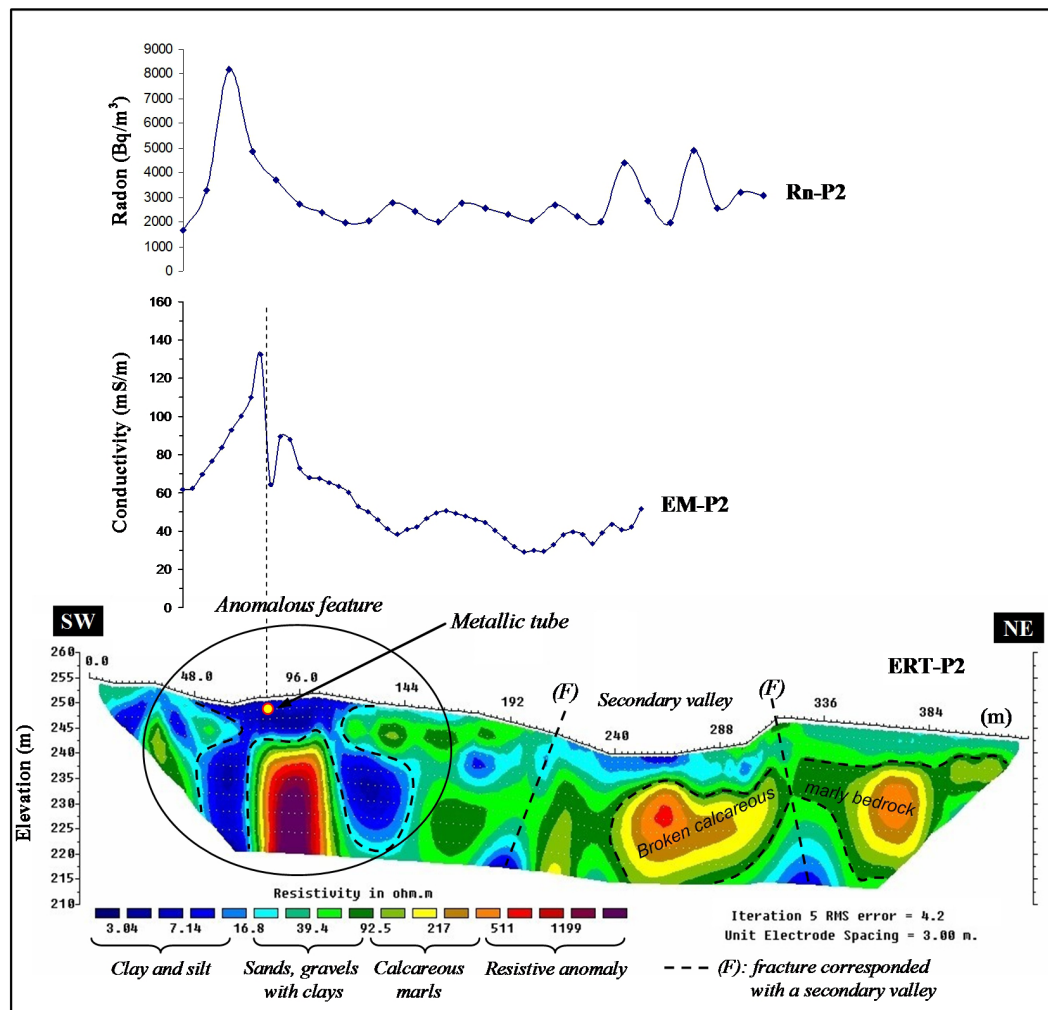
With regard to the ERT-P2 section (Figure 5), it seems to be structural different from the previous ERT-P1 profile because it does not has the same direction locality with respect to the general bedding trends. The most important thing which characterizes the geoelectrical ERT-P2 section is the existence of an abnormal subsurface feature located at the first third of the section. This anomalous feature has a special geometric shape and

located at a depth of 10m from the surface with downward extension. The real nature of this structure did not precisely determined and it could be related to compact massive rocks or archeological remains such as road or tunnel. Thus, more geophysical and archeological investigations are needed to confirm the true nature of this anomaly since the dam's lake is located within the geographic zone of the ancient Roman Afamia city and the site is filled by hundreds of buried Roman graves, wells and others subsurface archaeological monuments. The resistivity of the detected anomalous feature is relatively high and reaches more than 1200 Ω .m, whereas it very low and does not exceed 20 Ω .m for the clayey deposits that surround the outer edges of the feature. The structural discrepancy between the unknown feature and its surroundings may led to the development of an inhomogeneous

Figure 5. Interpretation of the P2 profile which includes the results of ERT, EM and soil radon measurements carried out in Afamia B dam.

situation and could play a negative role in permitting the water to leak down through the cracks that bounded the anomalous object. As the survey proceeds along the same profile (ERT-P2), another clay deposits were observed between the distances 240 and 300m from the start point of the profile. These deposits are lying through a small depression of branch valley that intersects perpendicularly with the linear course of the main valley in the area. However, the field observations indicate that such upright junction is mostly controlled by local tectonics where small fault segments are probably branching out from the main fault associated with the main valley. Moreover, it is clear that the local tectonic setting has led to the break the impermeable hard marl bed coincided with the secondary valley between the distances 210-310m of the ERT section (Figure 5). This finding may enhance in certain way to the occurrence of vertical leakage processes across the secondary valley.

Concerning the EM-P2 measurements, it has been observed that the electrical conductivity values increased notably above the detected anomalous feature reaching 140mS/m ($7\Omega.m$). The high conductivity values can be attributed to the accumulation of the clay deposits above the aforesaid abnormal feature. The shifting point which

is observed on the EM curve at a distance of 80m from starting point of the ERT-P1 section is mostly related to the existence of a buried metallic tube at 2m depth, which is connected to the filling tower for air evacuation uses. As the concerned metallic tube is completely surrounded by clayey deposits, thus it cannot be differentiated clearly by the ERT technique because there is no sufficient contrast in the electrical resistivity, while the EM technique is more sensitive and adequate for detecting buried metallic objects (Bevan, 2013; Dionne *et al.*, 2011). On the other hand, a major radon anomaly with a peak value of more than twice higher than the average background level was also recorded at the same locality where the abovementioned subsurface anomalous feature was detected on the ERT-P2 section (Figure 5). This anomalous radon observation is probably related to the surrounding environment of the detected object itself, which may provide an additional driving mechanism that could enhance the upward flow of radon gas through the outer boundary openings and fractures. The detected buried feature seemed to be coated by a thin layer of clay which seems to be shifted downwards through bounding fractures and by the flowing water and re-precipitated underneath the surface along the periphery of the object. Such process indicates mostly vertical discontinuity zones which may possibly

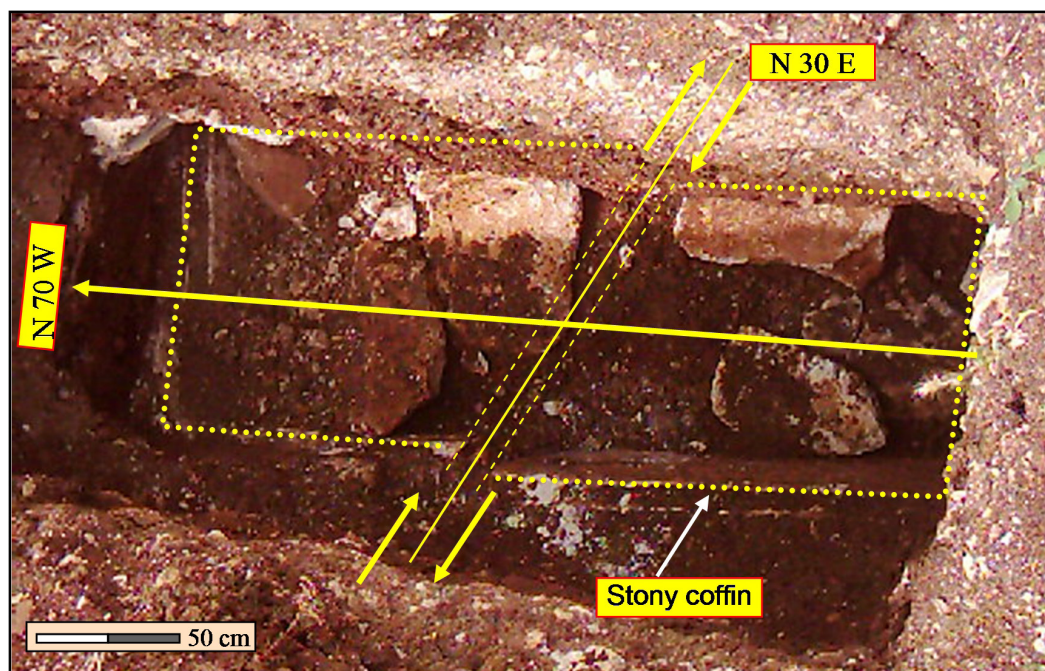
Figure 6. A photo of an archeological grave showing a diagonal fracture in a stony coffin found in the Afamia B dam's lake.

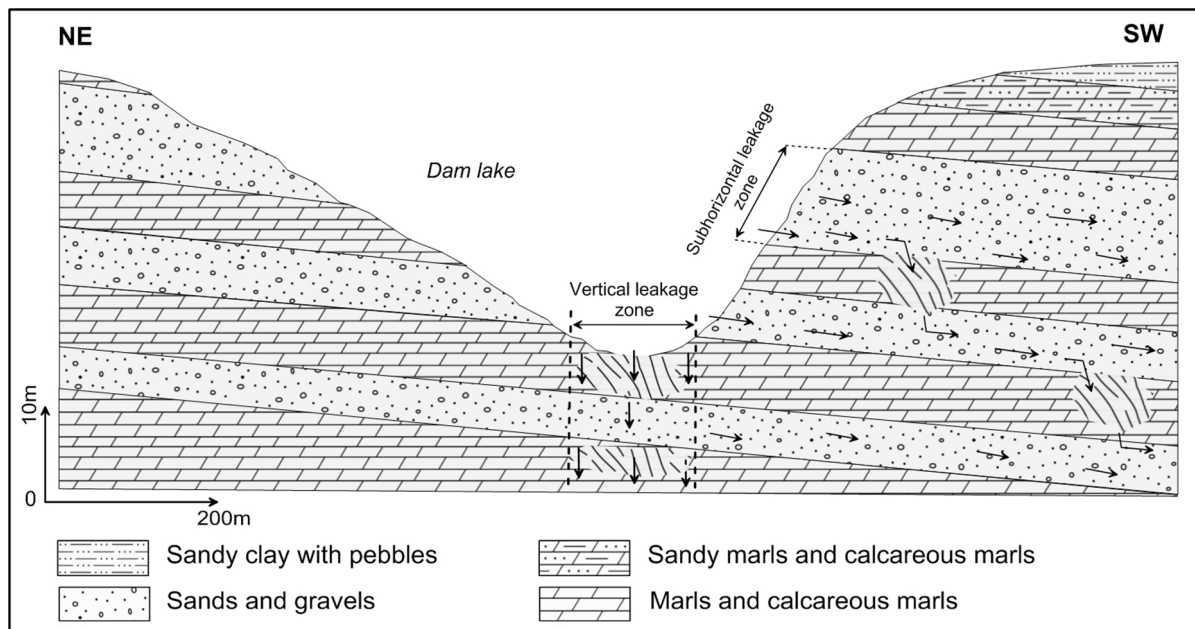
Figure 7. A conceptual model describes the mechanism of the water leakage in Afamia B dam depending on the interpretation of the geophysical and geological data.

Finally, depending on the results of the geophysical surveys interpretations and some lithological column of boreholes drilled in Afamia dam, a conceptual model was proposed to describe the probable mechanism of water leakage in the dam (Figure 7). Accordingly, two types of leakages can be identified; the first one is a subhorizontal leakage which occurs basically through the permeable layers of sands and gravels. The subhorizontal leakage afterward follows vertical paths in certain locations especially when it meets fractured zones within the calcareous marly beds. The second type of water losses is a vertical leakage, which basically takes place through the base of the main valley and its margins. The marly bedrock which constitutes the bottom of dam's lake seems to be severely eroded and deformed, and thereby it strongly enhances the vertical water leakage processes, which represents the major component of the leakage in the dam.
