Mendonça, Fausto; Urgessa, Girum; Rocco, José
Experimental investigation of 50 MPa reinforced concrete slabs subjected to blast loading
Ingeniería e Investigación, vol. 38, no. 2, 2018, May-August, pp. 27-33
Facultad de Ingeniería, Universidad Nacional de Colombia.

Experimental investigation of 50 MPa reinforced concrete slabs subjected to blast loading

This paper presents the results from blast tests conducted on four 50 MPa concrete slabs with reinforcement ratios of 0,175% and 0,37%. Two of the slabs were retrofitted with 50 mm thick foam in order to investigate the potential of using the foam as a strengthening option. The slabs were simply supported on two sides. Non-confined PBX (Plastic bonded explosive) was molded with the form of a cylinder measuring 20 cm in height and 10,5 cm in diameter. The explosive was detonated at 2 m stand-off distance. The equivalent TNT mass of the explosive ranges from 2,58 to 2,72 kg for the four tests. Accelerometers, displacement and pressure gages were used to measure blast wave parameters and global response of the slabs. A high-speed digital camera in conjunction with a rugged notebook recorded images. Qualitative and quantitative result

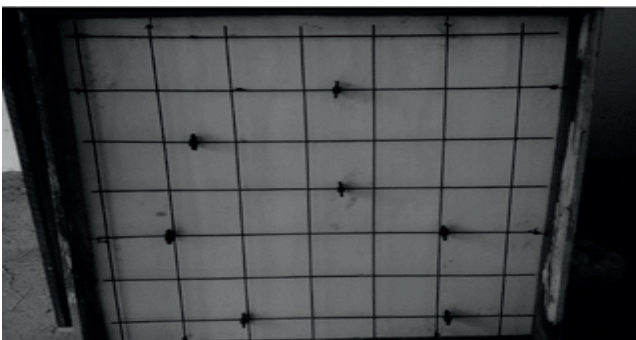
Both directions have 7 reinforcing steel with 5,0 mm in diameter, as shown in Figure 5. However, two more reinforcing steels of 10 mm were added along direction 1 to increase the reinforcement ratio in one direction of the slab, as shown in Figure 6. It was an option to verify the behavior of one more reinforcement ratio.

Figure 5. Reinforcement prepared inside the form before casting.

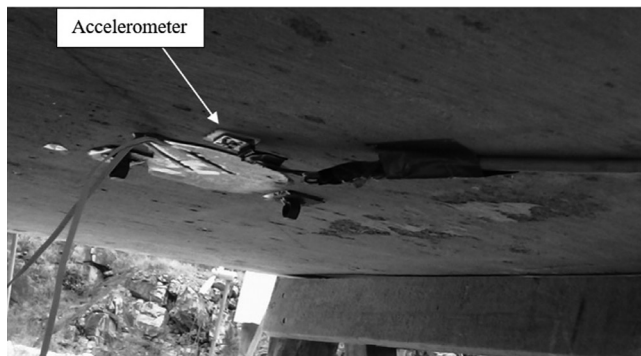
consisting of a circuit with 9V DC battery supply, a memory card, and an acceleration sensor MPU 6050. The accelerometers were calibrated using a turntable calibrator to guarantee that their recording was correct. MPU 6050 was attached to the bottom of the slabs to measure the acceleration due the shock wave as shown in Figure 8. The main circuit was placed inside a heavy lead box surrounded internally by foam where it was sheltered from shock wave and debris.

Figure 8. Accelerometer attached to the bottom of the slab before test.
Source: Authors

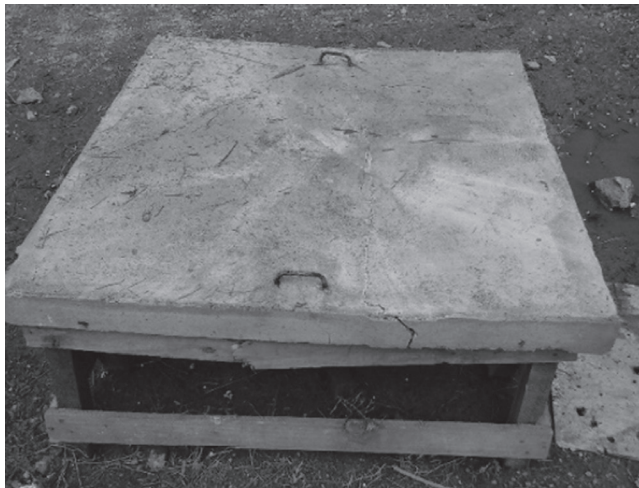
Overall slabs with EPS foam retrofitting experienced a higher linear momentum when compared to slabs without the foam retrofit. Slab 4 with EPS foam retrofitting developed the highest value of linear momentum, showing that the foam without thermal protection can increase the movement of the element retrofitted while the blast wave shocks the system. Slab 1 did not fail. Slab 2 failed as shown in Figure 14. Slab 3 developed the smallest linear momentum and did not fail as shown in Figure 15.

Figure 15. Slab 3 after test.
Source: Authors

Slabs 1 and 3 (Figure 15) resisted the blast effect in a better way than slabs having EPS foam retrofits. These slabs did not fail and remained in the original position even if they developed some cracks. The main and radial cracks generated at the bottom surface can be clearly seen in Figure 18.
