Project management applied to the infrastructure rehabilitation at the Universidad de Concepción,
Chile, following an m8.8 Earthquake

Revista de la Construcción, vol. 10, núm. 3, diciembre, 2011, pp. 29-40

Project management applied to the infrastructure rehabilitation at the Universidad de Concepción Chile, following an m8.8 Earthquake

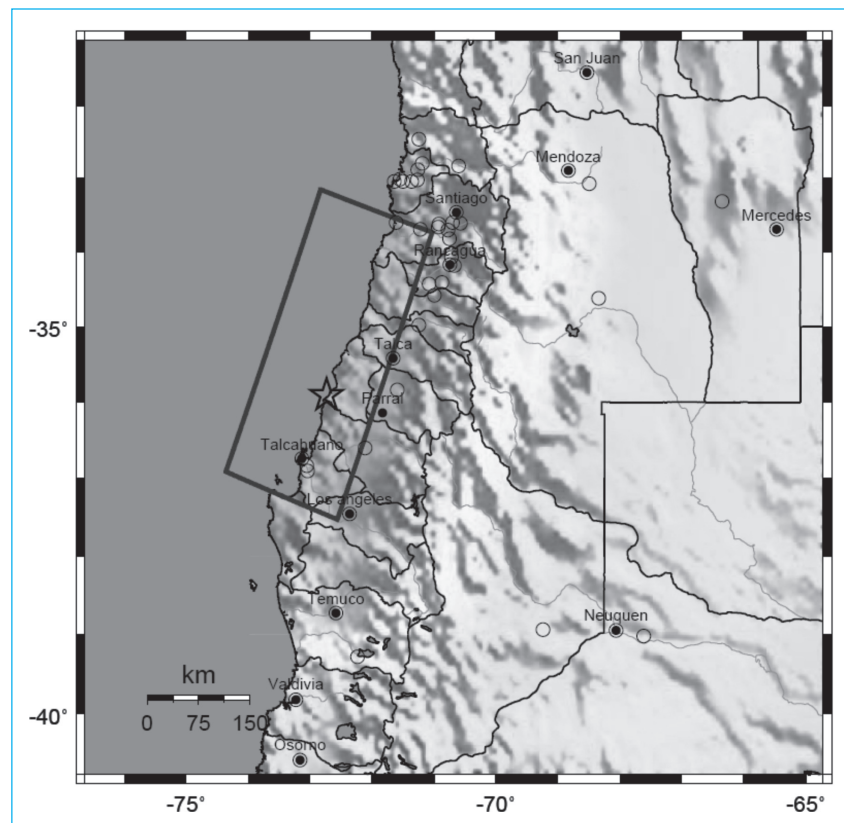
Figure 1. Diagram showing the epicenter of the earthquake on 27 February 2010 (USGS, 2010)

The 8.8 magnitude earthquake that occurred on 27 February at 03:34 a.m. (local time) in central Chile was caused by the sudden displacement of the Nazca plate under the South American plate in an area that extended from approximately the Arauco Peninsula on the south to Pichilemu on the north, covering about 450 km in length in a practically north-south direction and a width of some 150 km (Barrientos, 2010). The epicenter was located in the Pacific Ocean off Curanipe and Cobquecura, about 150 km northwest of Concepción (USGS, 2010).

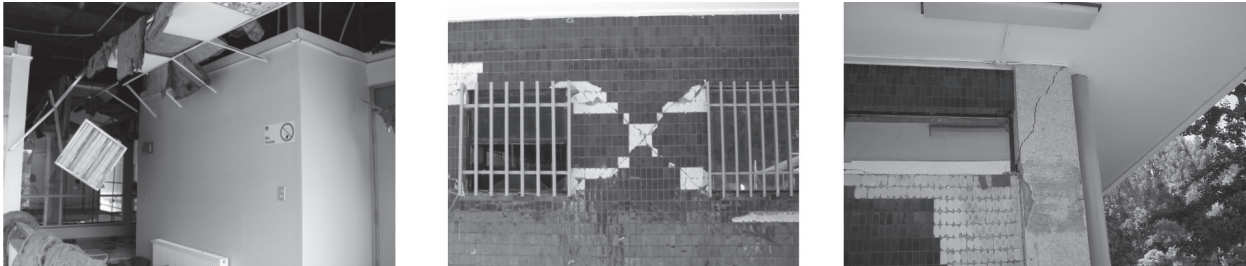
Figure 2. Damage to UdeC buildings (TCUDEC, 2010)

Those buildings constructed in the last 20 years (after the 1985 earthquake) received very little or no damage (classes 2 or 3). Typical problems included the falling down of ceilings, small cracks in brick partitions and walls, and movement in dilation joints between contiguous buildings.

The brick partitions of buildings constructed in the 1960s and 1970s, mainly buildings structured with frames, suffered abundant damage. However, the earthquake-resistant structure of the building remained unharmed. One exception was the Dental School building, which did experience structural damage.

The brick walls of the oldest university buildings (built prior to the 1960 earthquake) were damaged but withstood the earthquake well. These were subjected to a repair program based mainly on the incorporation of elements of reinforced concrete and repairs (or changes) of the confined brick masonry.

Excessively thick stucco, a lack of confinement (buttresses), and inadequate anchoring of secondary elements played a role in the recurrent faults of the buildings.

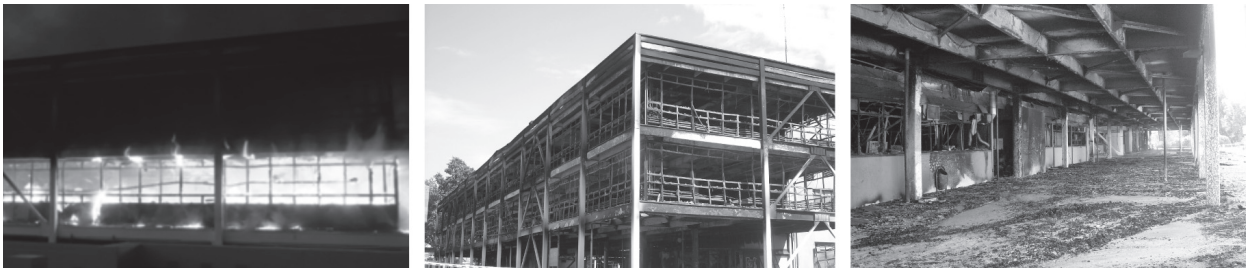
Figure 3. Burnt building of the Faculty of Chemical Sciences (TCUDEC, 2010)

The steel structure of the building of the Faculty of Chemical Sciences was totally destroyed by a fire that

was produced within the building as a consequence of the earthquake.

All the studies done recommended the deconstruction of the building.

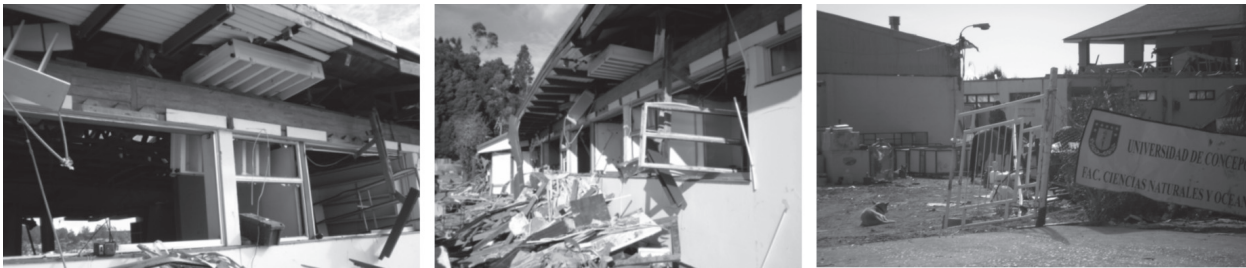
Figure 4. Destroyed Marine Biology Station in Dichato (TCUDEC, 2010)

The Marine Biology Station was destroyed by the tsunami that affected the town of Dichato. This station had a dock, buildings, and a vessel, among others.

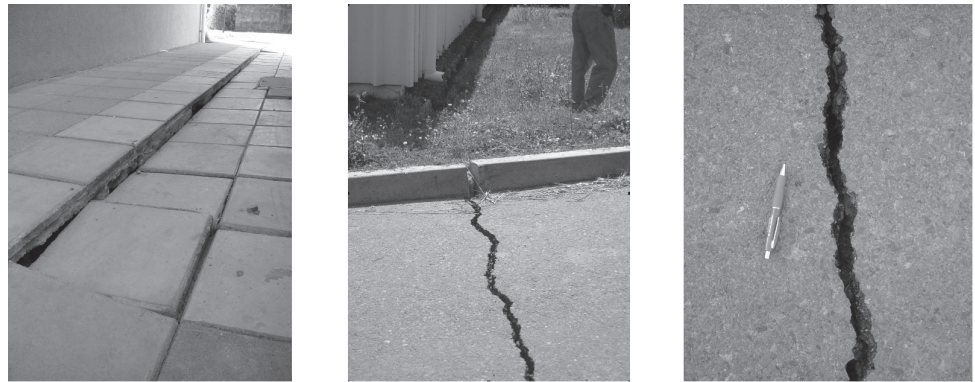
Figure 5. Damage to other infrastructure (TCUDEC, 2010)

Along with the damage to university buildings, other infrastructure was affected, including unpaved roads, paved streets within the campus, paved areas outside of buildings, and service networks. These repairs were not important in terms of amounts or time.

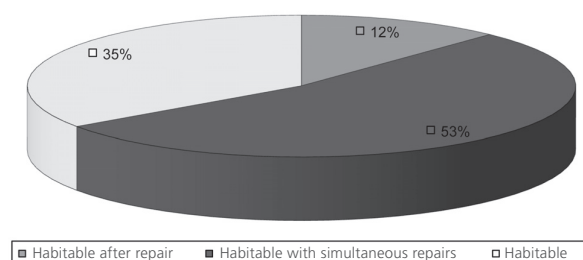
Figure 6. Habitability of UdeC buildings as of 5 April 2010 (TCUDEC, 2010)

Following the habitability criteria defined earlier, Figure 6 shows the habitability situation of the UdeC buildings on 5 April (the start of classes).

This figure was constructed over a universe of 141 buildings. Quantitatively, the buildings were classified as follows:

- Category 1: 17 buildings (12%)
- Category 2: 75 buildings (53%)
- Category 3: 49 buildings (35%)

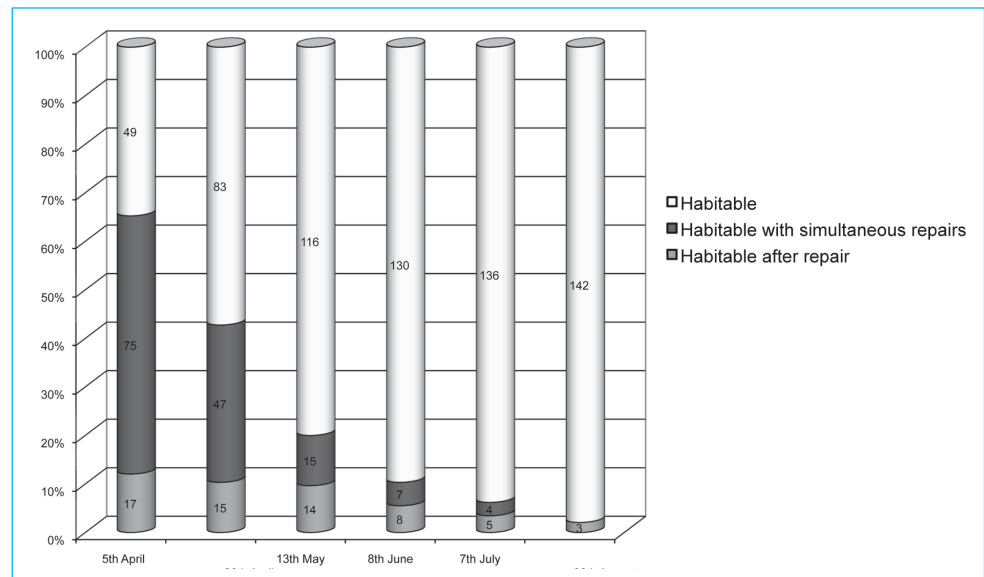
Figure 7. Habitability of UdeC buildings on different dates (TCUDEC, 2010)

In a certain way, the committee work was reflected in the progress of the recovery projects. As these advanced, the habitability classifications of the buildings were adjusted as shown in Figure 7.
