Melo Júnior, Carlos Mariano; Carasek, Helena
Relationship between the Deterioration of Multi Story Buildings Facades and the Driving Rain.
Revista de la Construcción, vol. 13, núm. 1, abril, 2014, pp. 64-73
Pontificia Universidad Católica de Chile
Santiago, Chile

Relationship between the Deterioration of Multi Story Buildings Facades and the Driving Rain.

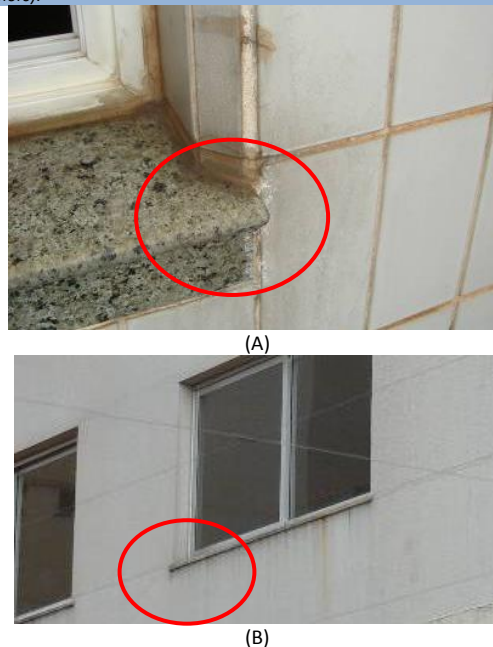
Fig. 1: Place of sample 1 collect (a) and place of sample 5 collect (b) (Developed by the authors).

Samples 1 and 5 were obtained from surfaces close to the window's ends, with the purpose of verifying if the stains originated from water flow, only described as dirt, also had microorganisms. Sample 1 was collected over the ceramic coating of the facade turned to the North direction, according to Fig. 1 (a), and sample 5 refer to the collection made over the coating in textured acrylic painting of the facade turned to West direction, according to Fig. 1 (b). The selection of the facades was done by the dirt aspect, in other words, facades with bigger proportions of stains were selected.

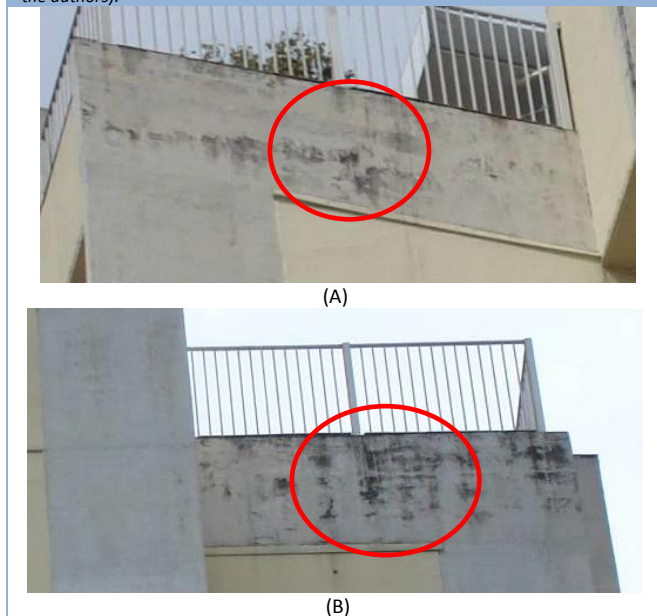
Fig. 2: Place of sample 1 collect (a) and place of sample 5 collect (b) (Developed by the authors).

Samples 2, 3 and 4 were extracted from the top region of the building, illustrated on Fig. 2, specifically of platbands having smooth painting finishing. The samples were collected from different orientations, being sample 2 collected from the facade turned to North, sample 3 collected from the facade turned to South, and sample 4 collected from the top region of which

divides the apartments, not having specific orientation because they are located in the middle of the building.

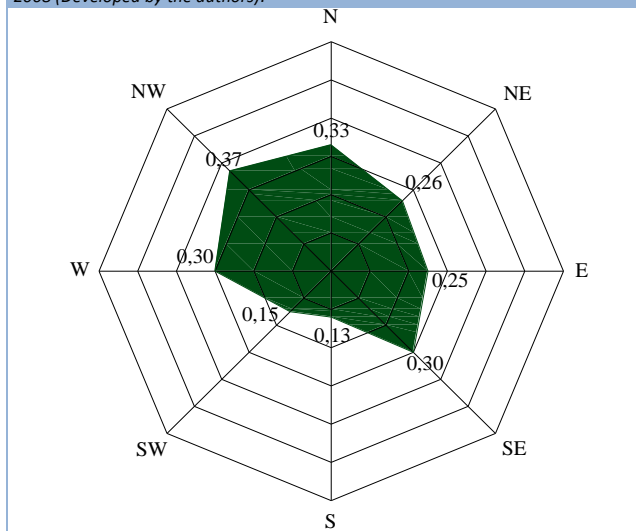
Fig. 4: Average of monthly directional driving rain indexes (m²/s), January, February, March, November and December, for Goiania in the years from 2002 to 2008 (Developed by the authors).

Through m-ddRI, which demonstrates the amount of incident rain related to the cardinal points, it is noted different behavior of the directed rain for the city of Goiania. By the average of the results, it is found that NW and N orientations receive higher rain indexes and S orientation lower index. Comparing the average of I₀, N, E, W and NW orientations presented higher values in mm/year and S and SW orientations the lower values.

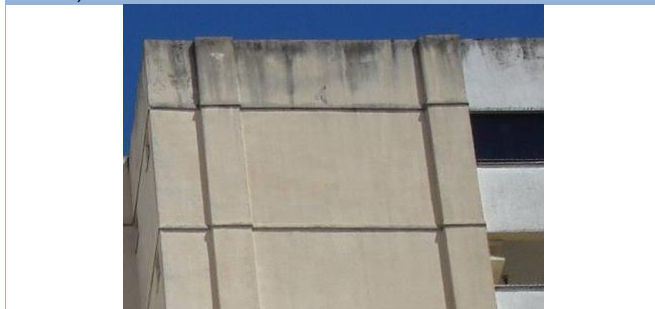
Fig. 7: Stains formed in platbands of Building 3. Facade N (Developed by the authors).

Fig. 6 shows the maps generated with the staining results in different facades of one of the buildings. These maps were made for all buildings, and Tab. 4 and Tab. 5 present the compilation of the results obtained in these maps. The results without numerical value are relative to the absence of architectural element in that facade. For the buildings 1, 2 and 3, the biggest stains formation happened at facade N platband (Fig. 7), also influenced by the absence of crowning.

moisture from rain, showed a predominance of staining for the N orientation. However, the facades facing the south orientation showed higher staining in regions of windowsills. This occurrence is explained by the low incidence of rain on these facades, resulting in limited capacity for water cleaning these paraments and giving rise to the so-called washed dirty.

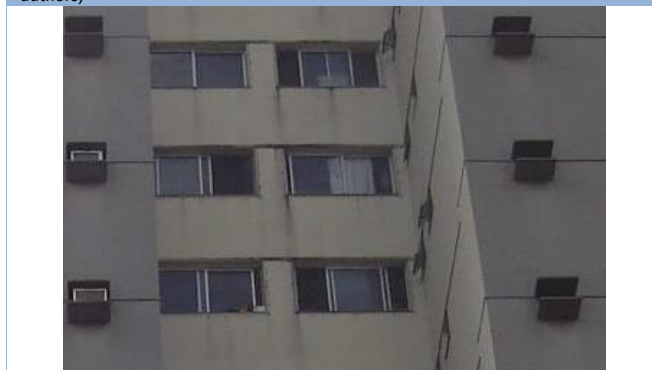
Fig. 8: Stains formed close to windowsill of Building 5. Facade W (Developed by the authors)

For stains formed in windowsill (Fig. 8), there were bigger cases on facades S for Buildings 1, 2 and 4. The stains formed over dripping pans occurred in larger quantity on the facades turned to South for buildings 2, 3, 4 and 5, highlighting that building 1

does not have dripping pans. The ghost-like stains occurred in higher percentage for facades S, for masonry walls.

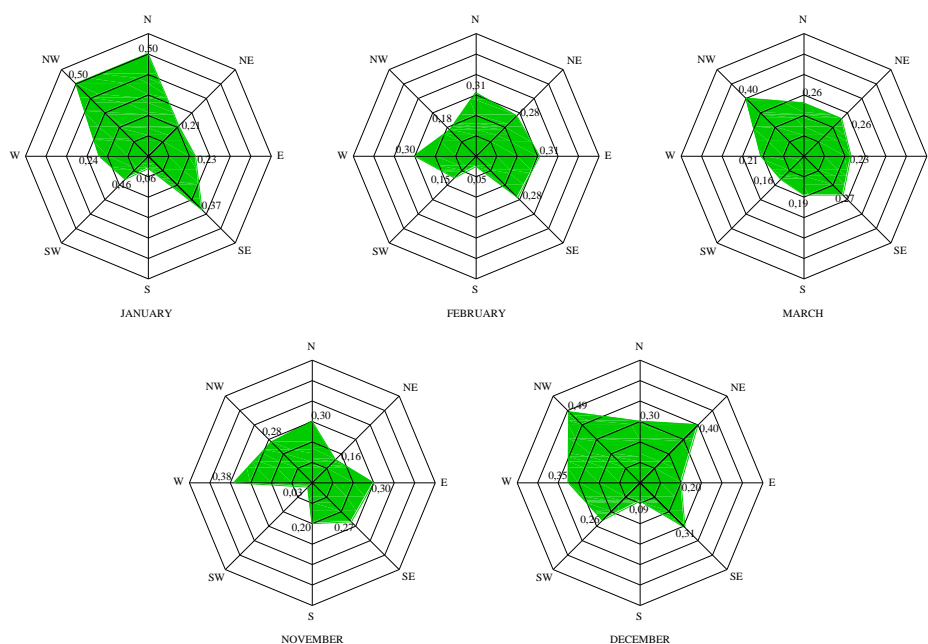
Fig. 3: Monthly directional driving rain indexes (m^2/s) for Goiania, from 2002 to 2008 (Developed by the authors)

From the classification proposed by Chand and Bhargava (2002), Goiania is classified with an exposure level of protected region. Fig. 3 presents the monthly directional driving rain (m-ddRI) within the period from 2002 to 2008, for the rainy period. Through the indexes, it is observed a different behavior for the orientations, having higher values in January for N and NW orientations. Fig. 4 results from the m-ddRI average for the rainy months of January, February, March, November, and December, presenting as higher value the NW quadrant (0.37 m²/s), followed by N quadrant with value equal to 0.33 m²/s, and with lower value quadrant S (0.13 m²/s). Fig. 5 presents the average of the driving rain amounts in vertical wall from period from 2002 to 2008. The NW, E, N and W orientations are presented as the most critical, followed by NE and SE facades, and S and SW facades are the less critical.
