Monteagudo, Silvia M.; Casati, María Jesus; Gálvez, Jaime C.  
Influence of the bed joint thickness on the bearing capacity of the brick masonry under  
compression loading: an ultrasound assessment  
Revista de la Construcción, vol. 14, núm. 1, 2015, pp. 9-15  
Pontificia Universidad Católica de Chile  
Santiago, Chile

# Influence of the bed joint thickness on the bearing capacity of the brick masonry under compression loading: an ultrasound assessment

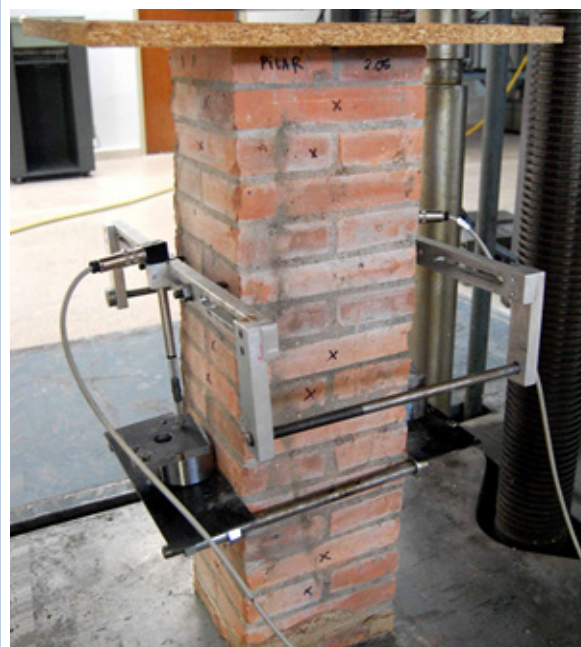
**Figure 1.** Compressive strength test in columns. Source: self-elaboration.

The nine walls and columns were tested under compression according to the European Standard UNE-EN 1052-1. The test was performed with a servo-hydraulic testing machine with 2000kN capacity and displacement control. In order to guarantee uniform load distribution, 1cm-thick chipboard was inserted between the plate of the load actuator and the specimen. In the case of the walls, a HEB250 steel beam was used. The contact of this beam with the wall was also made through 1cm-thick chipboard which was adjusted to the area of the wall base. The load was applied in load stages of 150kN, with deformation stabilisation at each stage.

Shortening of the specimen during the test was measured by LVDT extensometers with 40mm span. In the columns, two extensometers were attached on opposite sides by a steel frame fastened with screws Figure 1. Furthermore, four extensometers were attached to the walls, two on each face, by means of a methacrylate flange (Figure 2).

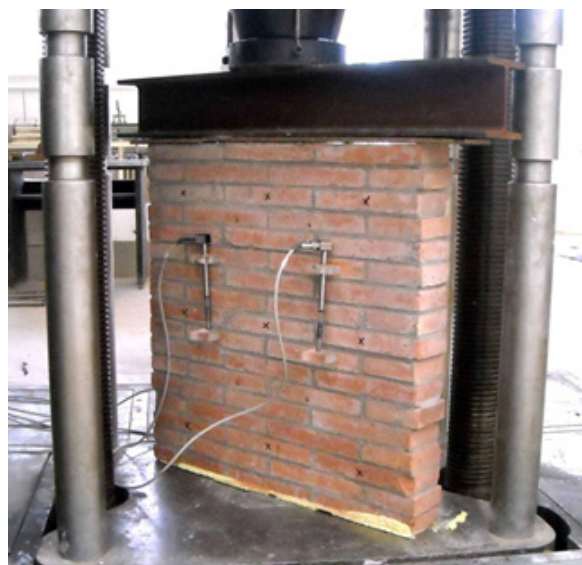
**Figure 2.** Compressive strength test in walls. Source: self-elaboration.

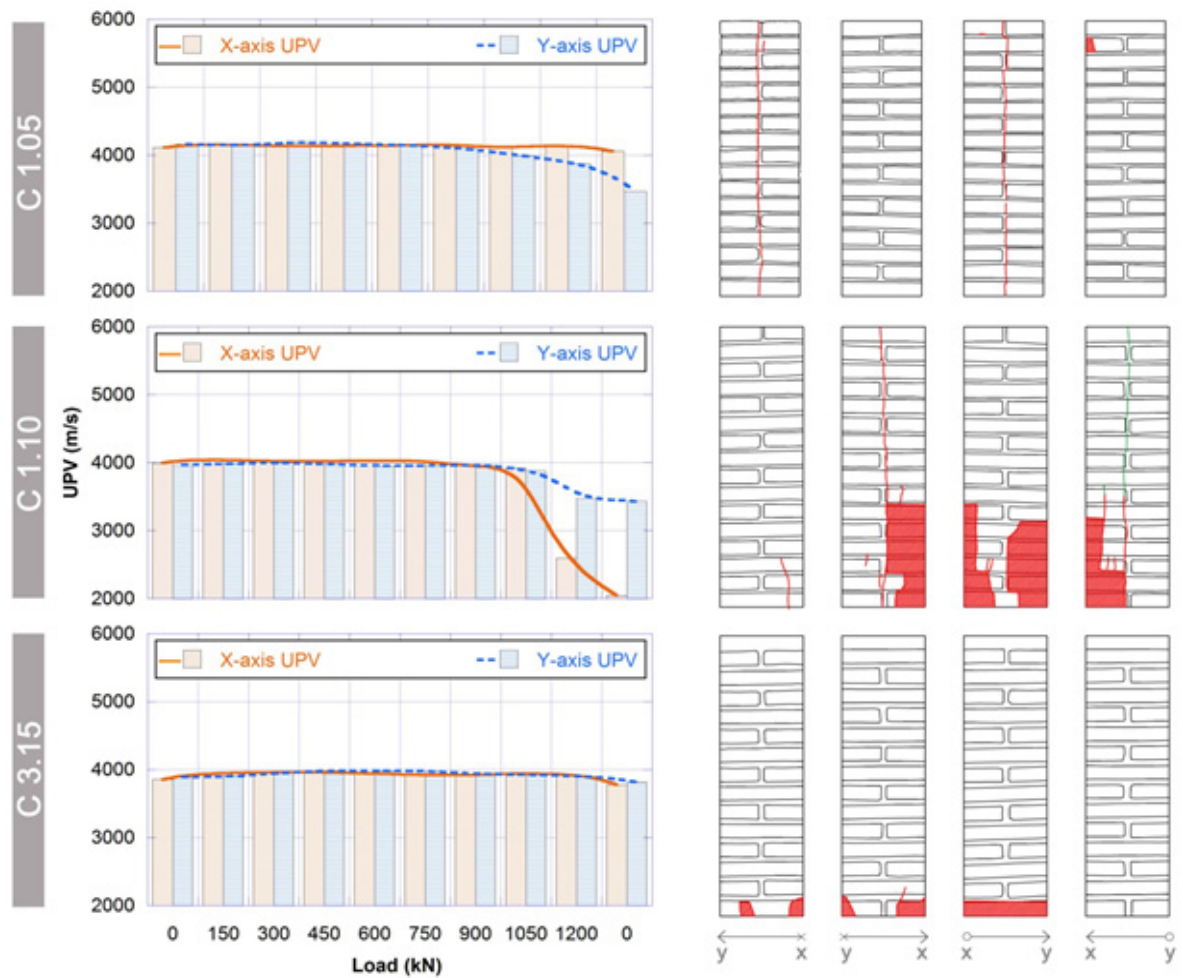
Figure 9. UPV depending on the load and scheme of the specimens rupture. Source: self-elaboration.

Moreover, the value of the UPV can be also indicative of the occurrence of internal cracks in the structure. As shown in Figure 9, there is a decrease in the Y-axis UPV measure for the specimen C1.05 from a load of 900N. This reduction corresponds to the appearance of a crack in the transverse direction (X-axis direction). Conversely, in the specimen C 1.10 the crack appeared in the opposite direction (Y-axis) and, therefore, the UPV wave decreases in the X-axis direction. Finally, the specimen C 3.15 has not produced any significant crack that interferes with the measures and, thus, the variation of the ultrasonic pulse is similar in each direction.
