IR thermography applies to the detection of solar panel

Revista de la Construcción, vol. 14, núm. 3, diciembre, 2015, pp. 9-14

In this work, we describe the use of infrared thermography (IRT) to detect anomalies in photovoltaic cell panels (ENERGY 10, 2000) used to generate electrical energy. The solar panel installation is located on the south-facing wall of the Science and Technology Building in the University of Oviedo (Spain).

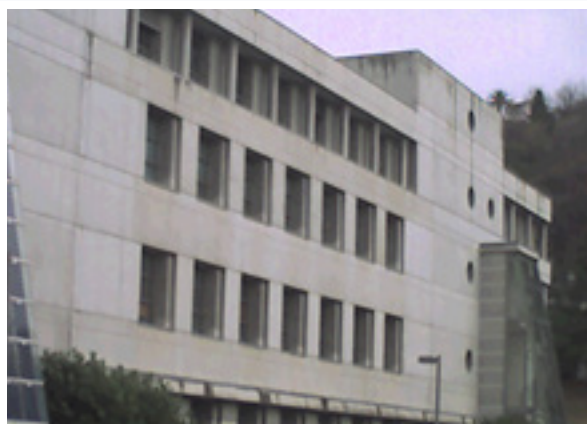
Fig. 1. Location of the solar panel installation. Source: Self-Elaboration.

The studied photovoltaic panels were installed in one of the outer glass south-facing walls of the Science and Technology Building in the University of Oviedo (Spain) in September 2008 (Fig. 1). Its purpose is generating electrical energy for its delivery to the network.

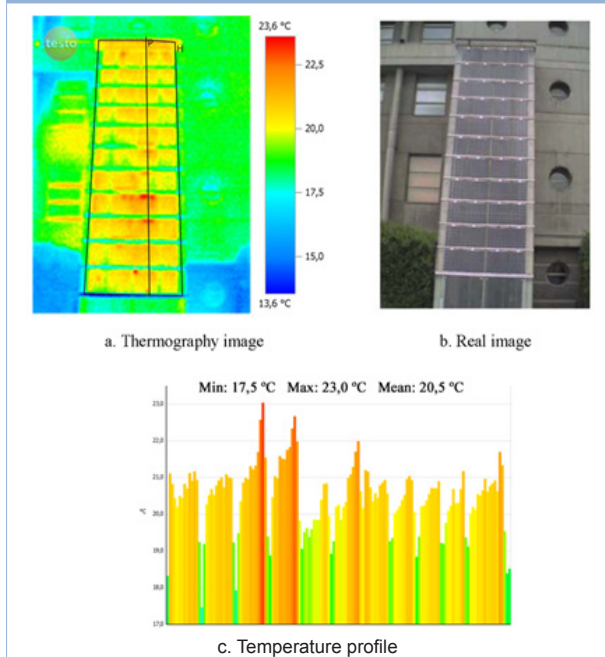
Fig. 3. General installation. Source: Self-Elaboration.

The thermography image (Fig. 3a) shows a very uniform temperature distribution with a 95% of the surface with temperatures between 18,5° and 21°C, and some isolated points with temperatures above 22,5°C. The same results are obtained from the vertical temperature profile (Fig. 3c). In addition, in this case the image shows a very light reduction of the temperature from the highest zone of the building to the lowest one. This behavior is caused by the lean of the building.

However, from this previous analysis it is possible to divide the area of study in three anomalous different zones:

- Zones with lower temperatures, between 17° and 18° C. These ones come from the metal supports.
- Zones with higher temperatures. These ones come from the panels near to the metal supports. In this case the metal sections increase the temperature due to the solar radiation reflected (Lyberg, Mattsson, & Sundberg, 1990), (Seeber, 1984).
- Critic zones. These points display very high temperatures (23°C) with respect to the average one. These values can be the result of damages in some cells or damage inside the circuit of transport, and they must be analyzed.

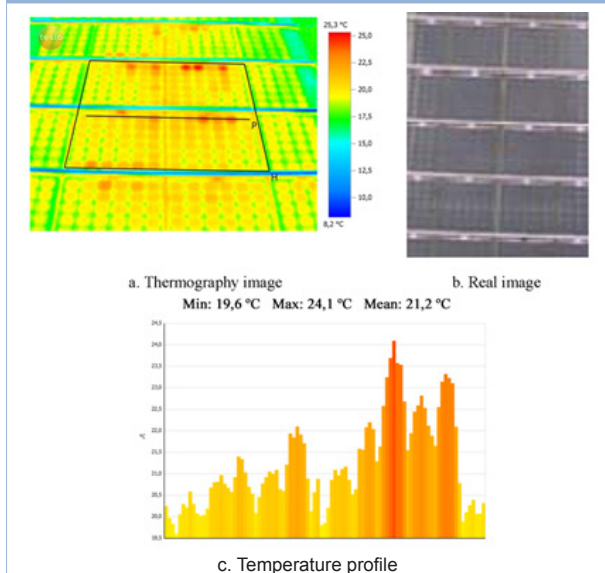
Fig. 4. Groups of panels. Source: Self-Elaboration.

In the same way that the analysis previous, the study of the different panels shows that a great percentage of the surface has temperatures with values near to the average one. As it was previously mentioned, the lean of the building produce changes in the temperature so the average value of the panel depends on its situation. However, in all the panels it was found that the average value is bigger that the gotten in the general installation. This increase is because of the exclusion from the analysis, of the metal supports and the gaps between panels.

But although the metal supports are outside the analyzed area, they cause that the nearest cells display higher temperatures (Fig. 4a). In the panels there are also areas with lower temperatures than the average one. These areas are the separations between panels (Fig. 4c).

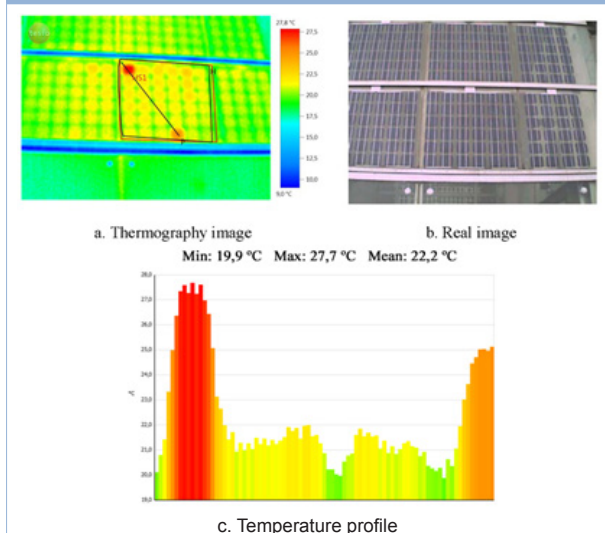
Fig. 5. Critic zones. Source: Self-Elaboration.

The study of the general installation has showed one critic zone in the lower panel of the building (Fig. 3a). The analysis of this zone has displayed two hot spots (Fig. 5a) with temperatures around 26 and 28 °C against an average temperature of 21 °C (Fig. 5c). Their visual inspection (Fig. 6) has revealed that these high temperatures were due to deterioration in the cell-to-junction box transmission circuit that generated a positive temperature gradient.

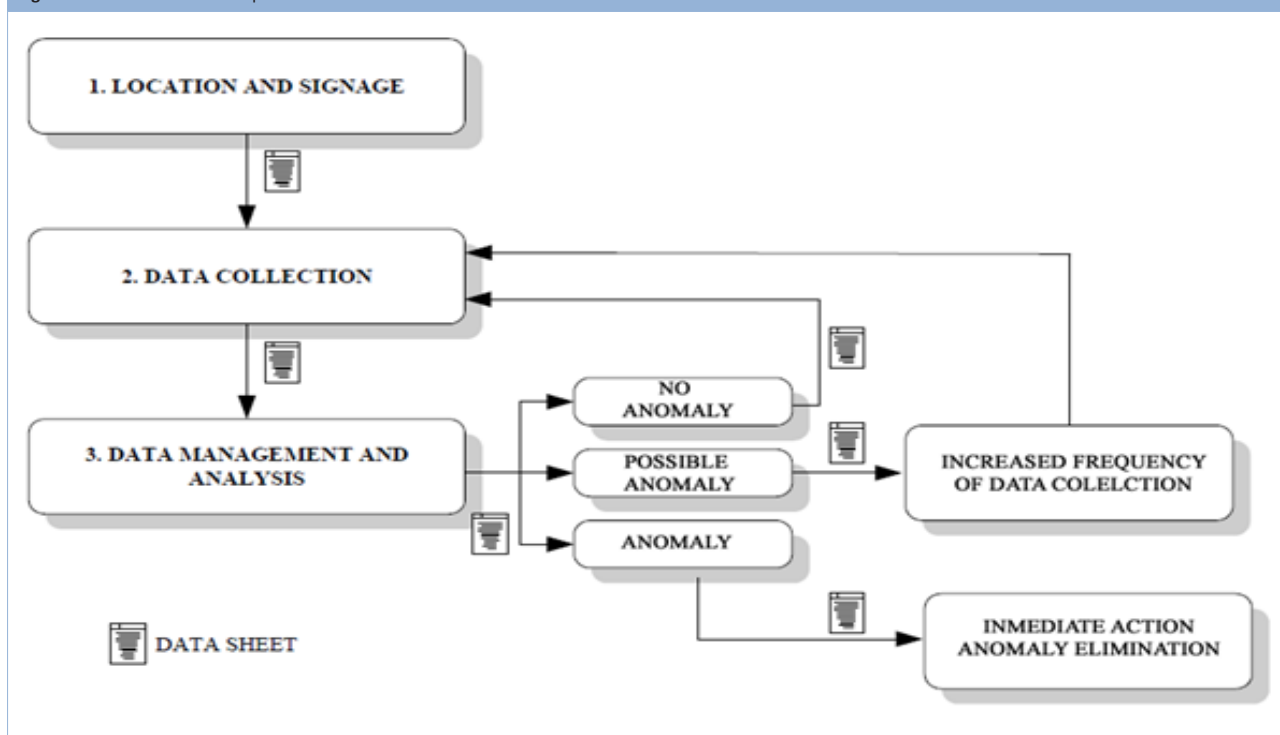
Fig. 7. General schema for the procedure. Source: Self-Elaboration

Based on the previous analysis it is possible to identify and evaluate the areas with anomalies. Three levels are established with different protocols for action (Fig. 7).

- No anomalies: continue gathering and monitoring data with the established frequency
- Possible anomalies: increase the frequency for gathering and monitoring data.
- Anomalies: proceeded to carry out the required operations to eliminate the failure
