Nova Scientia, vol. 6, núm. 11, noviembre-abril, 2013, pp. 113-134

Estudio a nivel laboratorio de la Degradación  
atípica en un refractario tipo  $\text{SiO}_2$  utilizado en  
hornos de inducción

Laboratory scale study of uncommon  
degradation  $\text{SiO}_2$  refractories used on induction  
furnaces

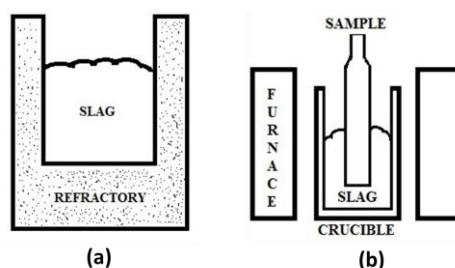
**Fig. 1** Slag methods test, (a) crucible test, (b) dipping test.

Two methods were used to analyze the slag attack and degradation mechanism. The first one is the crucible, cavity, cup or brick test (static), which consist in a hollow drilled piece of refractory or a brick that is filled with slag and exposed to high temperature to promote slag – refractory interaction, **Figure 1(a)**. The advantages of this method are that it is simple and many samples can be tested quickly. For this test, molten slag (1300°C) was poured into the drilled bricks and cooled down at room temperature. Crucible method allows evaluating the slag-penetration into refractories or reduction of wall thickness (by spalling or dissolution), also to evaluate by visual inspection as: unaffected, lightly attacked, attacked or corroded refractory and together with

optical microscopy analysis it will provide the enough knowledge of the refractory texture and raw materials binding (Freud, 2010, 3). The second ones, it is known as the dipping, immersion or finger test (dynamic) where one or more cylindrical or square pillar shaped refractory samples are held in the corrosive slag for a certain period of time in an induction furnace.

In this method, the atmosphere is easily controlled and slag with different chemical composition can be added to get a rapid saturation with reaction products which are controlled by using variable volume of slag relative to the size of samples, **Figure 1(b)**. In this case, two ductile iron pieces (used as scrap) were melted (1380°C) and adding Slag 1. Once the slag was dissolved, a refractory sample was submerged into the liquid/slag mix. The same procedure was applied using Slag 2.

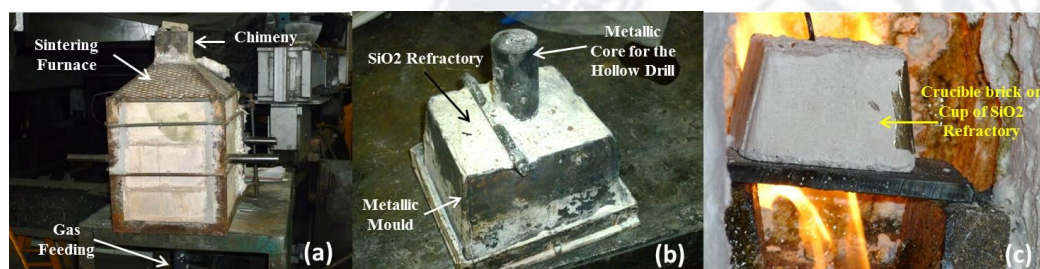
**Fig. 2** (a) Sinterising furnace, (b) metallic mould for refractory brick, (c) Sintered brick.

It is important to make clear that, because the  $\text{SiO}_2$  lining is hard and fragile, it was quite difficult to cut and drills a hole on it, so a small furnace and some bricks of vibrable material were made it following the standard sintering process, see **Figure 2**. The  $\text{SiO}_2$  material was vibrable compacted on a metallic mould and heated for 4 hours at 600°C, after this, the brick was pull out and heated again during 4 hours more at 1200°C until got it hard.

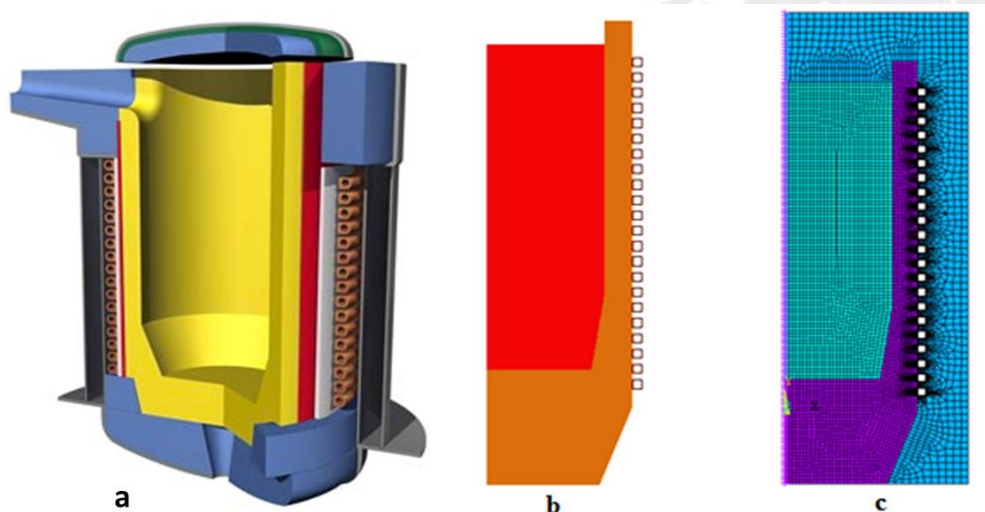
**Fig. 4** Induction furnace modeling: (a) Furnace, (b) axisymmetric model and (c) Plane 53 and fluid 141 grid.

Lorentz law is the universal expression of the force exerted by electromagnetic fields (EMF) on a volume containing a distribution of electrical charges and currents. If electric and magnetic dipoles are present in a material medium, they are traditionally treated by expressing the corresponding polarization and magnetization distributions in terms of bound-charge and bound-current densities, which are subsequently added to free-charge and free-current densities, respectively (*Mansuripur 2012, 5*). For the electromagnetic field (EMF) modeling, an axisymmetric model was performed using the Ansys® software, for this, it was necessary to take into account the coils characteristics, cast iron properties and the  $\text{SiO}_2$  base refractory features. In this case, for the furnace analysis, real commercial kiln dimensions were used (for an industrial capacity of 12 Ton of metallic charge). A designed grid with the Plane 53 element tool was used for the Lorentz force ( $f_L$ ), as shown on Figure 4, with this grid, a total of 7854 elements and 24507 nods was obtained and for the velocity fields ( $V_f$ ), a square grid of four nods, it was made it with Fluid 141 tool. Basically, the operative variables were the same that are used in a foundry process, as such frequency, current, voltage and potency. As first target of the simulation work, it was to determine the modeling conditions to known whether or not there is any preferential velocity vector of the metal liquid against the furnace walls. The properties of the cast iron are shown in Table 3, and the  $\text{SiO}_2$  base refractory and the coil properties are presented on **Table 4**.

The potency (P) and voltage (V) values used to operate the furnace were also employed to calculate the current (I) throughout the relationship  $I = P/V$ , the data results are displayed on Table 5, and taking into account the area and properties of the coil material, the current density (Js) was the next (see **Table 5**).

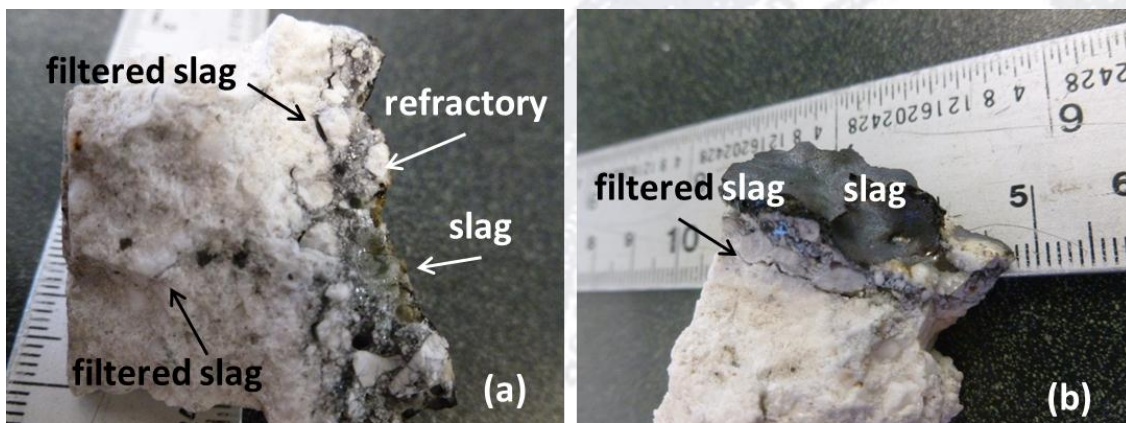
According to the visual inspection, the **Slag-2** penetrates up to two centimeter ahead of the hot face (slag area), **Figure 5a**, and also propagate along the slag/refractory line, **Figure 5b**, and spalling the  $\text{SiO}_2$  material (arrowed), it is clear that the grain boundary works as path corrosion but mainly across the aggregate grains but, the slag infiltration had must started in any porous. In refer to this, on they work, *Kaupuzs et. Al (2003, 40)* argue that silica has the advantage of strong expansion effect for getting high material density after heating and for closing cracks after reheating but, its chemical resistance is still, relatively, lower than other refractory materials. Very often coarse refractory grains break off when the matrix is rate determining for the corrosion rate (*Pötschke 2005, 111*).

**Fig. 5**  $\text{SiO}_2$  based refractory - Slag-2, (a) filtered slag about two centimeters from hot to cold face, (b) filtered slag on the slag/refractory interface.

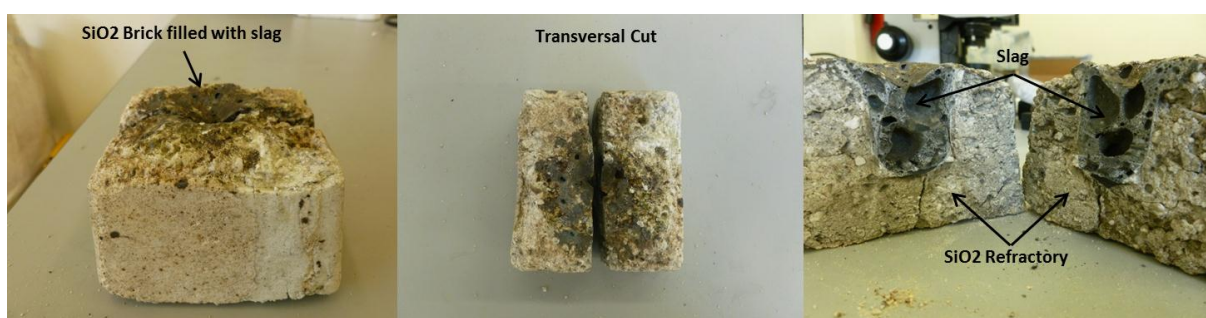
Despite the fact that working life of  $\text{SiO}_2$  base refractory linings used in foundry process has been extended greatly in the last decade, common problems still persist but with some variations on its failure behavior, thus, it is important to understand the degradation mechanism of these improved refractories under different slag chemical concentration. On **Figure 6**, the crucible test result is showed.

It can be observed that the cavity was well filled with Slag-2 and the same result was produced using Slag-1. At first sight, the fabricated  $\text{SiO}_2$  brick seems look very well compacted, so the industrial sinterised conditions were applied correctly. Similarly, the dipping test is presented on **Figure 7**, where a laboratory inductions furnace was used to add Slag-1 and Slag-2. Optical microscopy samples were carefully cut to be analyzed by reflected light technique.

**Fig. 6** Cup degradation laboratory test,  $\text{SiO}_2$  brick filled with Slag-2.

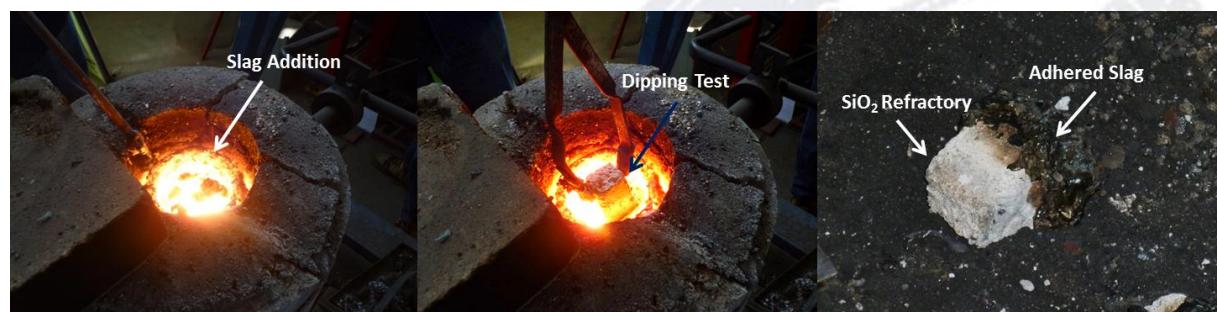
**Fig. 7** Laboratory Dipping test,  $\text{SiO}_2$  brick dipped on Slag-2.

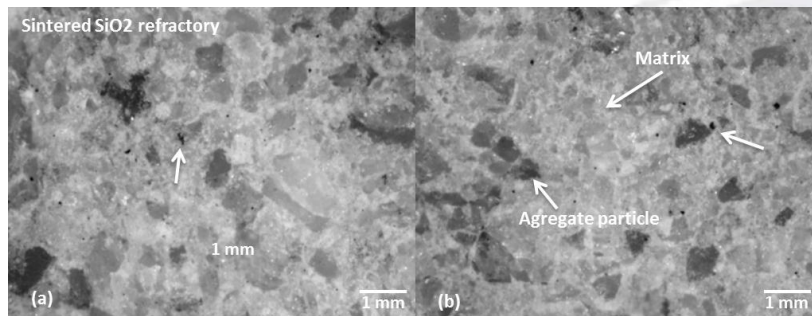
As was said before, laboratory SiO<sub>2</sub> brick was well sintered with the help of B<sub>2</sub>O<sub>3</sub> addition, not excessive spalling grain was observed before and after being cut which allows evaluating the slag effect on it. The matrix looks mostly uniform and some of the aggregate grains appear to be well bound having a particle size ranged from ~0.5 to 1.5 mm. **Figure 8.**

However, a noticeable aggregate grains sized from ~1.5 to 2.5 mm (or more) was found forming some kind of clusters as pointed on **Figure 8 (b)**, and not significant porosity was observed at these magnifications. In reference to this, *Kalpakli (2008, 85)* improved the properties of a material refractory reducing the aggregate grains size from ~3 mm to ~1.5 mm, and the apparent porosity was decreased from 18.5 % to 16.5% respectively, but in our case, the aggregate grains are grouping quite similar to the grains showed on **Figure 5** where the crack is propagated along their boundaries.

**Fig. 8** Matrix of the laboratory sintered SiO<sub>2</sub> – brick.

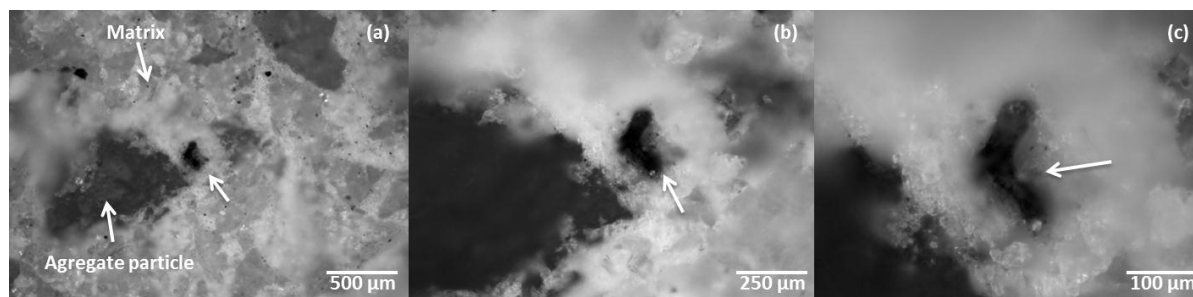
Not surprising, analyzing the refractory at 200X magnifications, some particles of irregular form were found close to the aggregate grains, some of them remain partially there but other just gone leaving hollows, **Figure 9**. So far, we can consider as normal these materials characteristics since certain porosity is allowed, about 10%.

**Fig. 9** Small particles found close to aggregate grains.

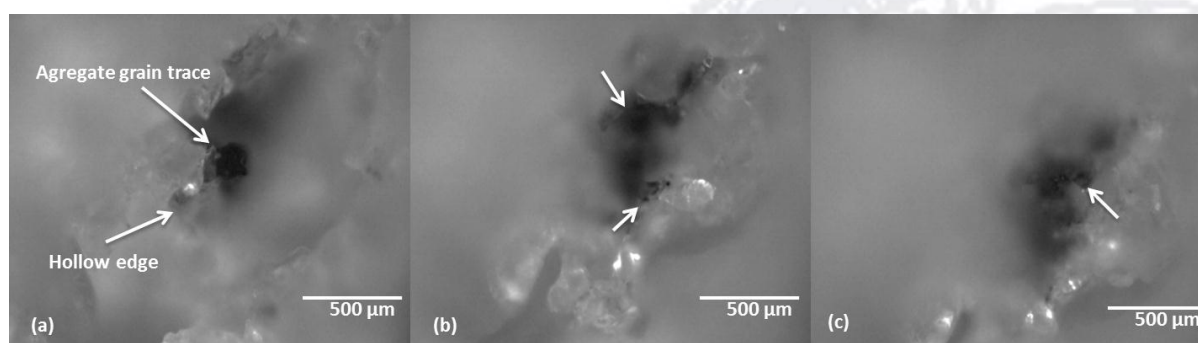
The same kind of pores was observed on the  $\text{SiO}_2$  refractory matrix, most of them produced by a particle came off, sometimes there is a small pieces on the bottom of the hole or attached on the pore walls, **Figure 10**. On his work, *Jansson (2005, 283-284)* explain that slag resistance is also affected by the refractory porosity. Refractory corrosion is favored by slag penetration which soaks into the pores, dissolving the material refractory and causing stresses and cracks in the lining due to differential expansion, of course, all these factors are affected by the melting temperature which is controlled by the current and voltage variables.

In addition, difference of thermal expansion between the aggregates and the matrix of  $\text{SiO}_2$  refractory can lead, during heating and cooling stages, to the development of a large microcracks network within the microstructure, having a strongly effect on the thermo-mechanical properties: thermal expansion coefficient, Young's modulus and stress-strain law (*Huger 2009, 578*).

**Fig. 10** Small particles found on the refractory matrix.

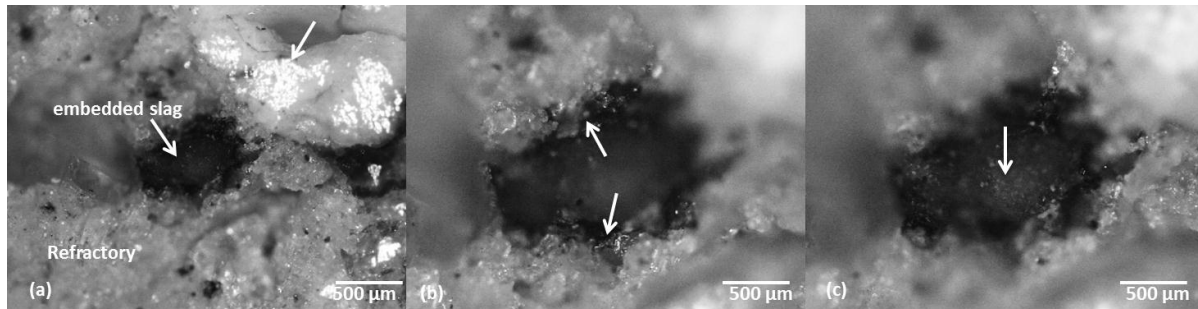
The results obtained from the crucible and dipping test developed similar slag penetration behavior to the specimen extracted from the industrial induction furnace. The favorable points to initiate the slag filtering were the pores as was explained before, **Figure 11(a)**. The Slag-2 is filtered in the pinholes and kept inside, starting a refractory degradation both in walls and bottom of the hollow, as can be seen on **Figure 11 (b) and (c)**. It can be observed that the pore is shaped very similar to the one showed on **Figure 10**. Similar behavior is reported by Wang *et al.* (2008, 111 ) who explains that the corrosion reactions occurs around pores and along crack toward the interior due to the grain boundary acts as path of corrosion reaction.

**Fig. 11** Slag-2 penetration in a hollow produced by a particle came off.

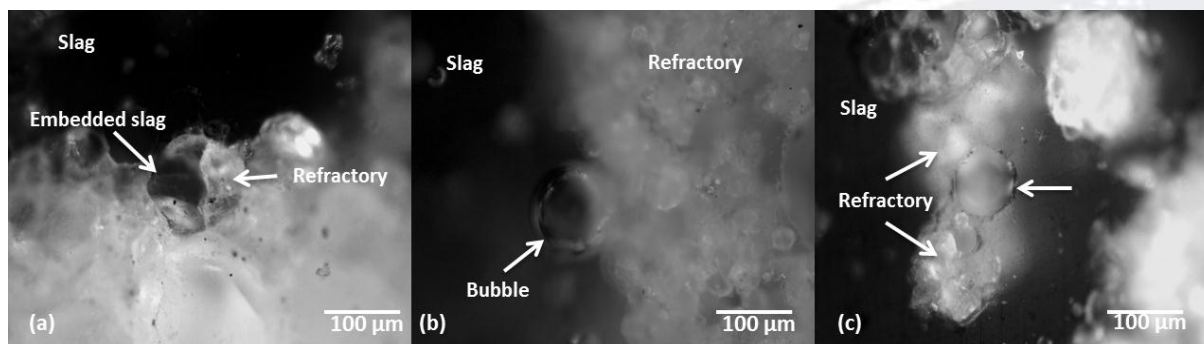
Lee and Zhang (1999, 186) explain that, capillaries, such as pores and microcracks are the main way to initiate slag penetration into a refractory material. Thus, the penetration rate  $dl/dt$  of slag into a capillary can be expressed by Poiseuille's law which is reported by Jansson (2005, 285) as follow:

Where  $\Delta P$  is the capillary pressure difference (Pa),  $\gamma_{l-g}$  is the surface tension liquid – gas (N/m),  $\theta$  is the wetting angle slag – refractory (°) and  $d_{\text{pore}}$  is the diameter of pore/capillary (m). From this relationship, there is no doubt that a pressure is required to fill the pores of the refractory material - in this case a refractory  $\text{SiO}_2$  base - where the pressure force is dependent of the wettability of the refractory by the slag. This capillary effect is well illustrated on **Figure 12** for Slag-2. It can be observed how the slag is embedded into a pore which is partially occupied by a refractory grain, **Figure 12(a)**, and it seems to be the beginning of the refractory spalling as can be seen on **Figure 12(c)**, also some bubbles (probably of gas) are located in the slag/refractory limit. Similarly, *Lee and Zhang (1999, 86)* explains that the slag penetration give arise to refractory degradation, where dissolution at refractory/slag interfaces is governed by (a) chemical reaction (or solution) at the interface or (b) transport (or diffusion) of reacting species through the liquid. Phases of dissimilar chemical composition tend to react at high temperature, so that to limit the extent of dissolution, the refractory material and metal liquid should be of similar nature which is not happening here due to the scrap quality, 2<sup>nd</sup> class slag. The corrosion rate of refractories is increased with the increasing of the FeO content in the molten, which come from the steel scrap, some reported values indicate that with 12% of FeO a corrosion rate of 2.5 g/h could be produced (*Liu 2008, 51*).

**Fig. 12** Slag-2 penetration and refractory spalling.

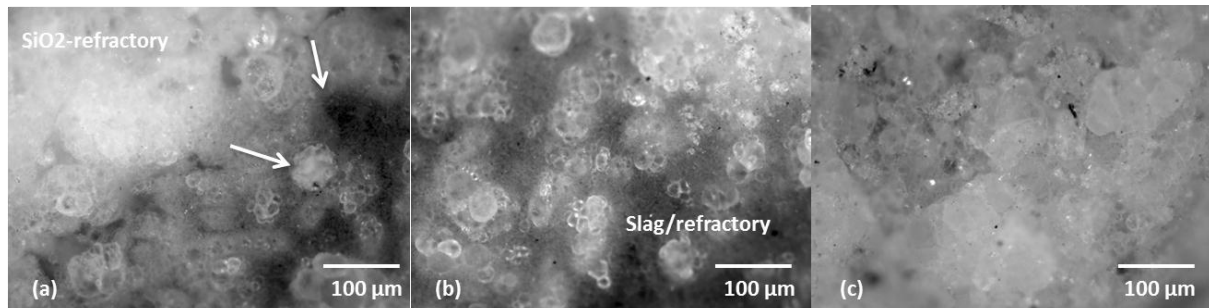
In refer to the slag produced by the 1<sup>st</sup> class – scrap; the degradation effect was less aggressive than produced by the 2<sup>nd</sup> class, as can be seen on **Figure 13**. The Slag-1 wet the material refractory and appears to form a thin slag film covering the material (**Figure 13a**) and delaying the refractory degradation (**Figure 13b**). Some research works explain that one of the reaction products of the slag is a solid phase that forms as a continuous, adherent layer on the refractory

surface, then this layer may act to delay the overall rate of corrosion of the refractory material (Lee and Zhang-1999, 87, Den Hoed-2000, 57).

**Fig. 13** Slag film formed on SiO<sub>2</sub> refractory using 1<sup>st</sup> class scrap (Slag-1).

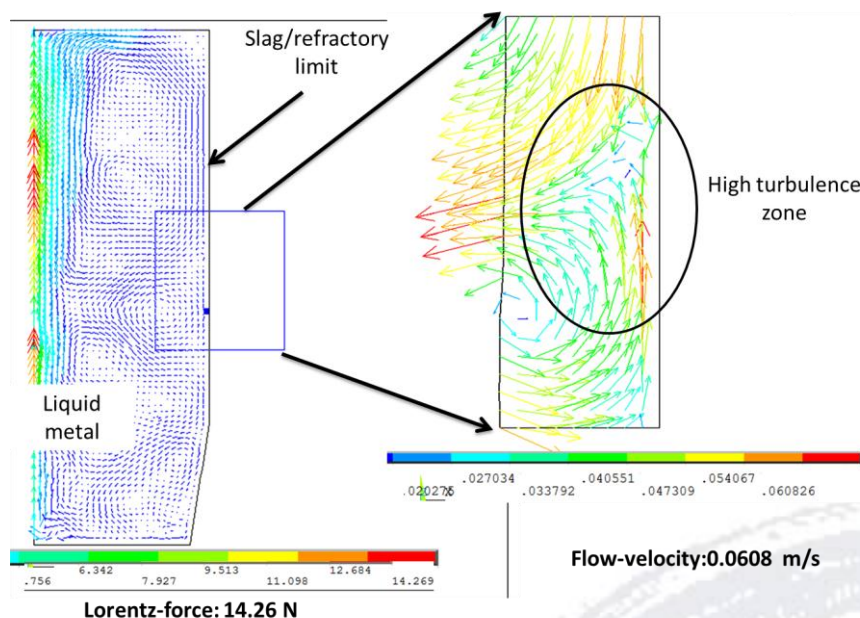
On the other hand, the molten modeling results showed that there is a preferential vector direction of the liquid metal against to the induction furnace walls. **Table 5** presents the modeling results. It can be seen that at low frequency (50 Hz) the Lorentz force is low (7.375 N) but the velocity is high (29.09 m/s) and its vector direction is parallel to the furnace walls, so is not a direct pressure that eroded the SiO<sub>2</sub> refractory as can be observed on **Figure 14**. However, at high frequency (240 Hz) the Lorentz force is incremented (14.269 N) but the liquid metal velocity is lower (6.08 m/s), but its vector direction is perpendicular (against) to the furnace wall favoring the refractory erosion, see **Figure 14** (circled area). Thus, this explain that capillary effect observed on the **Figure 12**, since the Lorentz force is higher at high frequency and providing the pressure needed to fill the pores. In refer to this, Lee and Zhang (1999, 88) explain that other physiochemical variables that effects a refractory – slag system as well the simple penetration due to wetting considered before are: (a) microstructural effects where a smooth surface and dense material may resist ingress whereas a porous one may not, (b) slag line attack and (c) the velocity of slag flow which is often a result of the Marangoni effect. More rapid movement will present fresh slag to the slag/refractory interface.

A vigorous agitation of the liquid metal is undesirable as it tends to pull out the fine grains in the brick by erosion (physical wear). An electromagnetic stirring velocity up to 50 cm/s is enough to provide a bulk material (slag and iron) with changing composition that favor the SiO<sub>2</sub> degradation (Pötschke 2005, 112).

**Fig. 14** Lorentz force and vector velocity direction of the molten.
