M. THOMAS, PRENTICE; CAMPBELL, L. JANICE
EXCAVATIONS AT RIO BEC GROUP B, STRUCTURE 6N-1, CAMPECHE, MEXICO
Estudios de Cultura Maya, vol. XXXI, 2008, pp. 123-148
Centro de Estudios Mayas
Distrito Federal, México

EXCAVATIONS AT RIO BEC GROUP B, STRUCTURE 6N-1, CAMPECHE, MEXICO

PRENTICE M. THOMAS y L. JANICE CAMPBELL
Prentice Thomas and Associates, Inc.

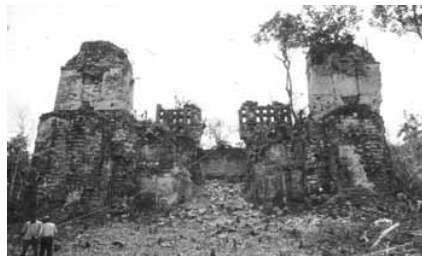
FIGURE 2. Structure 6N-1 as it appeared in 1973

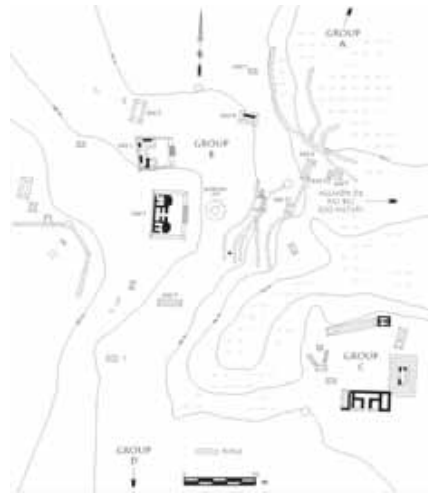
FIGURE 3. Map of Rio Bec, Group B structures and surrounding area

Following the site's rediscovery, the first controlled excavations at Rio Bec were undertaken in 1976. Directed by the primary author, the work was sponsored by the University of the Americas (UdA) and partially funded by a grant from the Jenkins Foundation. The primary focus of fieldwork was Structure 6N-1. A secondary aspect was to survey the area immediately surrounding 6N-1 to produce an accurate and complete map of the ruins of Group B as they existed in 1976 (figure 3).

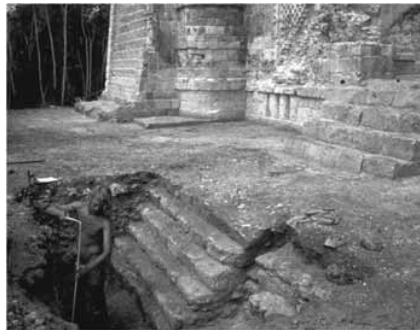
FIGURE 5. Structure 6N-1, Stairway 1

The plaza excavations uncovered a buried stairway two and a half meters due east of the entry stairway into Room C (figure 5). Designated "Stairway 1", it was composed of five steps of cut limestone blocks rising to a small initial plaza that originally fronted the structure. Stairway 1 was covered when the plaza was enlarged and a new stairway (Stairway 2) was constructed. Also consisting of five steps, Stairway 2 was constructed of rows of roughly-shaped limestone slabs with limestone cobbles set between the risers. A north-south retaining wall composed of at least two large, roughly-shaped rectangular limestone blocks

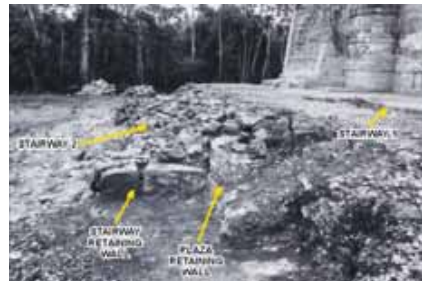
FIGURE 6. Structure 6N-1, Stairway 2

flanked the stairway on the north and south sides (figure 6). Subsequent work by Carrasco *et al.* (1986) and Arnauld (2007) independently confirmed the existence of both the first and second stairways. A cache (Cache 2), consisting of a lidded, unslipped vessel containing a jadeite fragment and a chert projectile point was recovered beneath the surface of the expanded plaza.

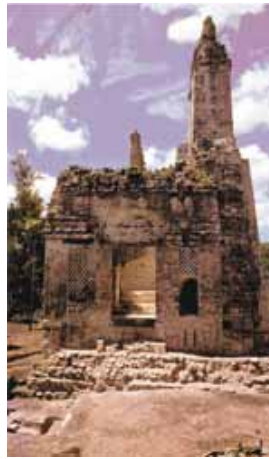
FIGURE 7. South side of Structure 6N-1 following consolidation in 1976

Sixteen 2 m by 2 m units were excavated on the south side of the structure, revealing evidence of a stairway leading from the plaza to the entry into Rooms

A and B (figure 7). No midden deposits were found and artifact recovery varied from a low of 10 sherds in the southeast exterior corner of the structure to a high of over 200 west of the entrance; diagnostics represented types from the Late Preclassic through Terminal Classic periods.

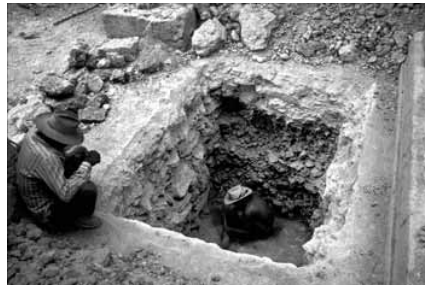
FIGURE 10. Interior pit 6 with limestone pebble and cobble fill under the floor and large slab fill under the exterior walls

There was no evidence of superimposed floors in any of the 13 interior excavations. Throughout the building, the plaster floors were set on top of a course of large limestone slabs overlying rubble fill. In the rooms where there was no

wall to support, the layer of large limestone slabs overlay a fill of small limestone cobbles, and one or more horizontal layers of *sascab* were used to stabilize and level the fill. For structural support of both exterior and interior walls, the large limestone slabs formed a foundation wall continuing unbroken to bedrock. The contrast in construction technique between structural support walls and non-supporting walls is apparent in the south and east profiles of unit 6 in Room 6 (figure 10).

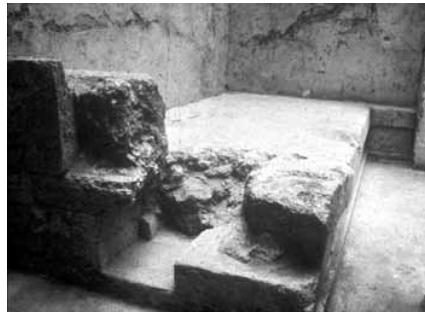
FIGURE 11. Bench with "backrest," north end of Room B

Benches coated with plaster represent original architectural features observed in three of the four rooms. The bench in Room B had a partially intact backrest on the west end where a niche was about 10 cm above the floor (figure 11). Room C had two benches, one at each end of the room, with a small niche in the wall above the south bench (figure 12). Room D was nearly covered by a bench, with a niche on the east side, facing the main entryway (figure 13).

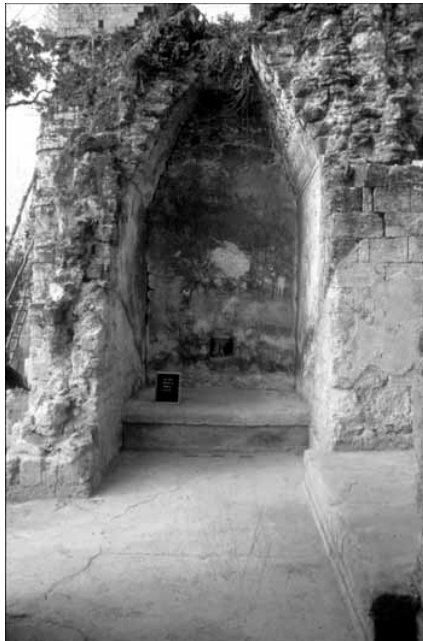
FIGURE 12. Bench and wall niche, south end of Room C

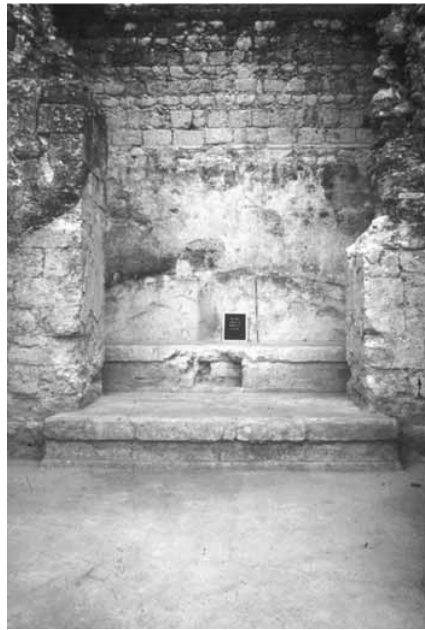
FIGURE 13. Room D from the main entryway showing the bench and central niche

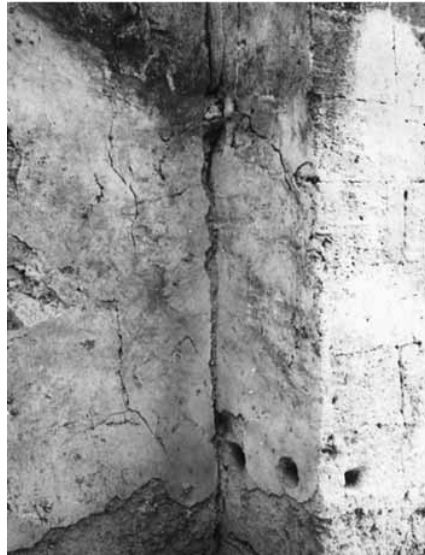
FIGURE 14. Cord holder in Room A

Numerous wall holes were observed in Room A (figure 14). There are two biconically-shaped cord holders flanking the entry doorway on the interior of the room, elevated an average of 50 cm above the floor. Also, four recessed rod holders flanked the interior of the entry door, two located just below the lintel and two elevated less than 50 cm above the floor. All of these holes, presumably for hanging or securing curtains, mats, or some kind of covering over the doorway, were plastered on their interior, indicating that they were installed when the building was erected or at least when the last coat of plaster was applied.

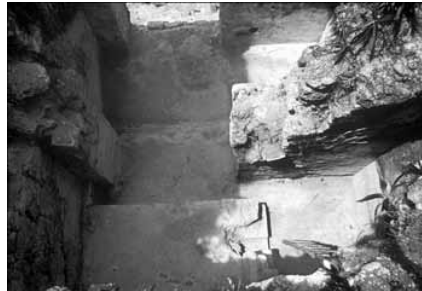
FIGURE 15. View of shortened Rooms A and B from above

On the interior, it appeared that the original east end wall in Rooms A and B was slab masonry of roughly-dressed stones set in mortar with considerable chinking and apparently not covered with plaster. In comparison with the other walls in the structure, this crudeness implies anticipated modification and, in fact, the rooms were subsequently shortened by the addition of rubble fill and the erection of a second wall (figure 15), constructed of more finely cut veneer stones set closely together and covered with a coat of plaster. Since the southern portion of both towers directly overlaid the north end of Rooms A and B, and E and F it is clear that the shortening of those rooms was designed for solid support for the weight of the tower and was apparently planned for in the original

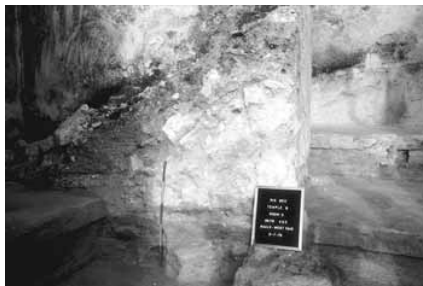
FIGURE 16. Profile of balk in Room C showing the stages of collapse

Subsequent to the first destructive event, the excavations produced evidence of a second episode of collapse, best illustrated in the profile of a balk left during clearing operations in Room C (figure 16). The first episode is represented by a 20 to 30 cm-thick stratum of gray midden-like soil containing artifacts and mixed with collapsed structural stones. We believe that this lower stratum was formed by the initial stage of collapse and was accompanied by a Terminal Classic occupation in the room. The "midden" deposit yielded Terminal Classic ceramics, including, among others, Altar Fine Orange, Jalapeño Scored, variant Jalapeño, Cedro Gadrooned, and Encanto Striated, variant Yokat, along with chert debitage. A metate found directly on the floor by the main entryway to Room C appears related to this occupation as well (figure 17).

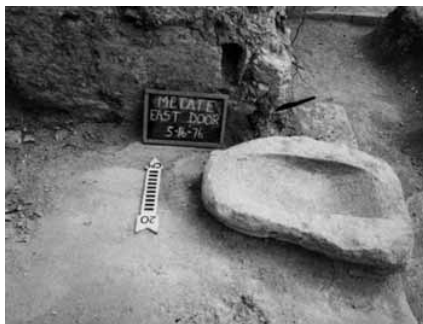
FIGURE 17. Metate found on the floor at the entry to Room C

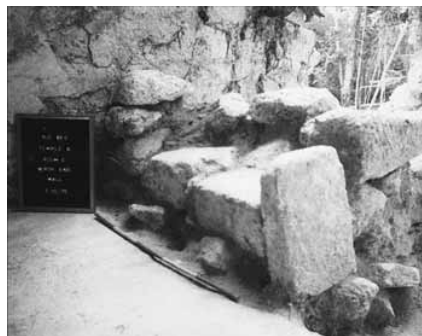
FIGURE 18. Crude wall and occupational debris above the floor in Room C.

midden and rubble from the initial collapse (figure 18). Oriented roughly east/west, this crude wall extended into the room, effectively subdividing the northern two-thirds of Room C from the remaining area. Three stone-lined hearths associated with this occupation were also found above the intact plaster floor, right on top of and amid the initial layer of rubble.

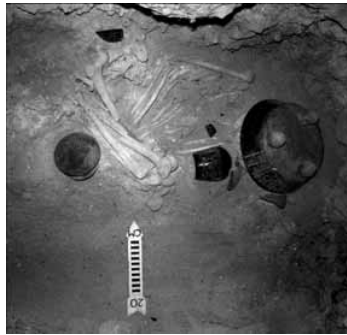
FIGURE 19. Burial 1 from Structure 6N-1, Room D

Unit 1 was laid out in Room D where a small area of the bench had been covered with a patch, on top of which were four stains from incense burning. Excavations extending through the patch encountered a flexed burial (figure 19) of a male, still partially covered with fragments of a woven mat. Ash and charcoal surrounded the skeletal remains. The bones and mat show no evidence of having been exposed to fire, so the ash and charcoal were added to the pit, either before or after the interment occurred.

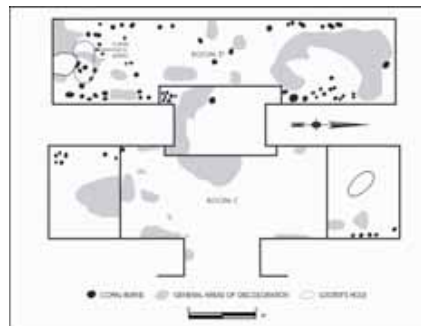
FIGURE 22. Plan of Rooms C and D showing circular stains on the floors

Besides the stains on the floor patch in Room D, mentioned above, circular stains of varying size covered the bench and a few were found on the floor adjacent to the bench. However, none were on the floor within the central part of Room C and the eastern part of the doorway into Room D, where the greatest amount of debris related to the initial collapse occurred. All but one of the intense stains in Room C (figure 22) were on the benches at either end of the room where the vaults remained intact during the Terminal Classic occupation. Very little debris from the initial collapse extended into Room D, and the circular stains occur throughout the room, with most near the side walls. Several stains were also in Rooms A and B, where there was no clear evidence of Terminal Classic occupation, so the affiliation of these episodes of burning is unclear. Within Rooms C and D, however, the combined data suggest the Terminal Classic occupation began after portions of 6N-1 had fallen.
