Acta Scientiarum. Agronomy, vol. 33, núm. 3, julio-septiembre, 2011, pp. 411-416

Gamma-ray computed tomography to evaluate changes in the structure of a clayey soil due to agricultural traffic

Luiz Fernando Pires

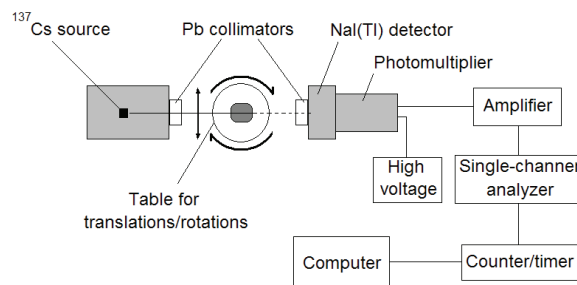
The CT scanner used was a first-generation system with a fixed source-detector arrangement and translation/rotational movements of samples

(Figure 2). Gamma-rays (661.6 keV) were emitted by a 7.4 GBq ¹³⁷Cs radioactive source. Circular lead collimators (1 mm) were adjusted between the source and the detector. A crystal scintillator detector of NaI(Tl) (7.62 x 7.62 cm) coupled to a photomultiplier tube was used to detect the gamma-monoenergetic photons. Samples were rotated over 180° at 2.25° steps; the linear movement steps were 0.14 cm. The voxel size was 1.14 x 1.14 x 1.00 mm³ (as calculated from the ratio of the diameter of the soil sample to the number of pixels of the reconstruction matrix and the diameter of the gamma-ray beam). The acquired data were stored on a PC and the reconstruction algorithm Microvis (2000), developed by Embrapa Agricultural Instrumentation (CNPEDIA – São Carlos, Brazil), was used to obtain the CT images. The calibration of the CT scanner was obtained through the correlation between linear attenuation coefficients μ (cm⁻¹) of different homogeneous materials (water, nylon, acrylic, alcohol, aluminum and brass) and their respective tomographic units (TUs) obtained by the image reconstruction program.

Figure 2. Schematic diagram of the first generation gamma-ray computed tomography (CT) scanner.

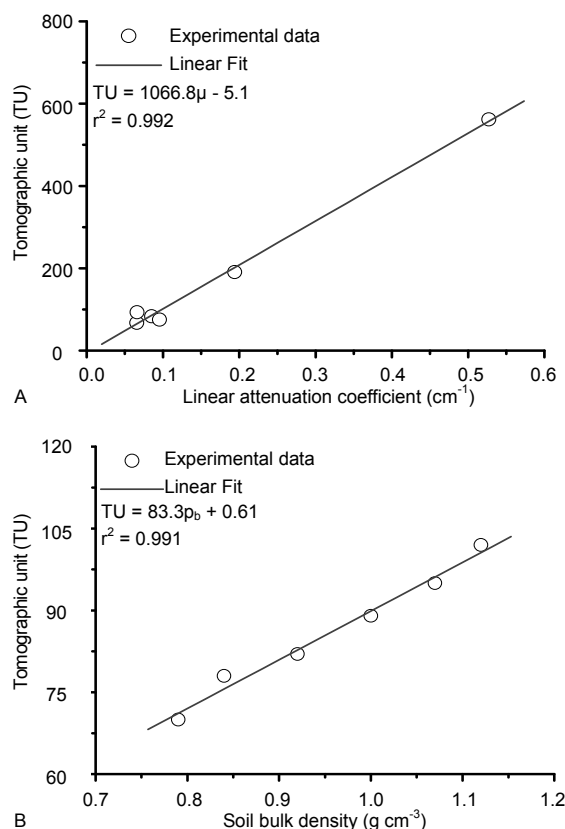
A good linear correlation between the tomographic units and the linear attenuation coefficients of different materials (Figure 3A) was obtained, which is essential to obtain quality CT images (CRESTANA et al., 1985). Soil and water mass attenuation coefficients, for the 661.6 keV photons, were 0.0836 ± 0.0007 and $0.0823 \pm 0.0008 \text{ cm}^2 \text{ g}^{-1}$, respectively. TU increases linearly with dry ρ_b (Figure 3B), showing a linear dependence for different soil compaction states and bulk density (VAZ et al., 1989).

Figure 3. (A) Calibration curve between the tomographic units (TUs) and linear attenuation coefficients (μ) of different materials for ^{137}Cs gamma-photons and (B) TUs versus soil bulk density (ρ_b) of samples with different compaction states.

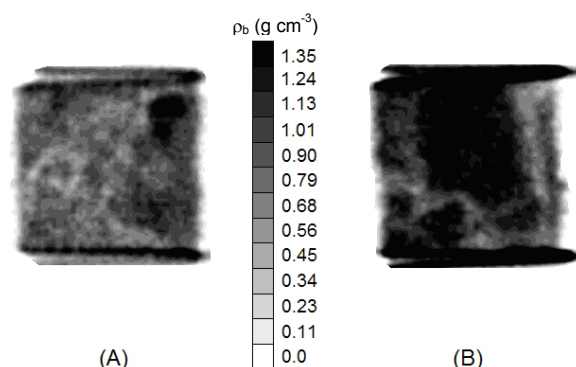
From the 2-D images taken through the gamma-ray CT, it is possible to observe the changes in soil structure induced by the machinery traffic (Figure 4). Figure 4A presents the soil sample not submitted to passages of tractor wheels, showing the existence of several areas of lower density (white areas) and compacted regions (black areas) next to the edges, which represent the photon attenuation by the steel cylinder. However, a very compacted portion can be observed near the lower sample surface.

In Figure 4B, one can see a great increase in regions of higher ρ_b inside the soil sample, which represents a direct result of the two-wheel (2P) tractor passages. As these effects appear to cover almost the entire sample, it is likely that this tropical clayey soil is very susceptible to great changes in its soil pore system after agricultural machinery traffic. According to Pagliai et al. (2003), important damages can be induced in soil structure after passages of rubber tracked tractors, due mainly to the reduction of elongated pores following the same trend of total porosity.

Figure 4. 2-D tomographic images of core samples used for evaluating the effect of passages of tractor wheels on the structure of a Brazilian clayey soil. (A) Sample not submitted to passages of tractor wheels, and (B) sample submitted to two-wheel tractor passages. The scale represents the soil bulk density (ρ_b) distribution.

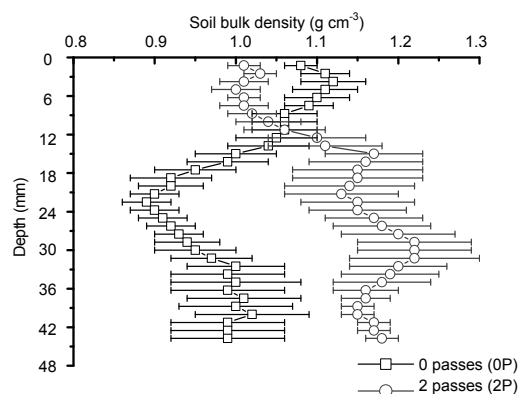
Soil bulk density variations before (0P) and after (2P) tractor wheel traffic are shown in Figure 5. It is possible to observe up to about 10 mm in depth a more dense area for the sample 0P than 2P, which can be explained by the presence of surface crusting for 0P (PIRES et al., 2007). Samples not submitted

Figure 5. Soil bulk density (ρ_b) variations along depth for core samples not submitted and submitted to two-wheel tractor passages. Errors bars are 95% confidence intervals.

However, those submitted to machinery traffic were collected in a 3 to 7 cm deep layer, being the excessive soil carefully trimmed off and top and bottom surfaces of samples made flat. Below 10 mm in depth, a significant increase in ρ_b can be observed after 2P when compared to 0P (Table 1). The ρ_b increment ratio for 0P and 2P in relation to samples collected in the native forest shows a difference of 14% between these two treatments. The increment ratio of density (Γ_n) parameters obtained in this study are higher than those measured by Marsili et al. (1998) also comparing 0P and 2P ($\Gamma_n=0.13$).

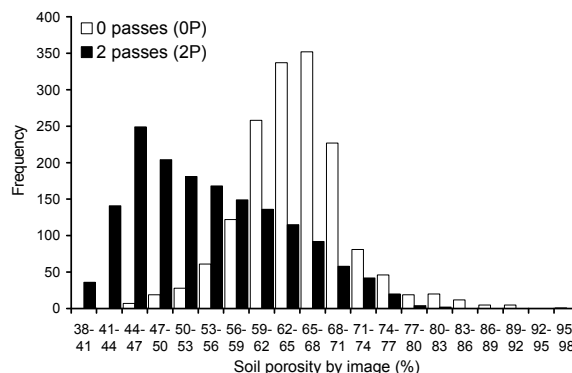
The increase in ρ_b after passages of tractor wheels can be explained by macropore decreases (MARSILI et al., 1998; PAGLIAI et al., 2003), once soil volume is reduced during soil surface load application by heavy vehicle traffic (Figure 6). This compaction

Figure 6. Changes in the soil porosity by image (ϕ_i) for core samples not submitted and submitted to two-wheel tractor passages. The frequency represents the number of points added in the matrix of soil bulk density (ρ_b) used to reconstruct the 2-D tomographic images.
