LAND REHABILITATION WITH THE USE OF BIOLOGICAL GEOTEXTILES, IN TWO DIFFERENT COUNTRIES

Sociedade & Natureza, vol. 22, núm. 3, diciembre, 2010, pp. 431-446

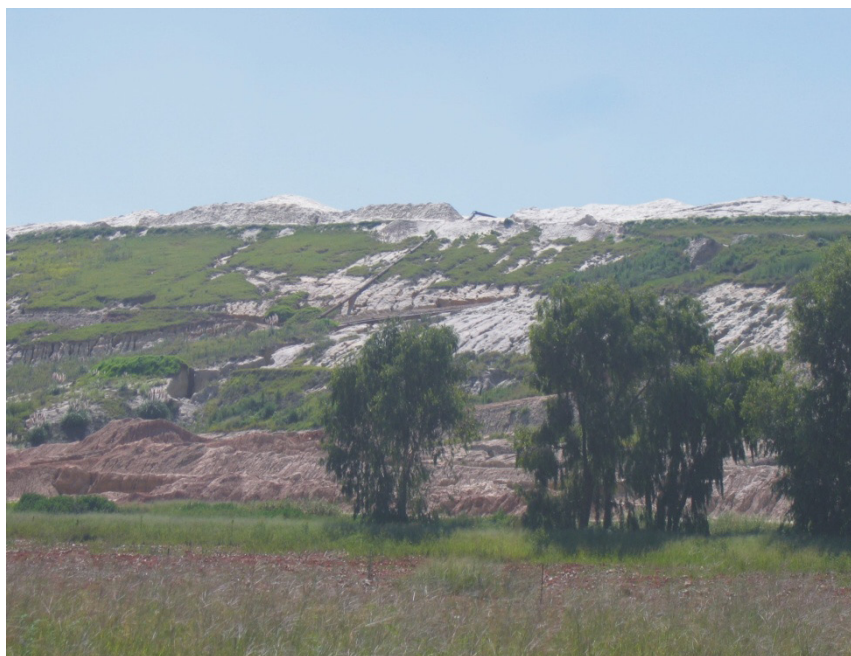
Figure 2: 'Mega-dump' of reprocessed gold tailings, south-east of Springs, Gauteng Province. Heavy rains in February 2008 led to landslides that denuded large parts of the previously vegetated slope.

Krugersdorp in the west part of Johannesburg and Soweto to Boksburg in the east and on to Springs (Figure 2). This waste belt is situated in a densely populated urban area.

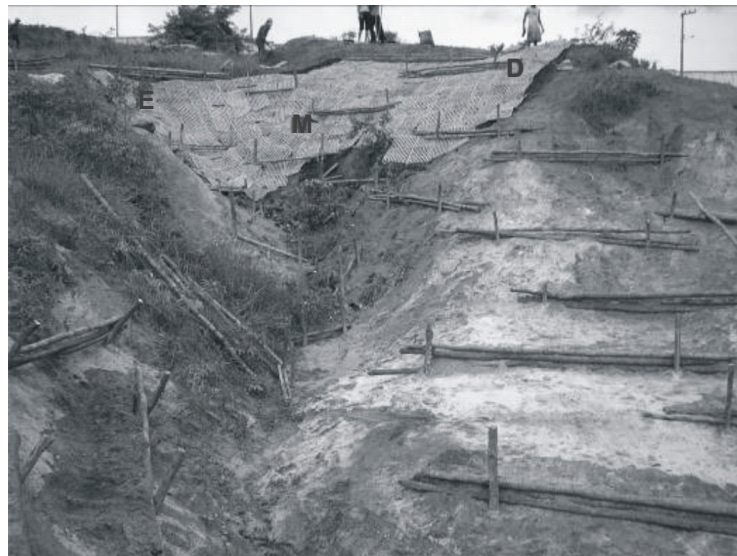
Figure 3: Area 3 of the rehabilitated area, with work in progress. E, M and D were reshaped exclusively by manual labour, São Luís, Brazil. Source: LAGESOLOS, 2008.

techniques included: 1. Buriti geotextiles in association with barriers of wooden stakes (Figure 3) and the construction of terraces along contour lines; 2. Analysis of sediment particle-size; and 3. Photo comparison of vegetation cover development.

The rehabilitation work in Sacavém was divided into three areas, presented in Figures 4 and 5, because of local relief characteristics. Areas 1-3 (Figure 6) were constructed with men and tractors; areas 4-8 (Figure 6) were made in the higher parts with a tractor; and areas E, M and D (Figure 3) were reshaped exclusively by manual labour.

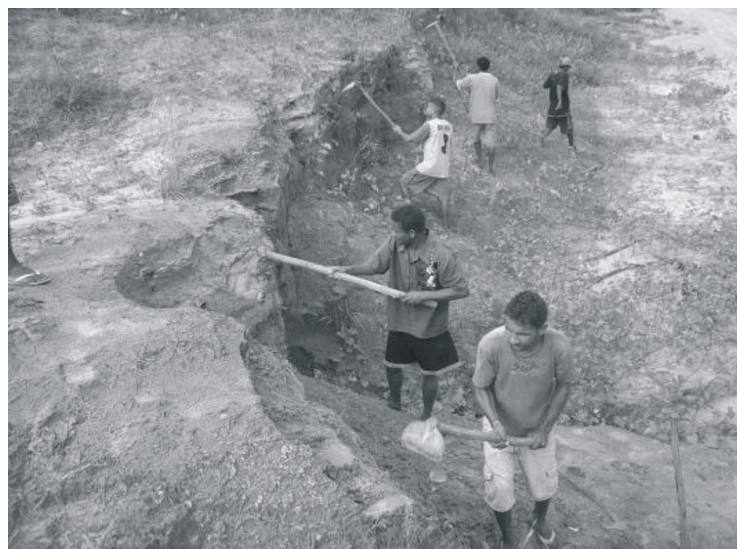
Figure 4: Men working with hand-held tools, São Luís, Brazil. Source: LAGESOLOS, 2008.

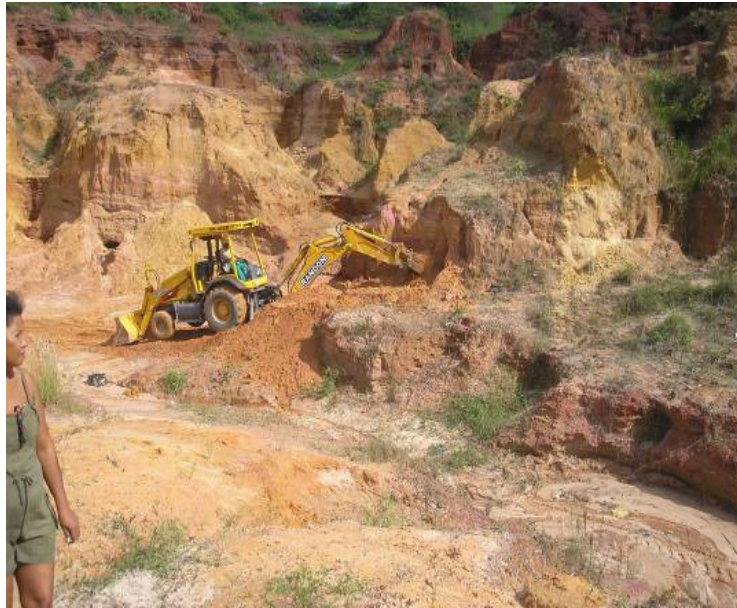
Figure 5: Initial work in areas 4-8. Source: LAGESOLOS, 2008.

caesalpiniae folia) was used on the higher parts of the gully, to protect the topsoil. The rehabilitated area was fertilized with 500 kg ha⁻¹ of NPK (4-14-8) and decomposing palm was added to topsoil, as a source of organic matter. The project employed 10 local men for six days, who conducted the work using hand-held tools (Figure 4). A tractor (type backhoe loader) was used for two days to construct the terraces (Figure 5).

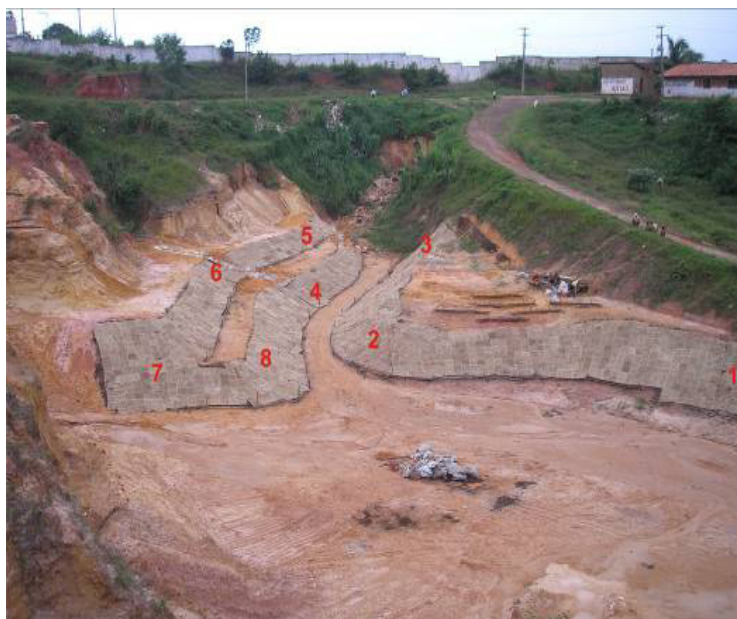
Figure 6: Rehabilitated areas with cover of buriti geotextiles, Sacavém Community, São Luís, Brazil (Areas 1-3 were constructed with men and tractors; areas 4-8 were made in the higher parts with a tractor). Source: LAGESOLOS, 2008.

In Part 1 (Figure 6: areas 1-3) the team used biological geotextiles and organic matter from decomposing palms, seeds and inserted barriers of wooden stakes along contour lines. This area had formed due the concentration of runoff from the street above the gully (Figure 7).

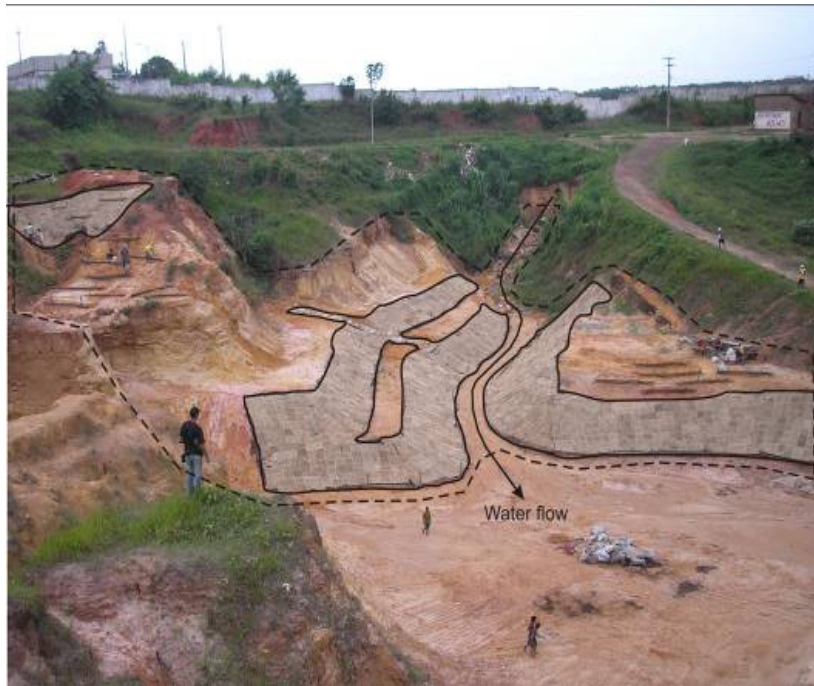
Figure 7: Continuous lines: areas rehabilitated with Buriti palm mats.

Hatched lines: the rehabilitated area in Sacavém Community, São Luís, Brazil. Source: LAGESOLOS, 2008.

Area 3 was made by men using Buriti biological geotextiles, organic matter from decomposing organic material (palm trees and leaves), wooden stakes and the planting of shrubs, as inaccessibility prevented tractor work. To reshape the internal part of the gully, we used techniques to minimize water flow energy, using many barriers of wooden stakes (Figure 3) and the application of biological geotextiles, grass seeds and organic matter from decomposing palm leaves. On the barriers, Sabiá bushes were planted to stabilize the topsoil. The rehabilitated area in Sacavém Community is ~2000 m² and ~800 m² is covered with Buriti biological geotextiles (Figure 7).

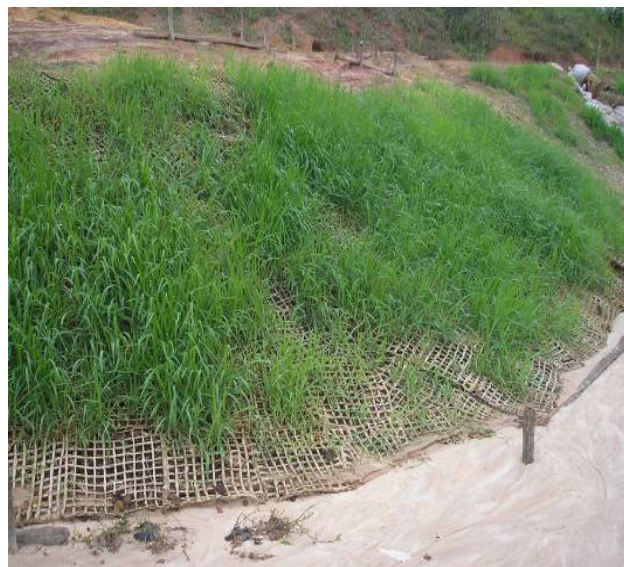
Figure 9: Grass development, one-month after rehabilitation, Sacavém community, SãoLuís, Brazil. Source: LAGESOLOS, 2008.

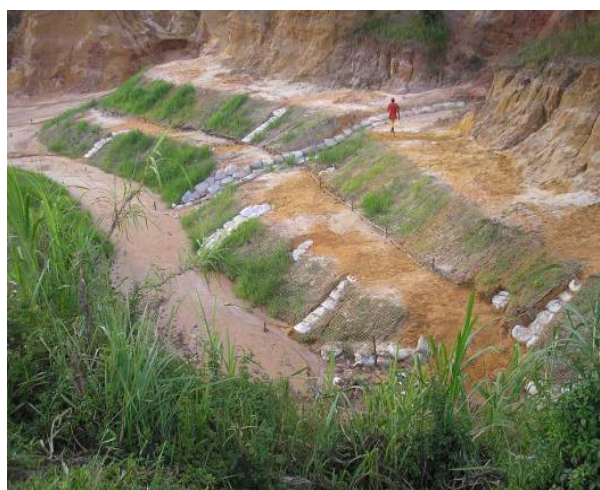
Figure 10: Maintenance work at the rehabilitated area one month after rehabilitation, Sacavém community, São Luís, Brazil. Source: LAGESOLOS, 2008.V

For one month after the rehabilitation work São Luís City experienced intense and prolonged rains (Table 4), which presented attendant problems for the rehabilitation work. However, we again employed local people to work on site maintenance (Figure
