The Intense Rain and its Contribution to the Collapse of the Embankment at the Highway GO-213 of the city of Caldas Novas, in the State of Goiás: a Contribution to the Studies of erosive dynamics.

Sociedade & Natureza, vol. 1, núm. 1, mayo, 2005, pp. 815-824

The Intense Rain and The Collapse of the Highway GO 213: Some Comments

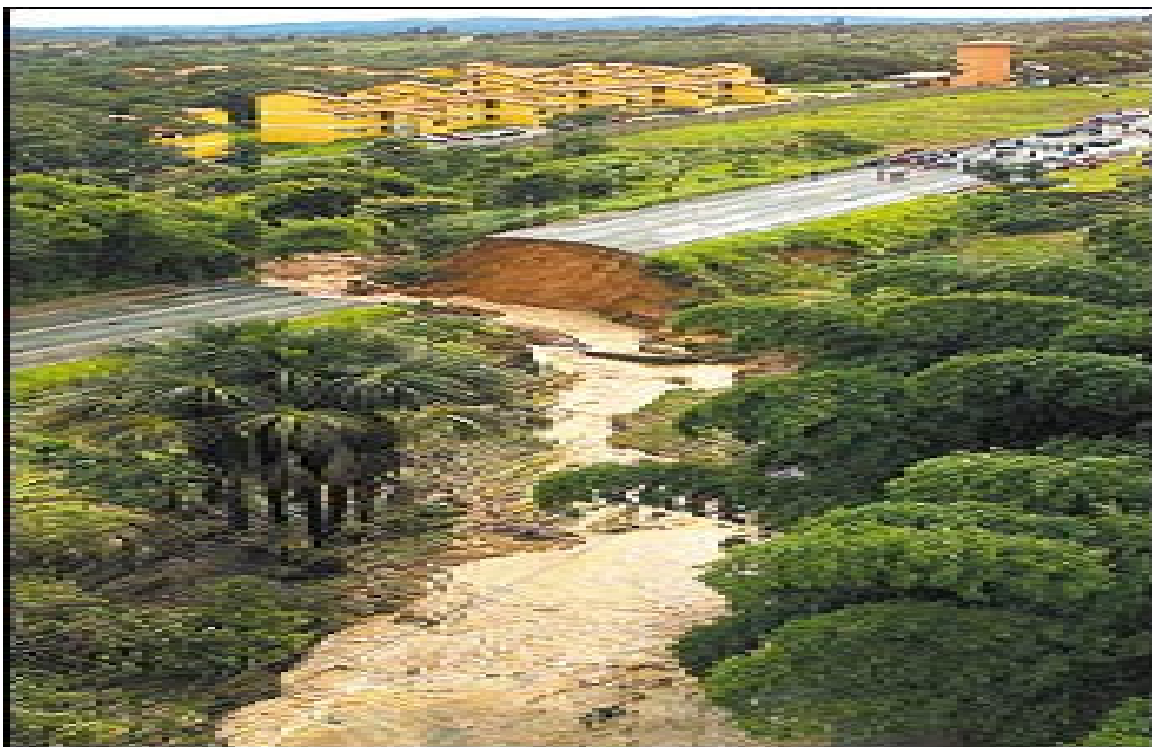
Picture 01_Open crater on the highway GO-213.
(Source: Journal O Popular)

In Caldas Novas, the rain which occurred mainly in the summer months, has been causing a lot of problems for its population. On January 17th, 2005, after a long period of rain, the embankment under highway GO-213 collapsed (Picture_1), taking the lives of three people. One of the hypothesis proposed out by the authorities to explain the causes of this accident was the great intensity of rain on the 17th. Nevertheless, the observation of the data on the precipitations, as well as the location of the collapse and its surroundings, reveal that not only these factors, but other

volume of water caused the infiltration and destruction of the embankment, for the pressure of the highway lane and of the trapped water forced its collapse, creating a crater of approximately 40 meters long and 15 meters deep, engulfing three vehicles that were passing by at that very moment, taking the lives of three people.

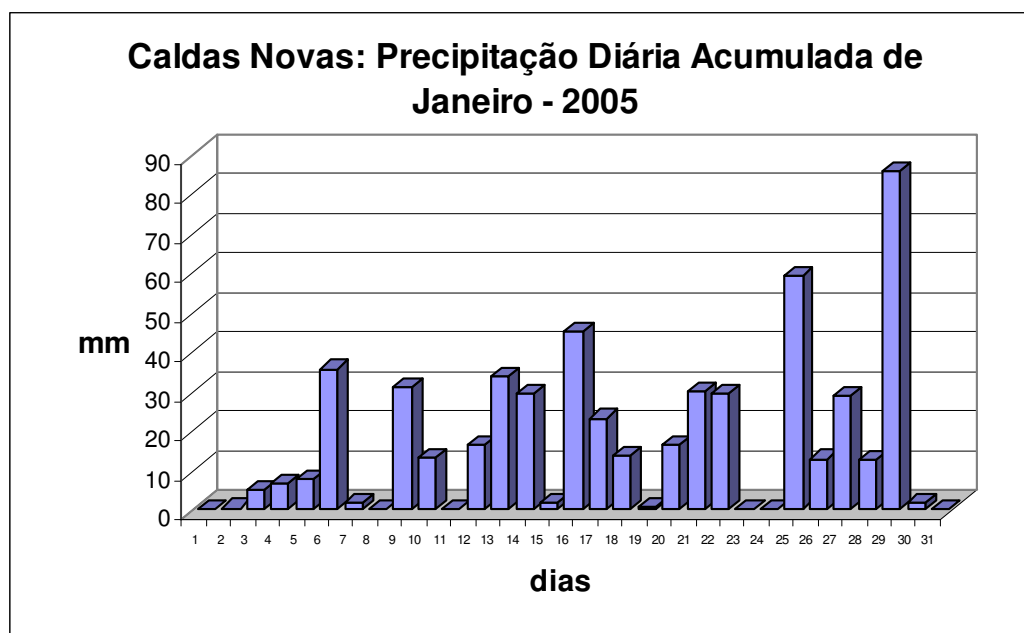
Caldas Novas: Daily Accumulated Precipitation of January 2005.

In January, 2005, as shown in the graphic below, the rain was distributed in three big episodes, which correspond to the period of time between the arrival and action of a cold front and its replacement by a new cold front. The first started on the 3rd. and ended on the 11th, the second began on the 12th. and came to an end on the 22nd, and the third that commenced on the 25th. and finished on the 30th.

As observed in the graph, from the data collected in the FURNAS station, the rain which occurred on the 17th. was not the highest level of January, but that of the 29th which registered up to 85.5 mm. But, if this rain was not as heavy as believed nor the highest of the month, what might have caused the damage at GO-213? The problem is that the precipitation occurred in a concentrated way, that is, almost all of the precipitation occurred in a short period of time, right after a long period of rain that lasted approximately two weeks. This precipitation encountered a soil very close to reaching its field capacity, which resulted in a rapid superficial drainage to the Jacu stream, causing a sudden elevation of its water level and thus contributing to the collapse of the embankment built over the GO-213.

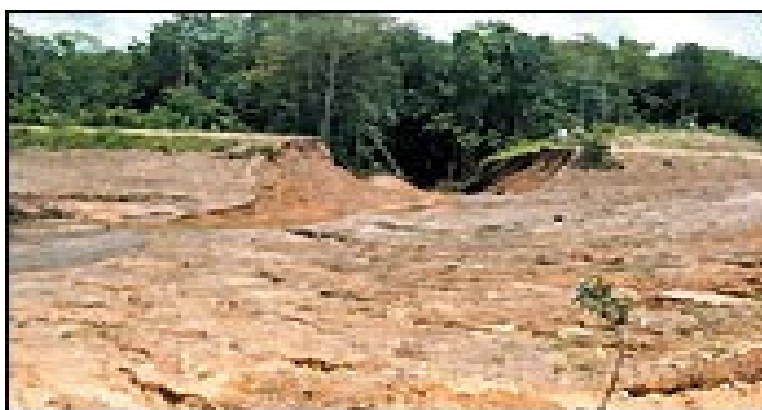
Picture 02 - Destroyed dam near the area of the collapse.

The region that the streamlet courses, from its headwaters to the studied area has a highly saturated soil, what can be easily demonstrated in the work done on the banks of the stream. Deforested areas, especially along the river in the micro basin of the Jacu demonstrate that the area shows a reduction of its water absorption capacity. Deforested areas contribute greatly in a large portion the erosive process and increase the process of sand accumulation in the bottom of the of the Jacu basin. Other noted environmental damage, besides the deforestation, are some areas of illegal exploration of the clay (soil) of the streambed, and the presence of collapsed dams probably due to the great volume of water during the studied period.

The sum of these elements: high pluviometric rates, the geomorphology of the region, the sand accumulation in some parts of the streambed, the collapse of dams and deforested areas contributed to the creation of atypical situation, with a great increase of the water volume that would normally pass through the water pipeline built under the highway GO-213, the location of the accident.

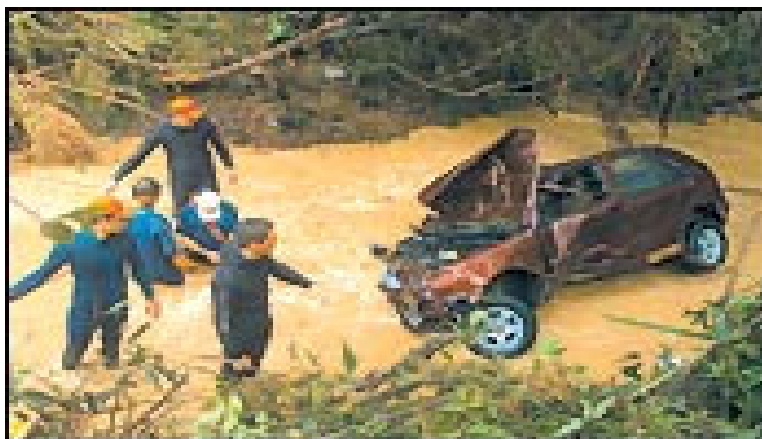
Picture 03 - Vehicle involved in the accident at GO-213
(Source: Journal O Popular)
