Lawall, Sarah; Tamiozzo Pereira Torres, Fillipe; Rocha, Geraldo César  
DIAGNOSTIC AND PROPOSAL OF RECOVERY OF THE LAKE MANACÁS WATERSHED, CAMPUS  
OF THE FEDERAL UNIVERSITY OF JUIZ DE FORA, MINAS GERAIS  
Sociedade & Natureza, vol. 1, núm. 1, mayo, 2005, pp. 494-501  
Universidade Federal de Uberlândia  
Uberlândia, Minas Gerais, Brasil

# **DIAGNOSTIC AND PROPOSAL OF RECOVERY OF THE LAKE MANACÁS WATERSHED, CAMPUS OF THE FEDERAL UNIVERSITY OF JUIZ DE FORA, MINAS GERAIS**

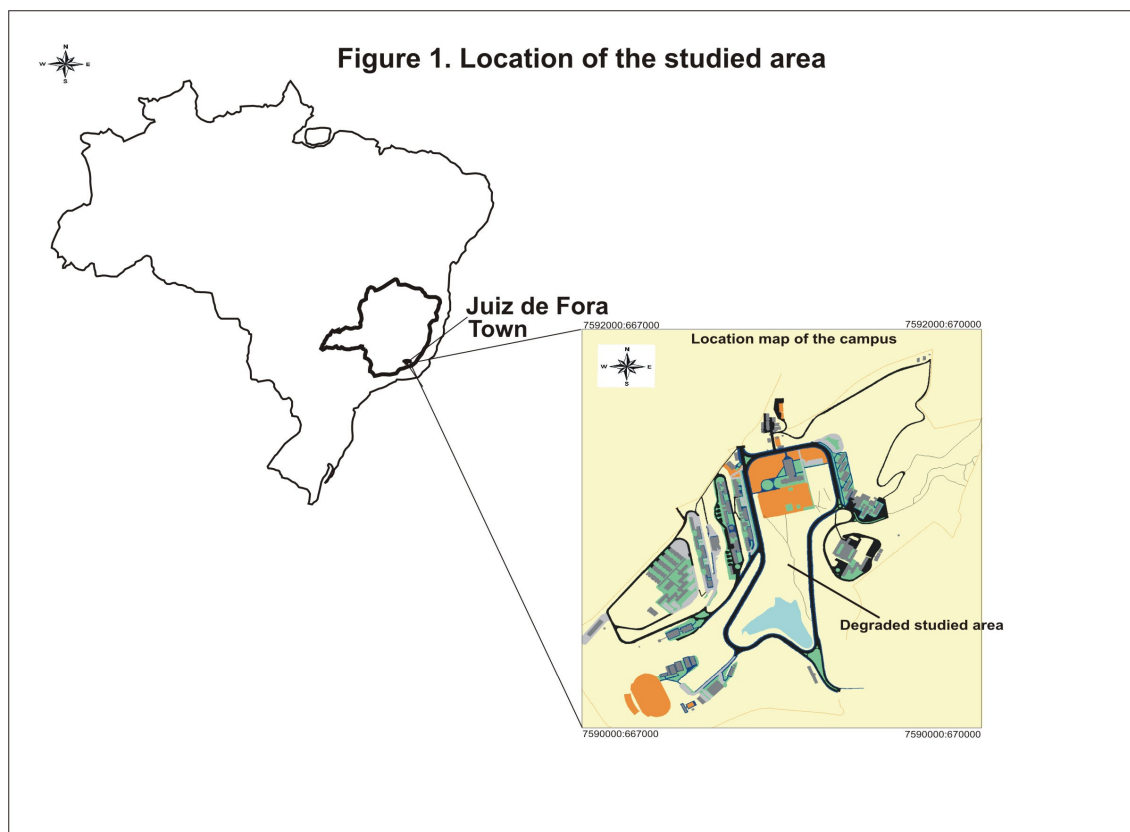
The Manacás Lake is situated at the central part of the Juiz de Fora University, at 21° 45' S and 43° 21' W, in the municipality of Juiz de Fora, Minas Gerais, Brazil (figure 1). After ROCHA et al (2003), the lake is an artificial system that occupies 2 ha in area and has 5

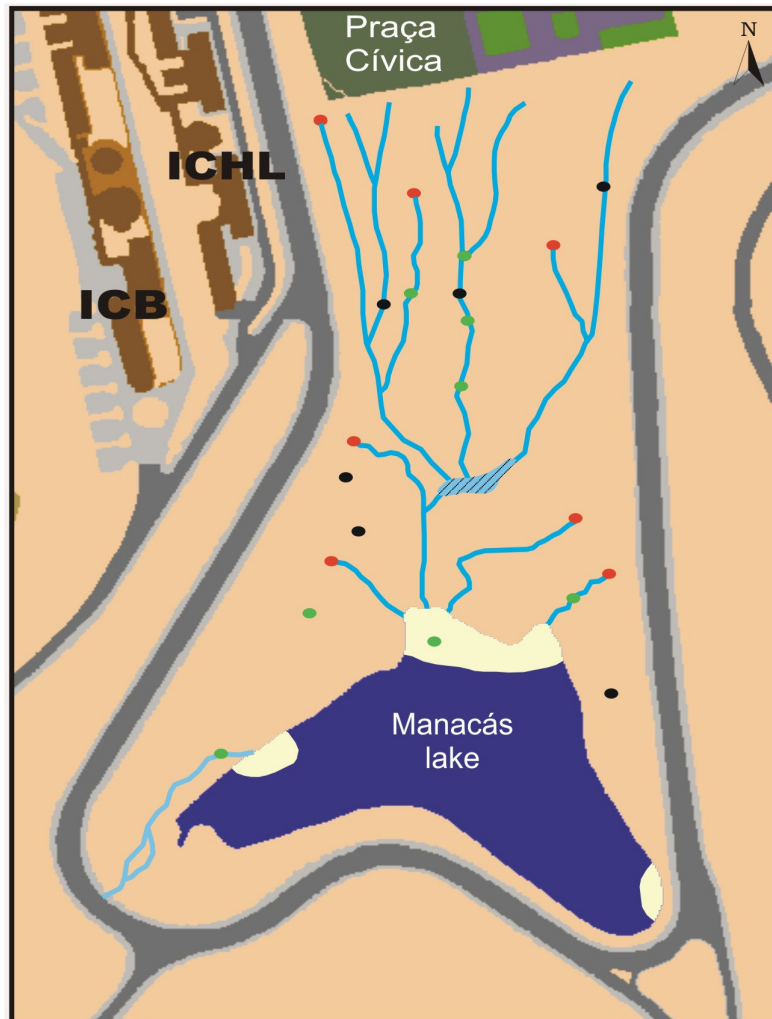
## Manacas Watershed, UFJF campus

The results obtained after the environmental assessment show a scenario of intense degradation of the studied area. The figure 2 displays the main physical characteristics that were mapped.

- Springs
- Soil profiles
- Erosion pegs
- Sedimentation in the lake
- Drainage and erosion lines

Several aspects can be cited related to the degradation of the area. At the drainage channels one can observe the severe impacts of erosion. The channels expose the soil profiles, where it can be noted the absence of A horizons, denoting intense laminar erosion. The channels itself are clear results of linear erosion, in the form of furrows, ravines and gullies, that follow the north/south linear erosion direction. Besides that, the strong soil compaction is another aspect

of degradation, resulting in decreasing of soil permeability, and, in this way, increasing the run off and consequent erosion and transport of sediments to the lake.
