DEGRADATION OF LANDS IN URBAN AREAS

Sociedade & Natureza, vol. 1, núm. 1, mayo, 2005, pp. 808-814

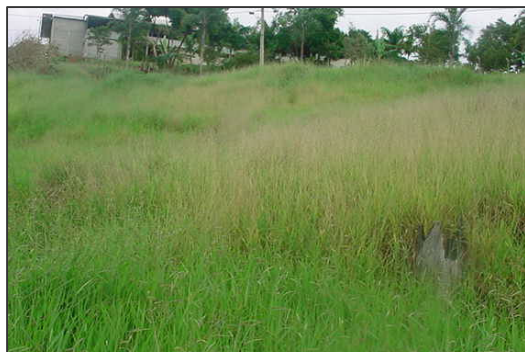
Illustration 1 – Erosion to laminate

1. Erosion to laminate. The water goes down the hillside, "washing" the surface of the land as a whole, do not forming much defined channels of drainage (Illustration 1).
2. Erosion in furrows. The water ponds for preferential roads, deepening the furrows for the transport of material of the soil, what can cause the appearance of ravines (Illustration 2).
3. Erosion for gullies. The ravine reaches such depth, reaching the sheet water table. The removal of material of the bottom and of the walls of the gully it forms emptiness inside the soil, creating collapses (Illustration 3).

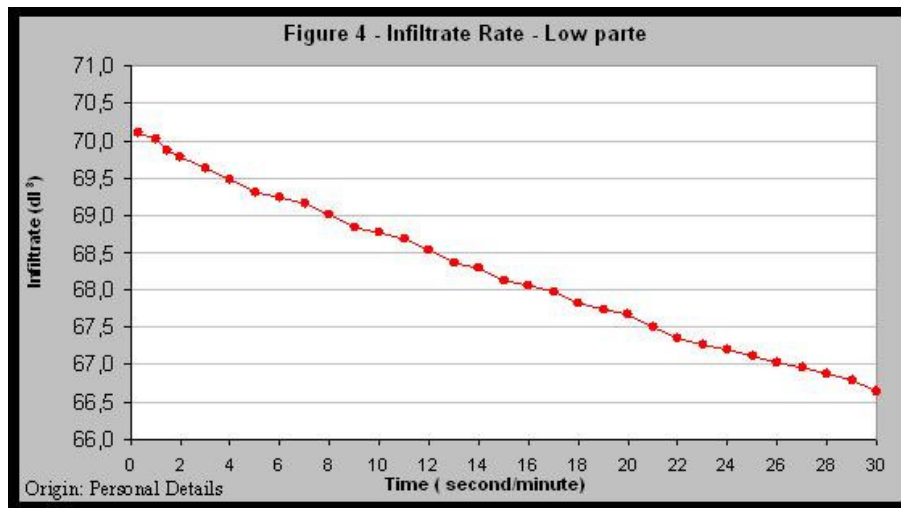
The infiltration tax was determined with base in three point's samples, for a darkened day of winter, with humid soils. The Illustrations 4, 5 and 6 correspond, respectively, to the first, second and third point of the sample.

The first point consists the base of the gully. That place is characterized by the prevalence of Red-Yellow Latossolo, with horizon exposed C. The Illustration 4 shows the tax of infiltration of the level base of the gully, elapsed 30 minutes of the first observation. It is observed that this place of the gully possesses a low capacity of infiltration of water, only 3,5 dl³. The characteristics that contribute to that result are the compacting of the horizon C in that place, which is very susceptible to the intense superficial erosion, due to the low capacity of retention of water. That contributes to the lowered of the level of base of the gully, pressing the bottom and their walls, giving origin to the fractures or collapses that can enlarge and/or to create arms in the gully.

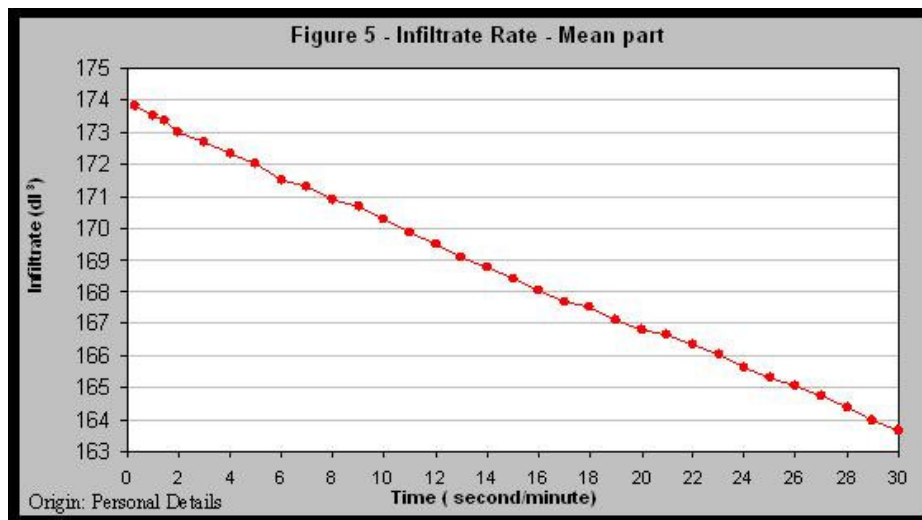
The second point's sample consists of the medium part of the gully. That place is characterized by the prevalence of Red-Yellow Latossolo, with horizon A superficial varying from 5 to 10 cm of thickness. The Illustration 5 presents the variation of the tax of infiltration of the medium part of the gully, elapsed 30 minutes of the first observation.

In this place, the gully presents a capacity of infiltration of water superior to the first point, being of the order of 10,5 dl³. The characteristics that contribute to that result are the existence of a superficial layer of organic material.

It is foreseen that such results can act in two ways: in an initial moment of precipitation, in the case that the capacity of the infiltration soil is not exceeded, the superficial erosion will be smaller, contributing to certain stability of the walls of the gully. On the other case, in casing the precipitation exceeds the capacity of infiltration of the soil, taking it to the saturation, fact already observed in the swinging watery rain of the months of October to April, this can cart the fall of the walls of the gully and formation of new arms.

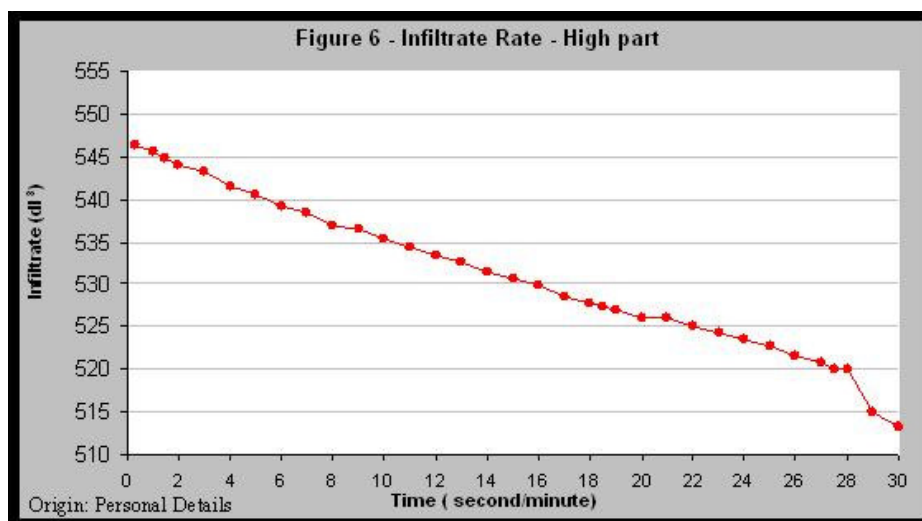
The third point's sample consists of the superior part of the gully. That place is characterized by the prevalence of Red-Yellow Latossolo, with horizon A varying from 15 to 20 cm of thickness, with low vegetation. The Illustration 6 presents the variation of the infiltration tax at the superior part of the gully, elapsed 30 minutes of the first observation.

The capacity of water infiltration at that place is very superior to the first and second points, being of the order of 34 dl³. The characteristic that favors that result is the existence of a significant layer of organic material. This contributes to promote the reduction of the superficial erosion, which collaborates for the stability in the degradation of the superior part of the gully.

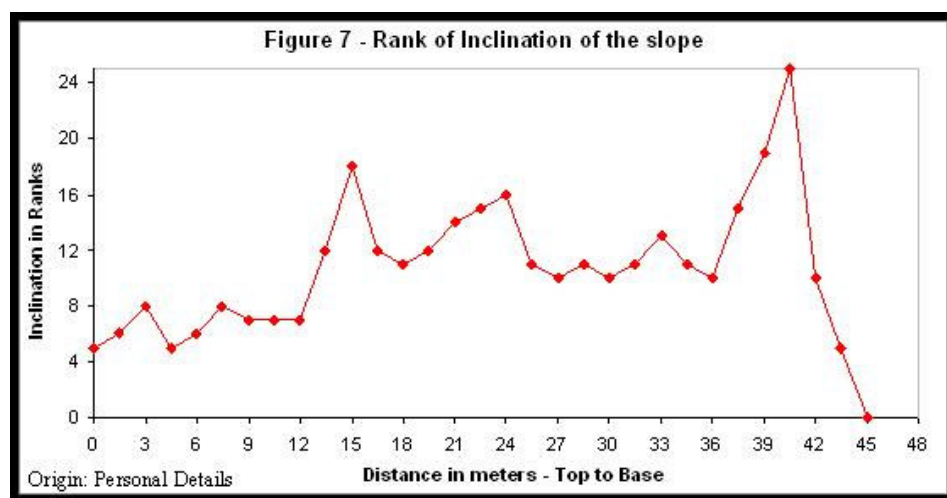
The largest steepness of the hillsides implicate in larger speeds of the superficial drainage of the waters. A larger length of the hillside suggests in a larger time of drainage, consequently, larger erosion. The Illustration 7 display the degree of steepness of the hillside where locates the gully, according to the method of Pitty (1968).

It is verified starting from the graph that in the high part of the hillside, place where begins the gully, the steepness are in general smaller and relatively homogeneous. However, in the medium part of the hillside, the steepness begins to oscillate with more frequency. There also locate the largest gullies of the lateral walls of the gully. Already in the base of the hillside this possesses a high steepness, but stabilizing quickly. Such results obtained don't make possible to associate yet, the lateral degradation of the gully with the intensity of the steepness variation, because the monitor results of the evolution of the gully still preliminary.

In the rising of the steepness, it was noticed that these begin to oscillate in the medium part of the reaching huge proportions, place where it also locate the largest land falls. The results point to a tendency of larger lateral degradation of the reaching huge proportions, because the rain allied to the steepness and the current deposition of residues. It was some factors that are aggravating the stability of the place.
